# REBUILDING WOOD TRUSSES WITH STEEL

Moisture damage to structural elements required an innovative solution to preserve a historic structure

By Ethan Buell, P.E., and David Carroll, P.E.

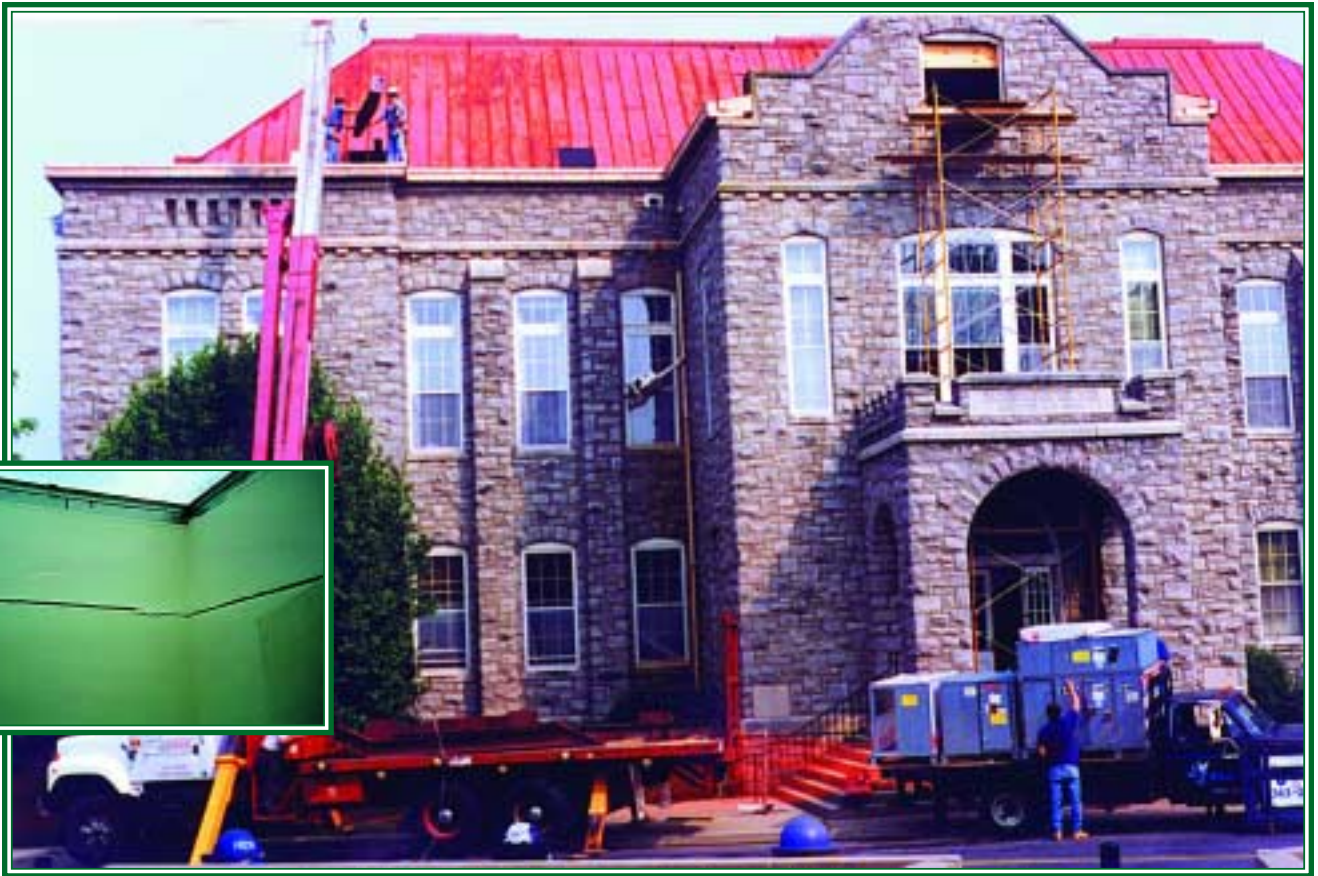
Pictured opposite: The front of Hume Hall, a historic building that suffered massive water damage from leaking, concealed gutters. (Inset: Typical large cracks that appeared in light wells prior to the renovation.)

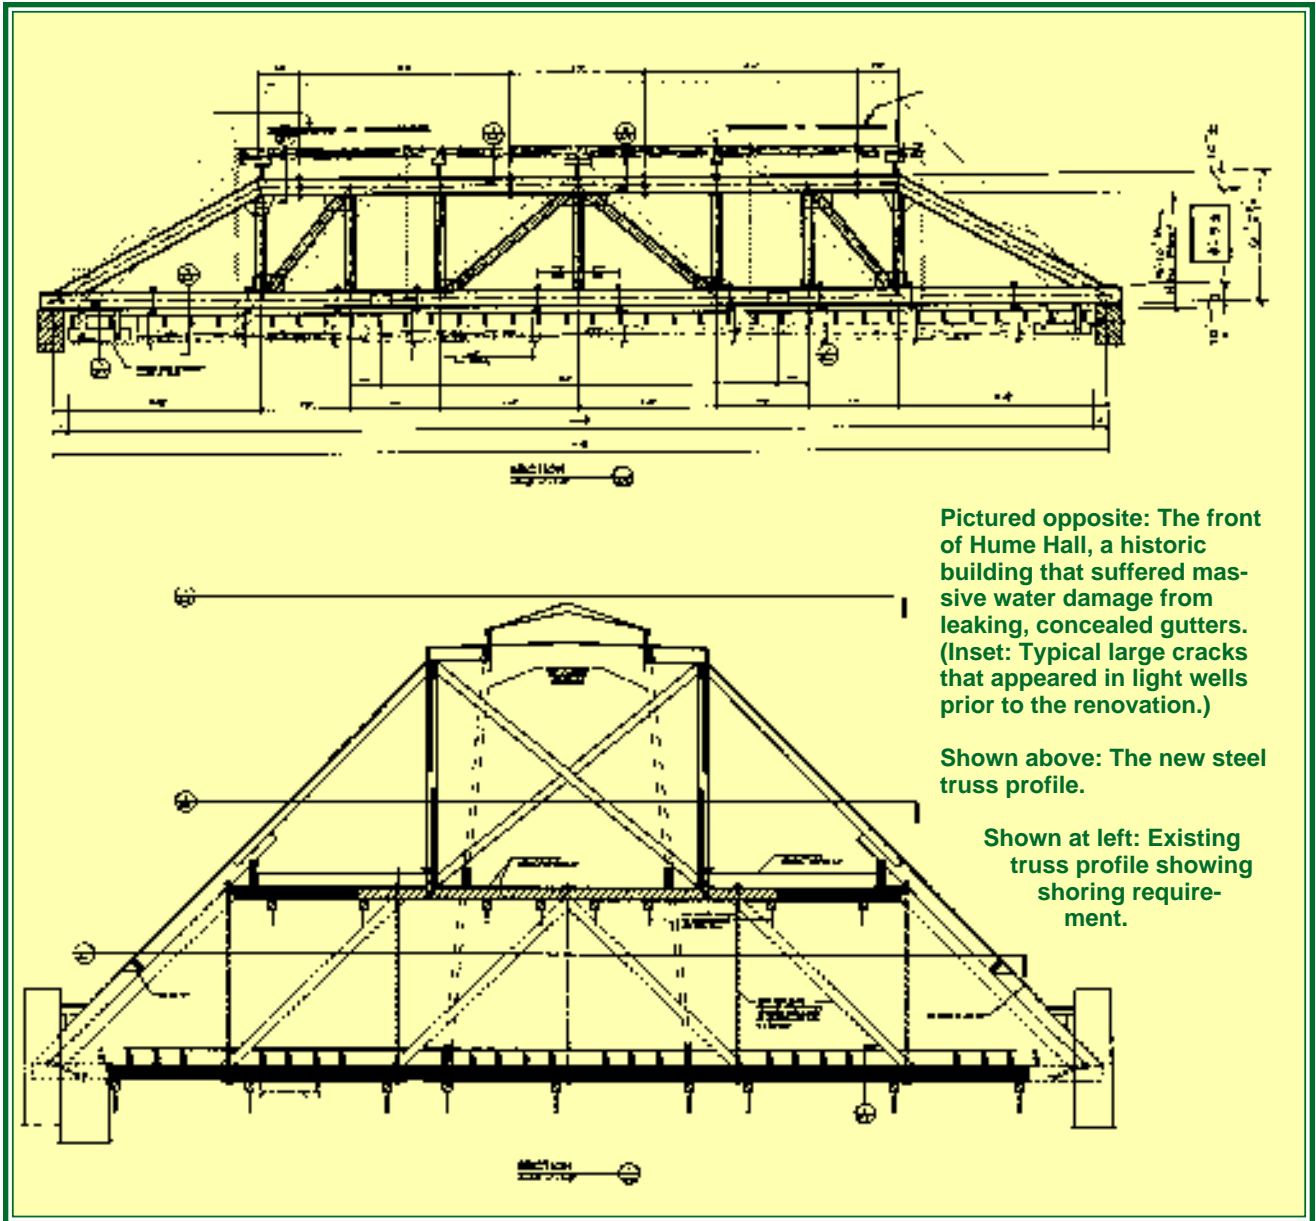
Shown above: The new steel truss profile.

Shown at left: Existing truss profile showing shoring requirement.

The third idea, which ultimately was accepted, was to build a new steel truss inside the chords of the existing wood truss after first carefully shoring the existing trusses' top and bottom chords (from the second floor). Since the trusses could be done one at a time, the shoring could therefore be reused. Additionally, shoring only one truss at a time would serve to limit the load to the second floor. After the shoring was installed, the contractor would then remove the existing trusses' web members. The new steel trusses would be prefabricated with bolt-

The new trusses incorporated adjustable supports to hold up the existing wood top chords and adjustable hangers for the existing wood bottom chords (which could not be removed since they were integral with the roof and ceiling). We developed preliminary sketches and met with two general contractors to get their comments and to collectively arrive at a budget cost figure. Once this method gained the constructability approval and we felt safe with our construction cost estimate and schedule, we then arranged for a meeting the owner and architects. We presented our concept, along with the cost and schedule estimates. We also discussed how only a small roof cut near each truss would be required for letting materials in, thereby minimizing the chances of storm water damage. Our method was reviewed in detail and approved. We then proceeded into final design documents.

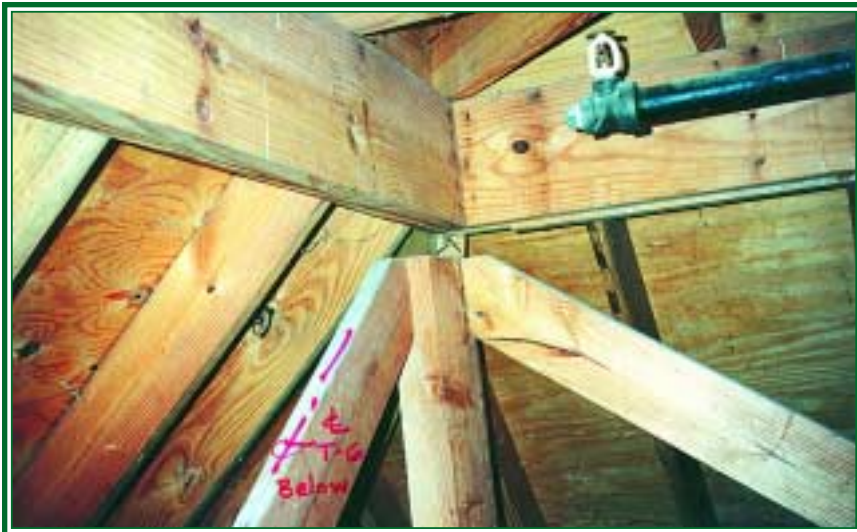
*Note the large separation in the roof framing.*

- Original and subsequently added lateral bracing on the trusses was inadequate, which created large lateral (sweep) and differential movement in the trusses.
- Nearly all of the trusses have had moisture decay to some degree, particularly near the bearing ends where the original concealed gutter was leaking (as a side note, many of the exterior walls had experienced significant water damage).
- The existing attic was very poorly ventilated due to insufficient louvers and a dysfunctional exhaust fan motor; this high temperature and moisture level in the attic contributed to the deterioration of the wood trusses.

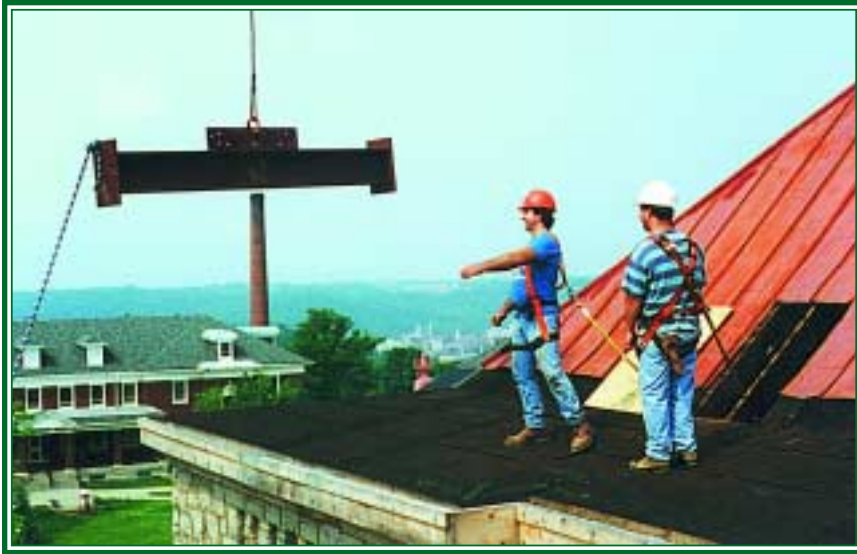
*Pictured is a close-up view of a truss member as it is transported to the interior of the structure.*
