Airport features a Seismic Retrofit during Construction

By Emmanuel E. Velivasakis
and John Abruzzo

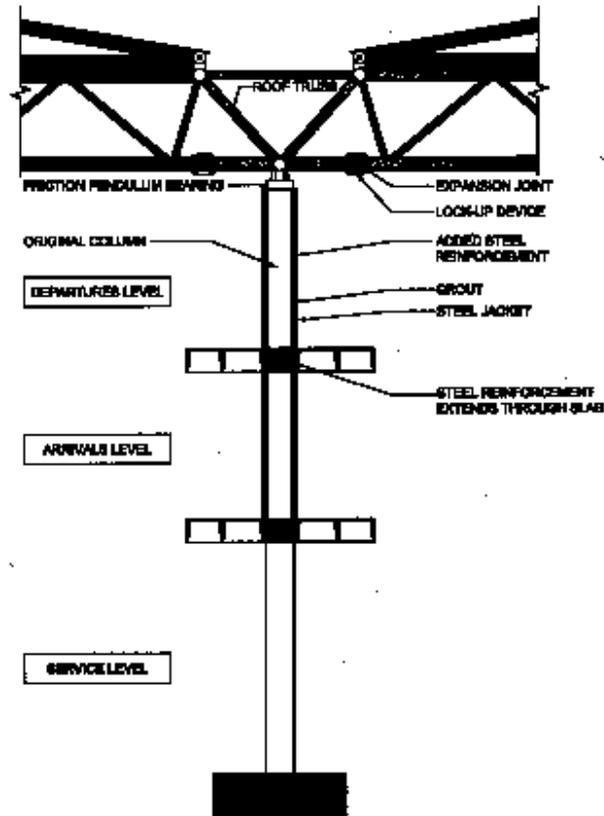
Terminal Building construction showing steel reinforcement.

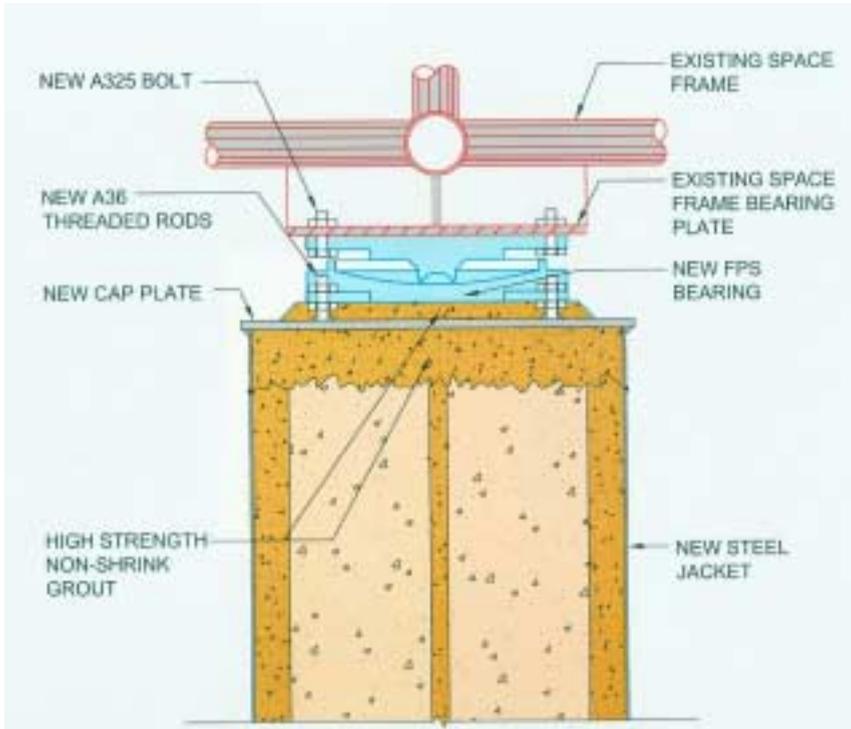
Top left: Retrofitted column with seismic isolator.

Isolation was achieved with the installation of Seismic Isolation Devices (SID's) under the steel space frame supports, at the top of the departures-level columns. The team decided to use friction-pendulum type isolators because they are compact, non-directional, and can readily accommodate the large deformations expected. These isolators would allow the roof to swing like a pendu-

lum, from side to side, as much as 250 mm during an earthquake. The roof shear is controlled by the friction coefficient of the isolators, thus allowing a reduction of the shear to acceptable levels in the columns below. The movement of the steel roof would be inconsistent with the movement of the penthouse slab. Therefore, rather than installing the required expansion joints and upgrading the penthouse slab support structure, it too was retrofitted to float with the roof. In all, 130 friction-pendulum-type isolators, manufactured by Earthquake Protection Systems, Inc. of Richmond, California, were installed in the terminal.

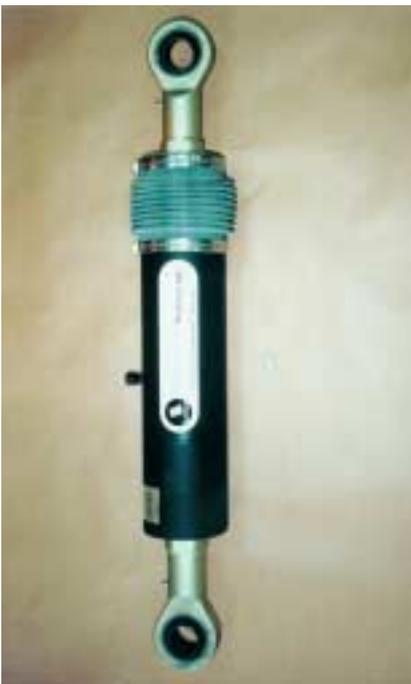
Bottom left: Typical lock-up device (Courtesy of Taylor Devices, Inc.)

be outfitted with a set of Lock-Up Devices (LUD's), located at key roof space-frame expansion joints. The LUD is designed to allow movement through the device when the motion occurs at a slow rate. However, the device will lock when the movement occurs quickly, as would be expected during a seismic event. This device effectively allows the space truss framing to move for thermal loads, but creates a diaphragm during a seismic event. This provides a rigid roof structure and allows the space truss framing to act as a single structural unit. The LUD's selected were manufactured by Taylor Devices, Inc.

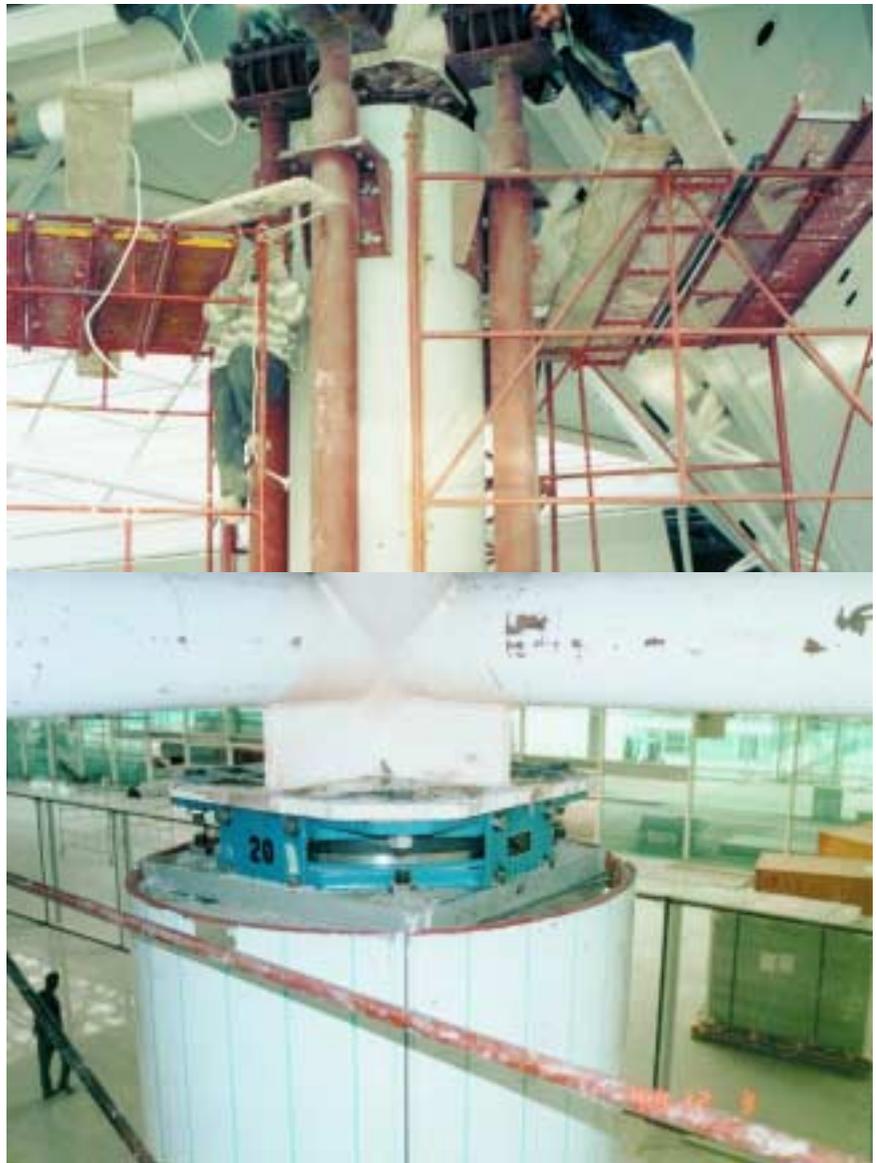
Top: Jacketed column with temporary bracket..

Above: Isolator in a finished state.

The second step in the seismic upgrade process required the installation of steel jackets on the 88 columns that extend to the roof at the upper two levels. The jacket served two purposes. In general, a jacket provides a tremendous increase in ductility and shear strength. In addition, the column previously split by the seismic expansion could be rejoined to effectively create a single column. The columns would then behave in an integral fashion to increase the column strength and stiffness, as well as providing support for the SID's. All voids within the jacket were filled with a non-shrink, high-strength grout, from the departures level all the way down to the arrivals level.

Construction moved forward at a rapid pace. The process started with the jacketing of the columns. Then a bracket was connected to the jacket to support the jacks. The jacks were installed and the steel truss was lifted off the column top; then the column top was removed. The joint extension was then installed and the column top was grouted. At this point, the SID was inserted and connected to the top of the column cap and the roof frame. Finally, the jacks were removed and the column closure was installed. The Ataturk International Airport terminal opened on time in January of this year amid much fanfare. The swift seismic modernization of the \$305 million terminal now ensures that the building will continue to function after a "design-magnitude" earthquake in the future. Due to these last-minute seismic upgrades, the newly retrofitted terminal will now be able to remain operational during an extreme seismic event. The use of seismic isolators at the roof level is a "groundbreaking" achievement for all of the engineers involved in this seismic upgrade. These exciting techniques will pave the way for future developments in engineering technology.
