Steel Revives Historic Structure

By Marie Ennis, P.E.

The United World College (UWC) commissioned Einhorn Yaffee Prescott to carry out the restoration and adaptive use of Montezuma Castle, a 90,000-sq.ft. structure dominating the spectacular landscape just outside of Las Vegas, NM, to house dining, student residential, recreational, administrative and conferencing facilities. The scope of work included complete upgrades of electrical, mechanical and plumbing systems, life safety upgrades, ADA compliance and façade restoration. Architecturally, public spaces with significant finishes were treated as a preservation project; other spaces were treated as a renovation project. As with most projects involving the restoration and upgrading of an old load bearing masonry and wood framed structure, there were numerous structural challenges. The scope of structural work included repairs due to prior inappropriate removals of bearing structure, the installation of a new elevator, reinforcement of floor framing to support Code required live loads and repair of deteriorated

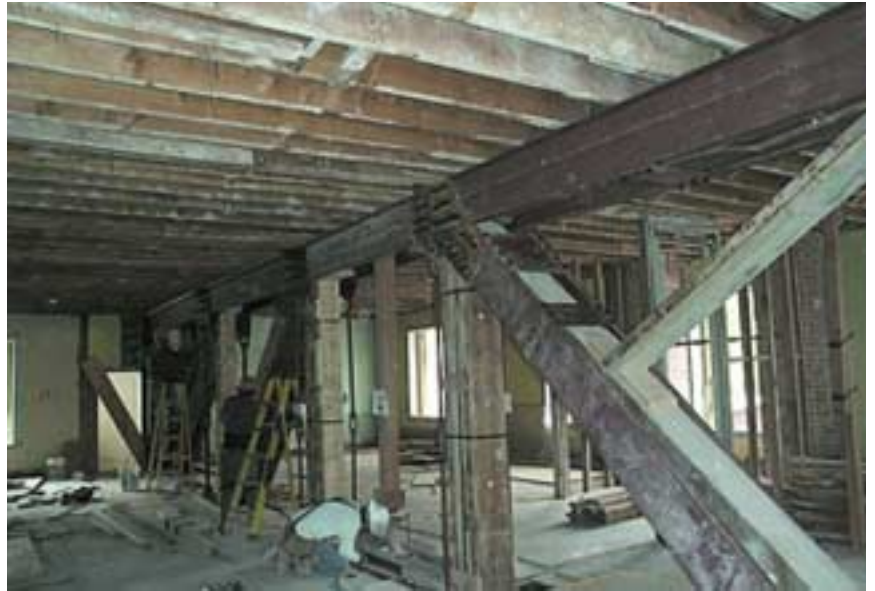
Dining room truss during reinforcing operations.

Reinforcement of the existing structure was ruled out as an option due to the variable conditions from truss to truss and the inherent difficulties of reinforcing the bolted connections. Instead, a scheme was devised to install pairs of steel trusses that would sandwich the timber trusses. All floor and roof loads would be directly transferred to new steel structure leaving the old trusses in place.

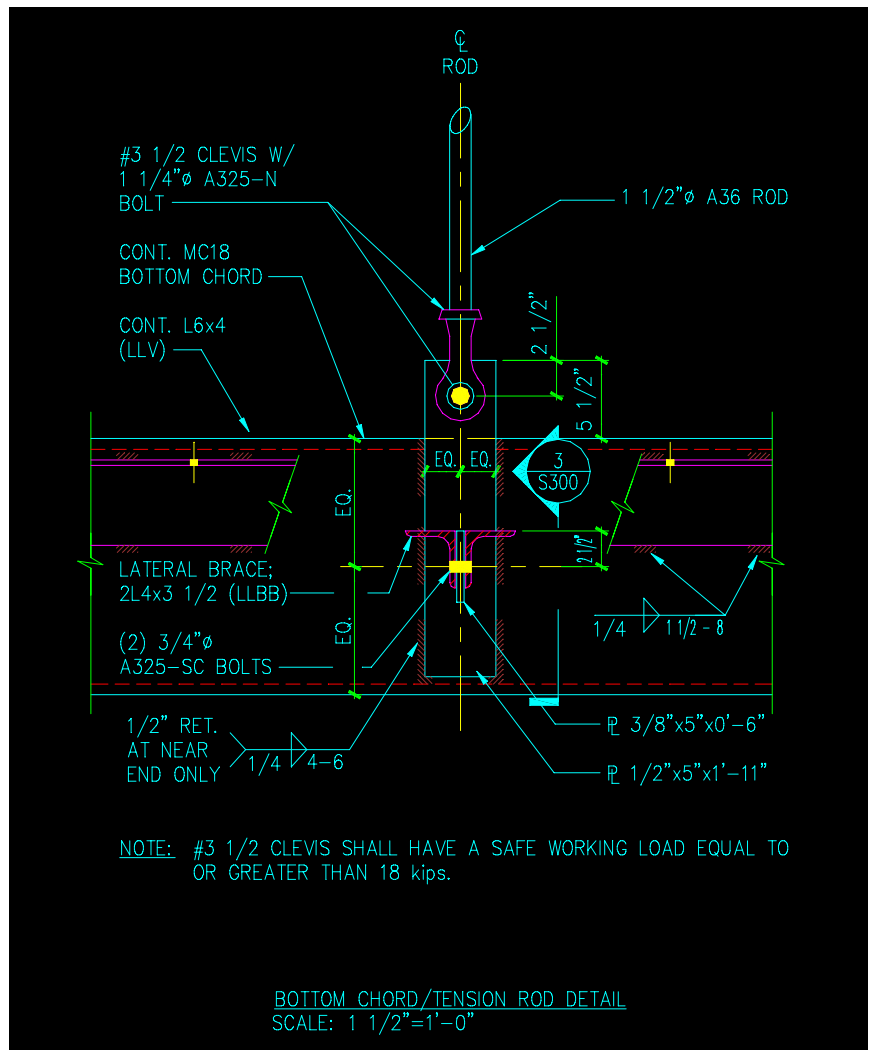
Detail at reinforced panel point with new lateral brace.

All new steel-to-steel connections were custom designed using ⁷/₈" diameter A325-SC bolts in oversized holes. The holes were oversized to facilitate the installation of the steel and to allow for adjustments of alignment prior to tightening the SC bolts. Additional ³/₄" diameter A325 bearing bolts in ⁷/₈" holes were provided for use in the erection process but were not needed for strength. Whereas the floor joists braced the timber trusses, lateral bracing using back-to-back angles was installed at new panel points on the steel trusses.

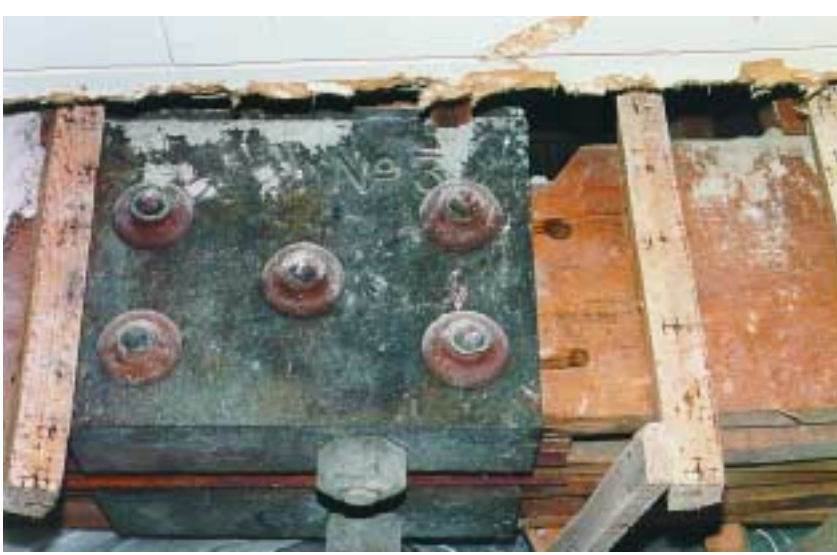
In 1938, seven-inch diameter steel shoring columns were added under the center of the bottom chord of each truss in the dining room down through the basement. It appears that during the installation of the shores the trusses were jacked-up slightly resulting in reverse curvature of the deflected shape. By removing the plaster concealing the trusses at the second floor, the reason for the shoring became evident: significant failure had occurred. The unevenness of the second and third floors reflected the deformation of the trusses.

The top chords are constructed of five 2" x 12" wood members that are through-bolted at the cast iron joint fittings; the bottom chord is similarly constructed of five 2" x 14" wood members. Diagonal members are 9³/₄" x 11³/₄" solid timbers with pairs of wrought iron tie rods, either 1³/₄" or 1¹/₂" diameter, at the four interior panel points. The nineteenth century designers had attempted to provide additional stiffness to the structure by inserting wrought iron flitch plates in the bottom chords of all the trusses for the length of the center three-panel points. The observed failure of the bottom chord occurred in a bolted connection just beyond the end of the flitch plate.

Dining room trusses had deflected substantially by 1938, prompting the addition of columns at the mid-span of each truss. This uncovered joint reveals significant structural damage.
