Why they stood— and how they fell

Silverstein Properties, Inc. released a report in October 2002 that takes an in-depth look at the structural behavior of the Twin Towers of the World Trade Center during the events of 9/11.

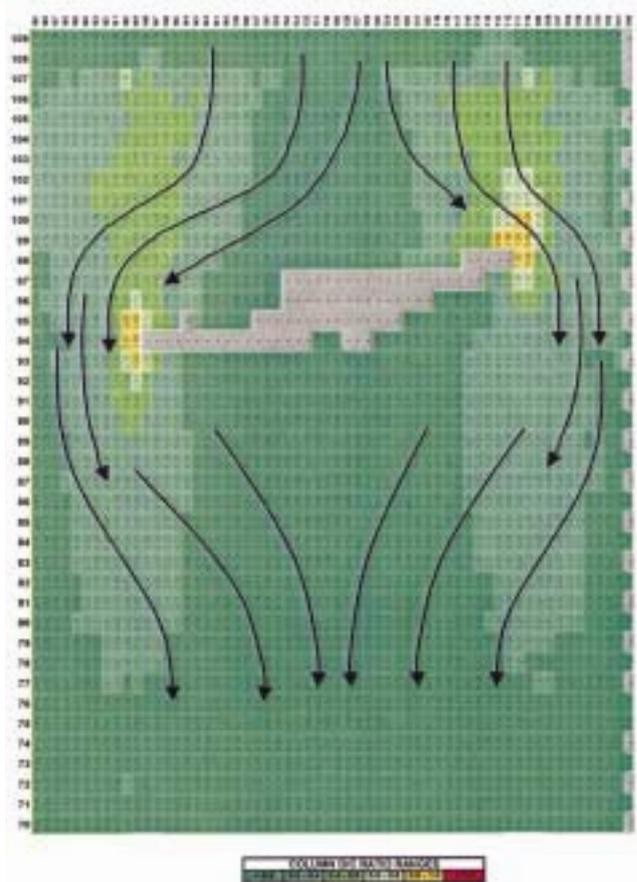
Figure 1. Diagram illustrating the way Tower 1 redistributed loads to other columns on its north face, and prevented immediate collapse, as modeled by Weidlinger Associates.

The analysis also shows that the tremendous force of each airliner crashing into a tower and breaking apart not only fractured columns outright but also stripped other columns of fireproofing (See Fig. 1). No fireproofing is designed to withstand such devastating impacts. The loss of fireproofing left those columns vulnerable to the subsequent fires, which after time, caused them to fail. Additional computer models of the towers assessed the status of each building at the time of collapse. Those models identify the failure of columns that either lost fireproofing or were destroyed on impact as the specific cause of the collapse of each tower.

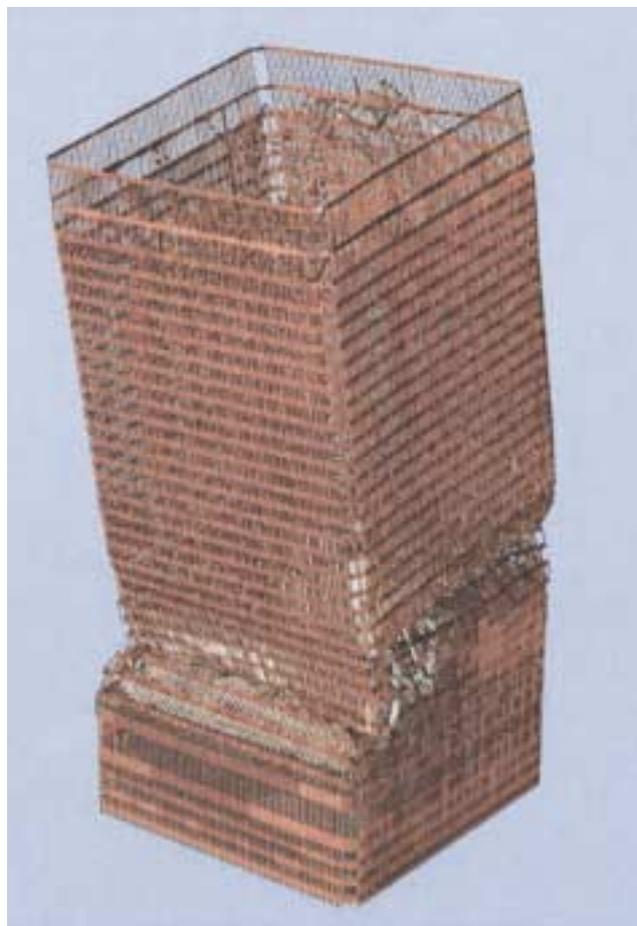
Figure 2. One frame from the computer model of the initiation of the collapse of Tower 2 performed by Weidlinger Associates.

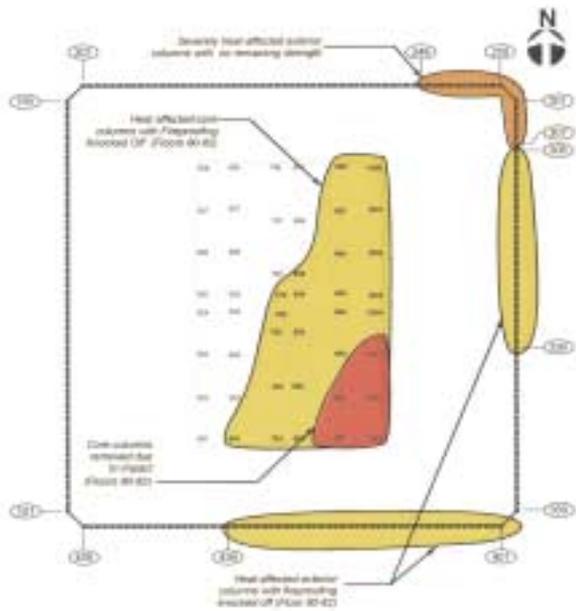
Figure 3. Schematic of impact of floor of Tower 2 showing estimation of core columns damaged by impact (in red) and columns stripped of fireproofing by impact (in yellow).

part floors were not as hot and did not spread as rapidly as normal office fires, primarily because the dust and debris distributed by the crashes inhibited the fires. The engineering team determined average air temperatures in the impact floors to be between 750° F to 1300° F (400° C to 700° C), with higher temperatures at some perimeter locations. Tragically, the fires were nevertheless hot enough to eventually weaken the columns stripped of fireproofing (See Fig. 3 and Fig. 4)

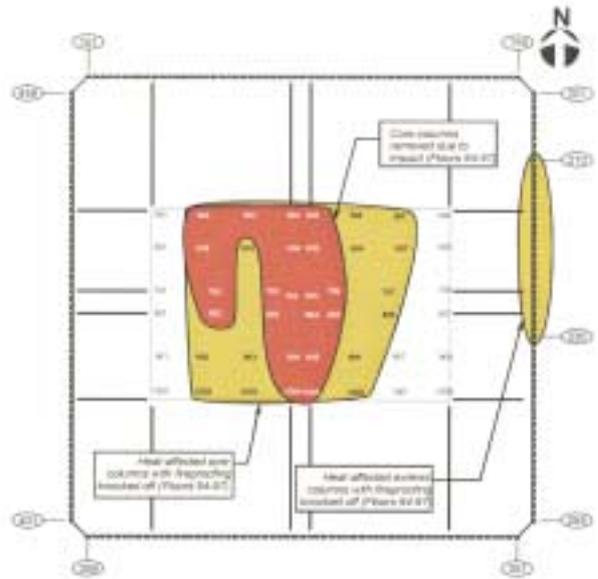
Figure 4. Schematic of impact of floor of Tower 1 showing estimation of core columns damaged by impact (in red) and columns stripped of fireproofing by impact (in yellow).

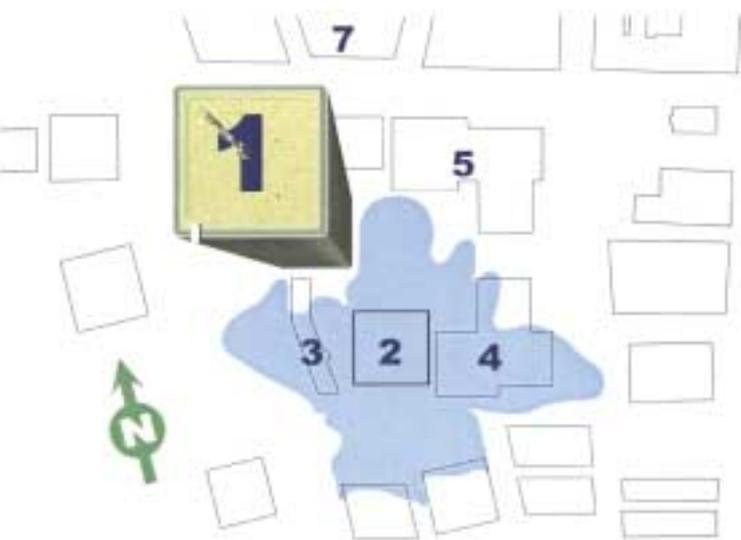
The engineering analysis led by researchers from LZA Technology/Thornton-Tomasetti examined the way in which each tower collapsed. Once collapse initiated in each tower, essentially all of the interior structure of the tower fell straight down, with floors pancaking on top of one another. The network of perimeter steel columns and spandrels acted like a chute to funnel the interior contents into the tower footprint. Some debris, primarily the perimeter columns, was thrown outward from the face of the tower, creating a lobe pattern of debris. Based on an extensive review of the collapses, debris captured in photos and videos, and observations of engineers involved in the Ground Zero rescue, recovery and cleanup efforts, the team was able to identify the actual pattern of debris from each building collapse (See Fig. 5). This analysis establishes that the collapse of Tower 2 did not cause any significant structural damage to Tower 1. Because the towers were offset, Tower 1 stood out of the way of the falling Tower 2 walls, and pieces of debris only scraped the surface of Tower 1.★

Figure 5. Pattern of heavy debris after the collapse of Tower 2, as mapped by LZA Technology.
