Learning from a Structural Failure

An inside look at the contributing factors to a South African structural collapse due to weld failure.

By Spencer Erling

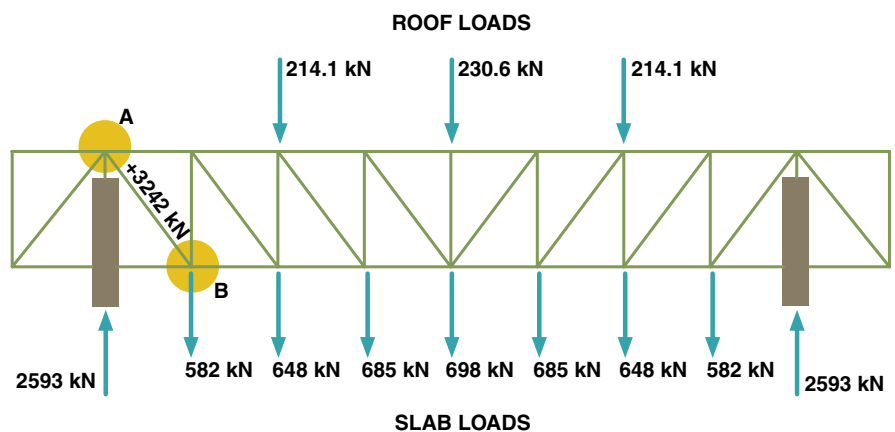
In the opinion of the writer, the weld connecting the first diagonal member to the top chord of the truss (node A in Figure 2) failed, causing collapse of the whole system. Fortunately, no deaths occurred.

Figure 2. Elevation view of main truss, showing the approximated floor and roof loads. The truss is 6 m (20') high.

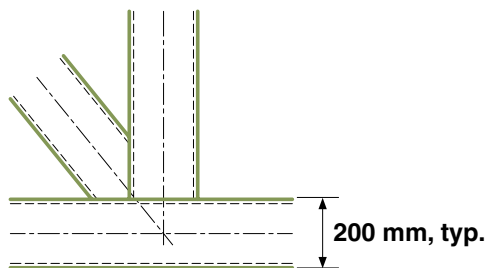
In analyzing the axial forces, eccentricities appear to have been ignored. If we look at the detail of node B (see Figure 3) and consider only axial forces, the theory would be that the forces acting through the centers of gravity of the members

Figure 3. Strict interpretation of line diagram at node B.

would all act through a common working point.

The engineers designed for the condition in Figure 3. However, the contractor's interpretation of the design drawings appears to have been similar to Figure 4.

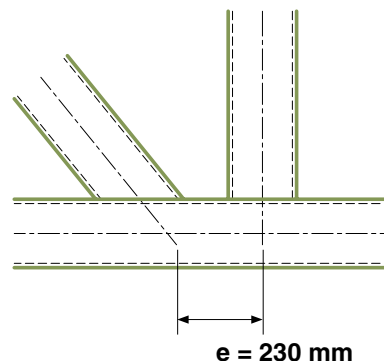
Figure 5. As-built geometry of node B. Note that other nodes had even worse eccentricities.

Drawn simply to scale, using the contractor's interpretation on his detail drawings, an eccentricity of about 150 mm (6") occurs which results in a bending moment of about 390 kN-m (290 ft-kips) to be shared between the members framing into the node (obtained using a first order moment distribution analysis). Whatever the moment the first diagonal carries, if the member is already highly stressed in axial force alone, the addition of the moment puts the member in trouble: it would be severely overstressed. The situation was exacerbated by poor workmanship as shown in Figure 6, which added more eccentricity.

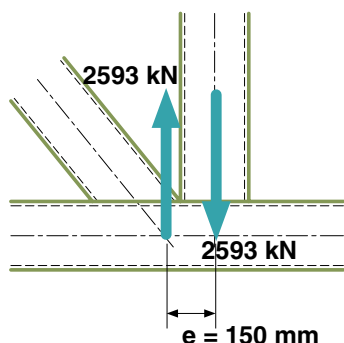
Figure 4. Contractor's interpretation of line diagram at node B.

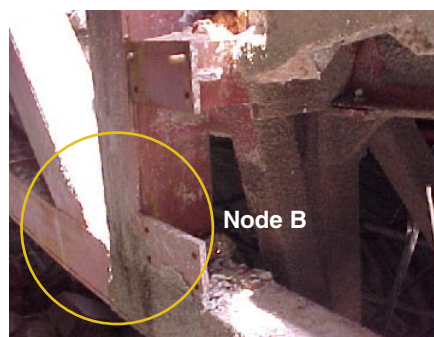
Figure 6. Photograph of node B after the collapse.

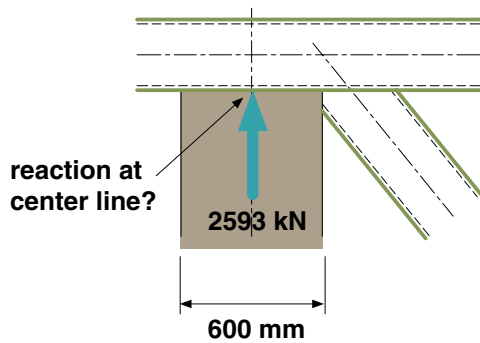
Similar eccentricity issues occurred at node A, but the determination of the eccentricities calls for some engineering judgment. This is a result of not being positive of just where the reaction occurs on the rather wide column, as shown in Figure 7. Most engineers seem to agree that it is likely to be at the quarter point

of the concrete column—definitely not at the face of the column or in the middle of the column for this configuration.

Figure 7. Strict interpretation of the line diagram at node A.

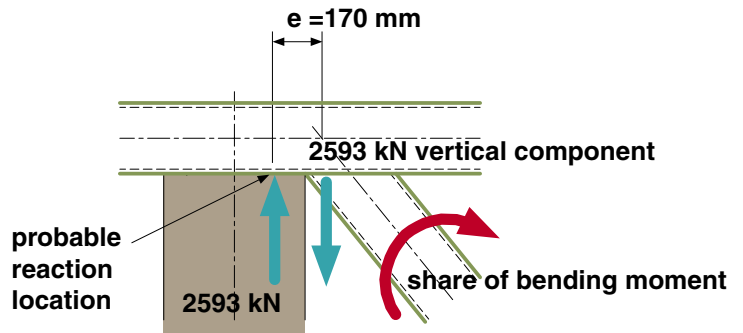
Once again, the contractor's interpretation of the geometry was different from the strict axial force assumption of the engineers, as shown in Figure 8.

Whatever geometric approach is taken, the eccentricity and resulting bending moment needs to be considered in the design of the members.

Figure 8. Contractor's interpretation of the line diagram at node A.

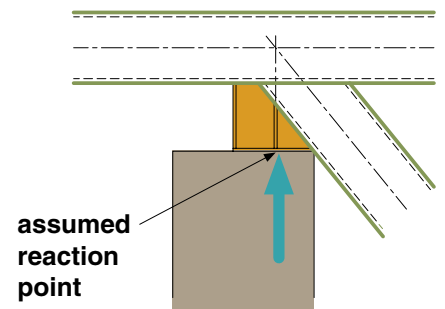
Figure 9. One possible solution that would eliminate eccentricity at node A.

In the case of node A, there is a simple solution that would have not only eliminated the eccentricity but also clearly ensured that the force path of reaction would be clear to the engineer, eliminating the need for a judgment call. This could be achieved by lowering the top of the column as suggested in Figure 9.
