Remove, Replace, Resume

A Louisiana highway overpass takes a hit from a semi but only requires partial replacement.

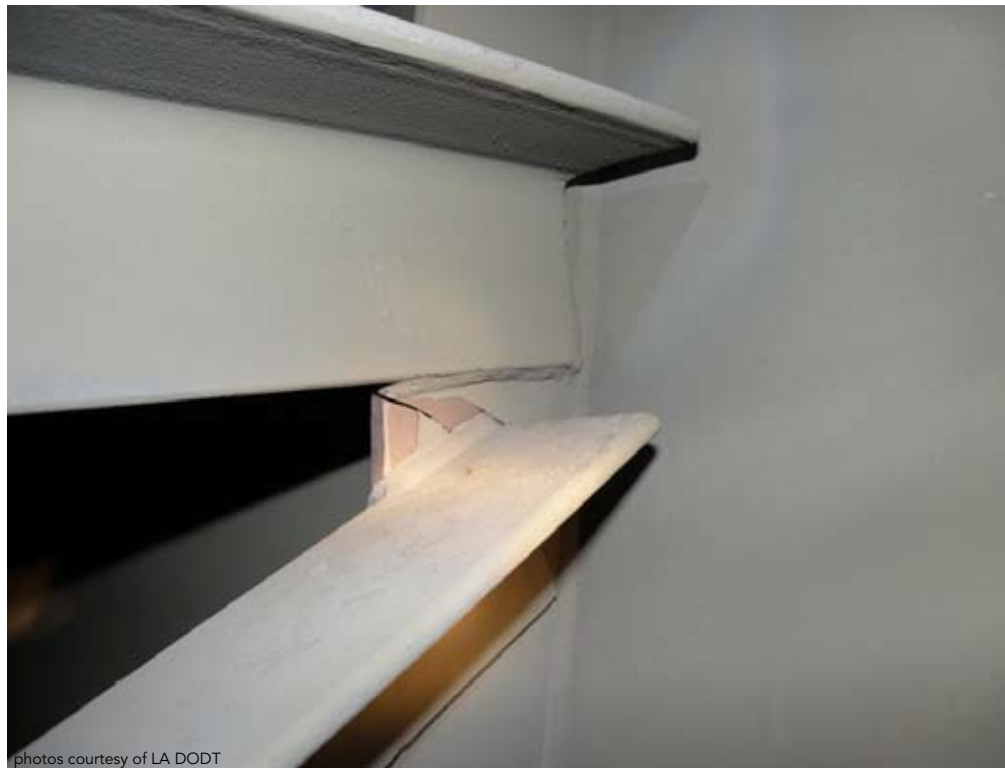
- ◀ The box girder, post-collision.
- ▶ Damage to the cross-frame connection plate.

The impact point exhibited permanent deformation of the web and bottom flange. The deformation involved approximately 50% of the web and 50% of the bottom flange and was basically a very large dent centered on the web-to-flange weld. A dye penetrant test was performed and found no cracking along the web-to-flange weld within the impact zone.

Internal inspection of the box girder revealed buckled cross-frame members and fractured connection plates (which also serve as web stiffeners) throughout the full length of the 86-ft spliced segment, and one cross-frame connection plate crack was found just outside of the spliced segment. Luckily, the crack was small, non-critical and could have been from normal operational stresses rather than the impact, as sometimes seen on other bridges where connection plates are welded to the flange.

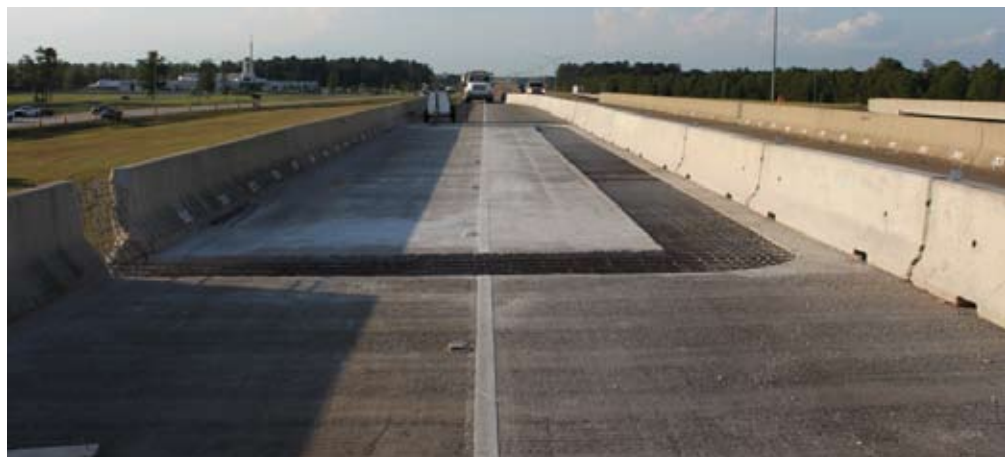
- ▲ The damaged section of the bridge, after being cut and before being removed.
- ▼ The damaged section is removed via self-propelled modular transporters.

The deck strip removal was initiated with a 1-in.-deep saw cut, for control purposes. Large-radius corners were used where the strip turns transverse, in order to minimize corner stresses in the deck. The concrete was then removed by hydro-demolition in order to preserve the integrity of all deck reinforcement. Once the concrete strip was removed and the reinforcing steel was cut, the damaged box girder, along with its composite portion of deck and barrier railing, was supported, un-spliced and removed.

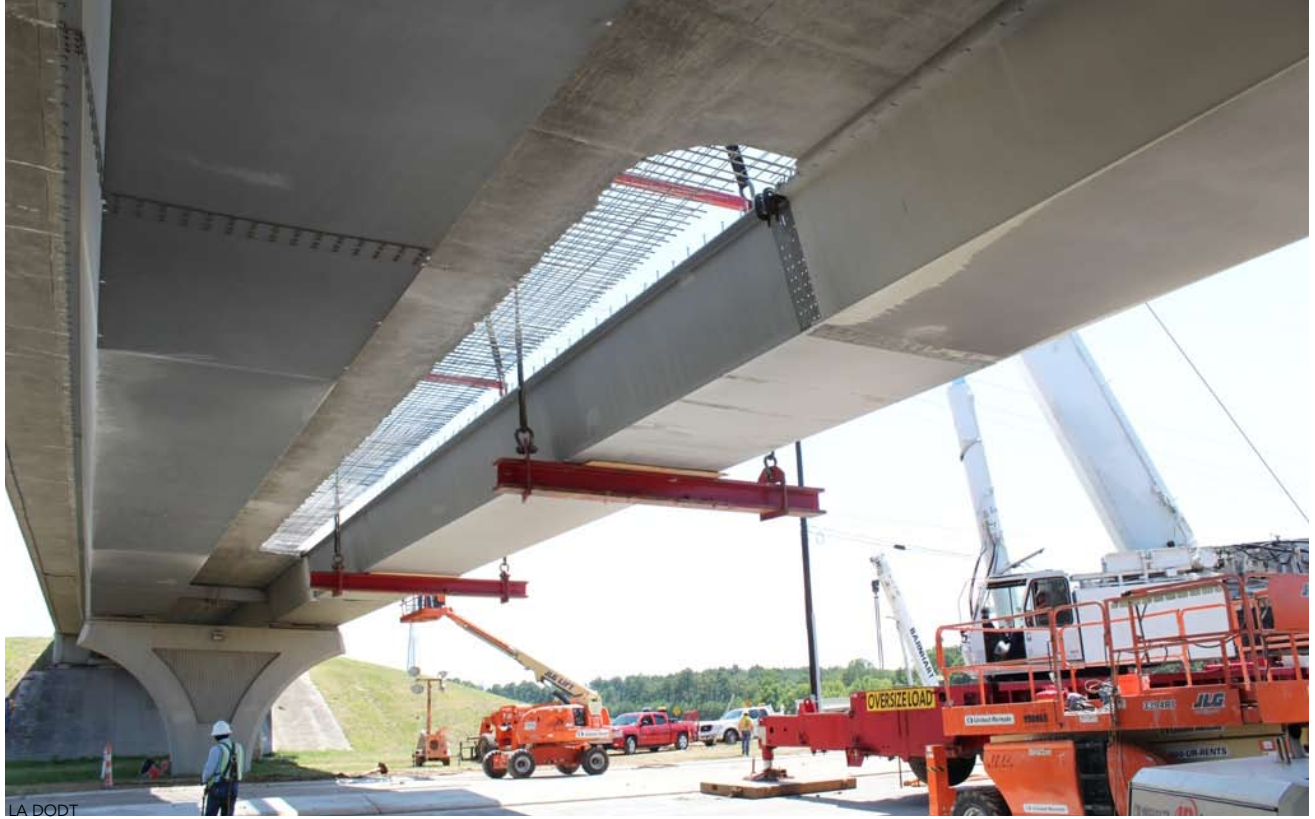
▲ The new section is put in place via a pair of cranes.

The new girder (approximately 23 tons, the same weight as the original) fit with very little difficulty. Self-propelled modular transporters (SPMTs) were used to remove the damaged girder, deck and barrier segment, and two cranes were used to erect the new box girder. This required the use of slings, straps, blocking, flange edge softeners and clamps to lift and hold the girder in position while the splices were connected.
