A lift bridge rehabilitation project takes place with the lift span in the raised position. And while the bridge was held high, construction time stayed low.

UP & at 'em

BY JEFF NEWMAN, P.E., AND GEOFF FOREST, P.E.

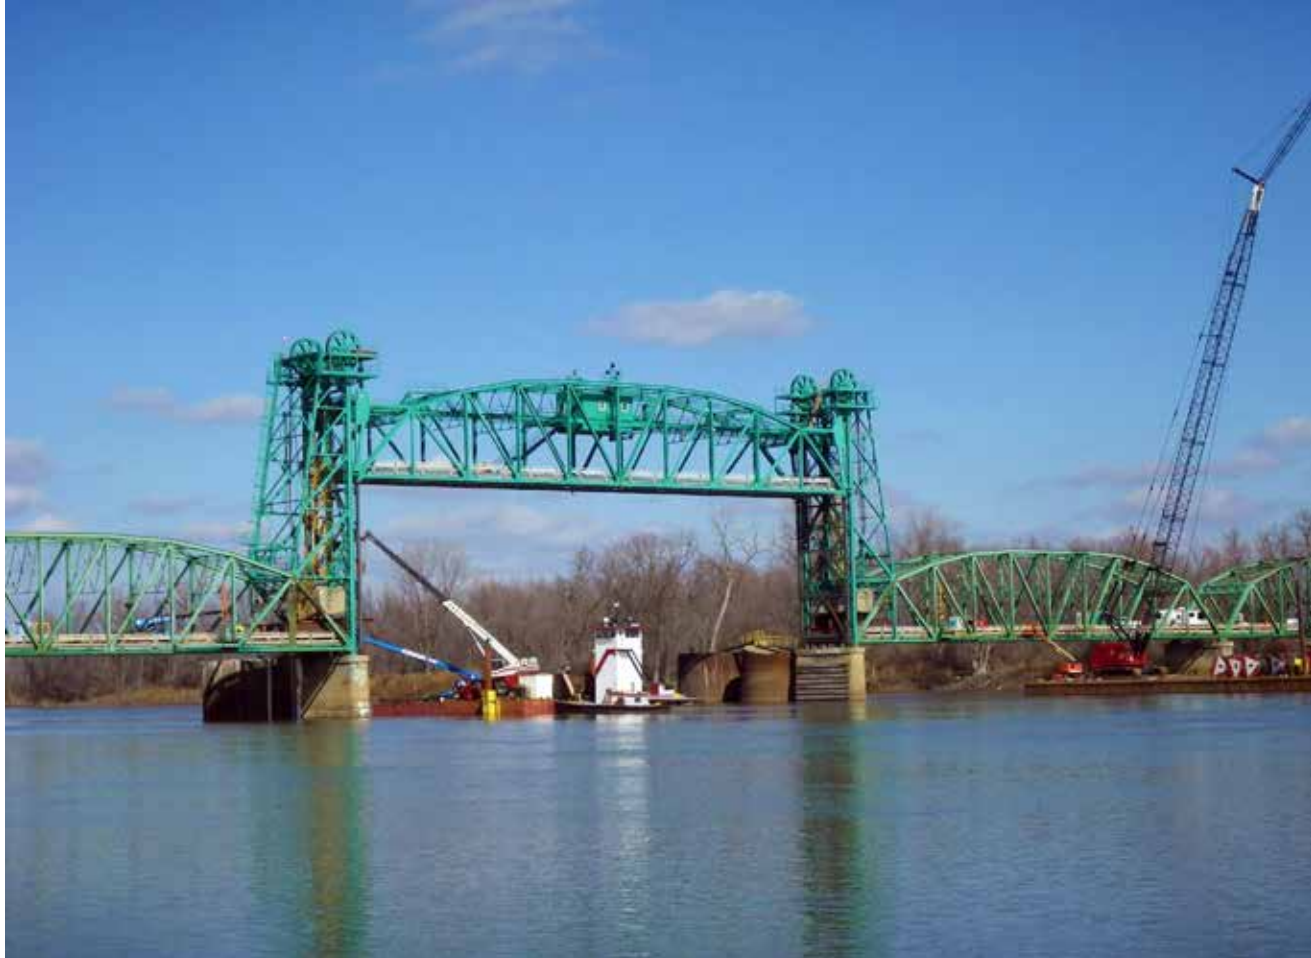
▲ The lift span was supported in the open position, thus allowing barge traffic to continue during the rehabilitation work.
