Technology, MEET Constructability

The second installment of the “But It Worked in the Model!” series serves as a cautionary tale about the overdependence on technology and the underestimation of constructability factors.

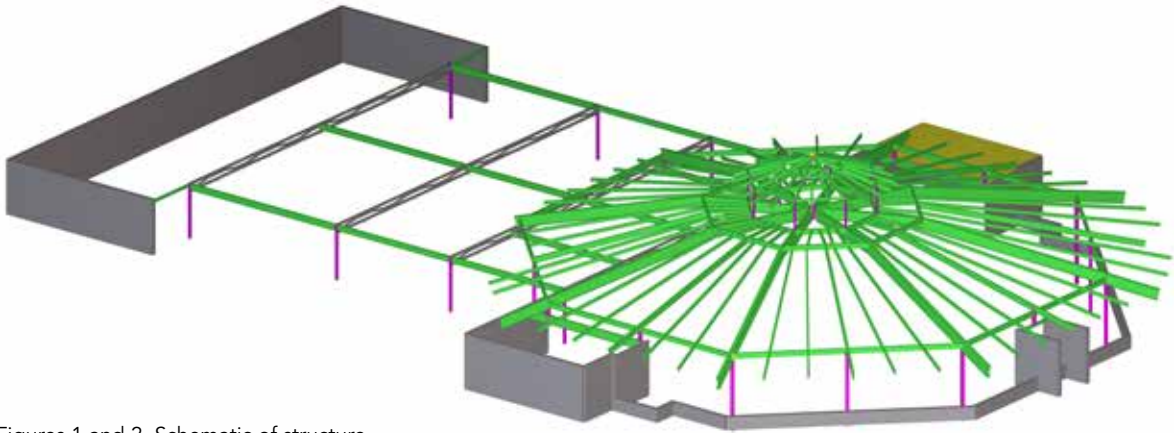
Our example begins with a single-story flat roof structure with an open-web steel joist roof and reinforced masonry shear walls (Figure 1). The building is architecturally enhanced by a dome roof structure above the lobby (Figure 2). The structural design documents presented the framing as rather simple with no obvious signs of complexity. However, the design documents did not contain critical information about the structure’s stability requirements. As noted in the AISC *Code of Standard Practice for Steel Buildings and Bridges*, ANSI/AISC 303-16 (available at www.aisc.org/standards): “The owner’s designated representative for design shall identify the following in the contract documents: (a) The lateral-load-resisting system and connection diaphragm elements that provide for lateral strength and stability in the completed structure.”

The design documents did not note the interaction of the reinforced masonry shear walls with the metal deck roof diaphragm, nor did they identify the structural interdependence of the dome’s tension and compression rings. In addition, the documents did not identify the interdependence of the structural steel and nonstructural steel elements of the lateral-load-resisting system. The initial design and modeling of the structure may have produced a conclusive result, confirming the strength and stability of the design concept. However, the design documents/model failed to communicate the nature of the structure to the fabricator and erector.

▶ Figures 1 and 2. Schematic of structure and dome with tension and compression rings.

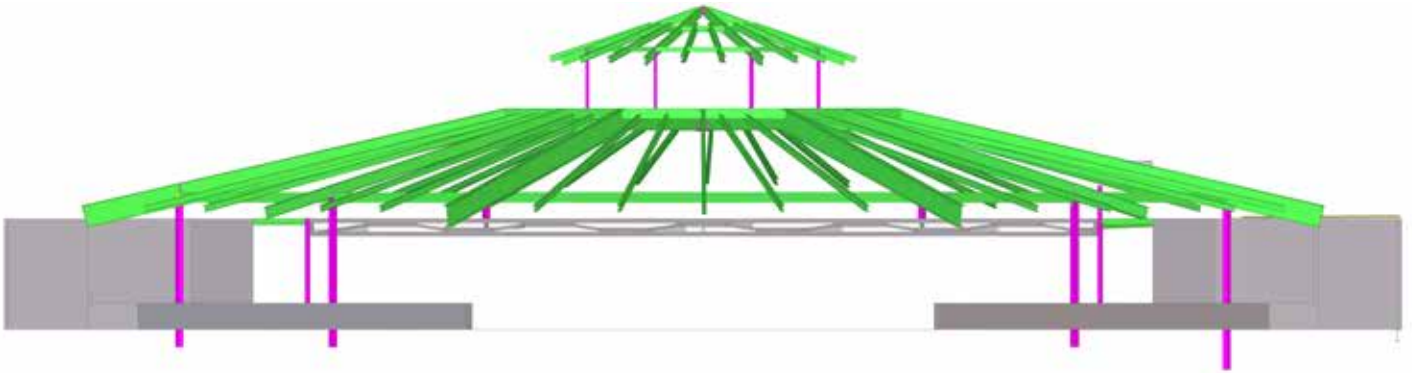
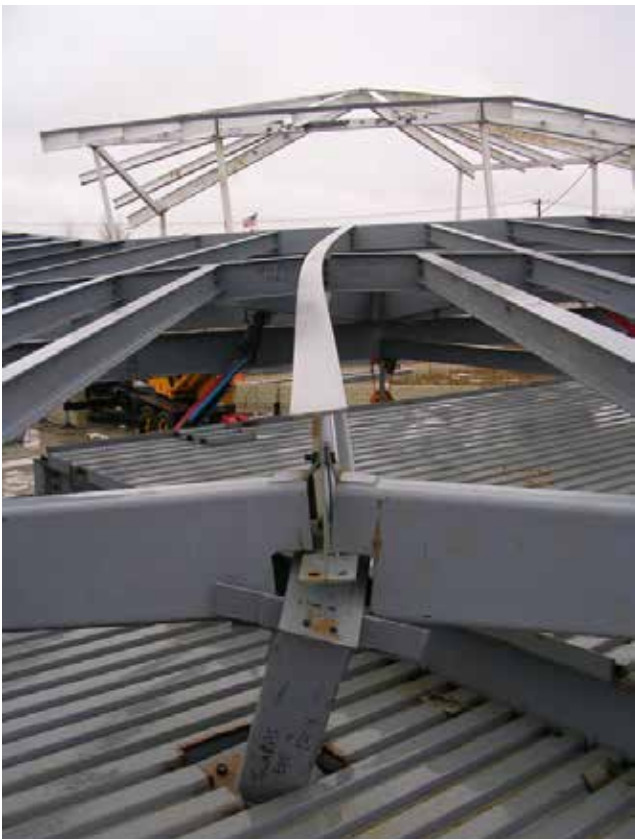
▲ Figure 3. The tension ring after initial failure.

With the majority of the structural steel in place, the roof joists installed and installation of the metal deck on the flat roof portion of the structure nearing completion, a sudden breach of the dome tension ring precipitated a partial collapse of the structure (Figure 3). At the time of the collapse, the majority of the flat roof and dome structural elements were in position but not fully connected. Tension ring members were tack-welded in position, ties to the supporting shear walls were incomplete or nonexistent and the lateral-load-resisting flat roof diaphragm was not attached to the exterior shear walls. Thus, the lateral-load-resisting system did not exist. The owner and the contractors were perplexed, and in this case the structural engineer of record's response was, "But it worked in the model!"

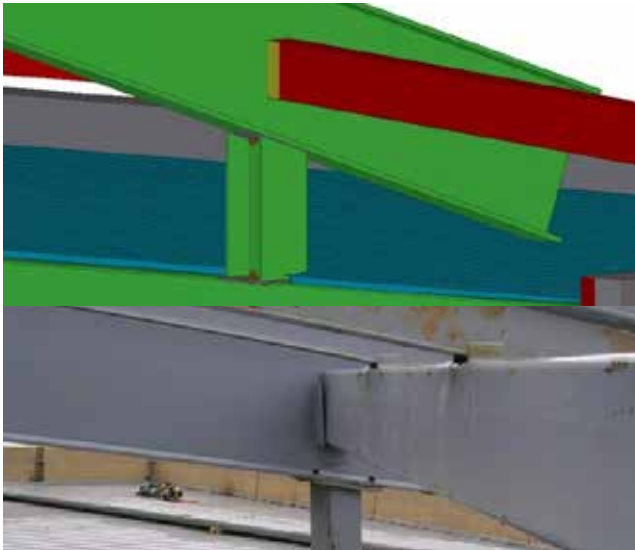
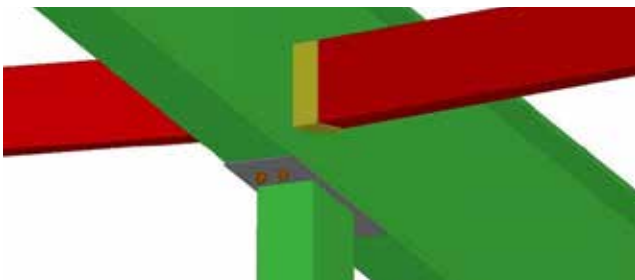
Fifth, the erector accepted the fabricator's tension ring connection detail and deemed the temporary tack weld of the tension ring connections to be adequate (Figures 4 and 5). And without direction otherwise, as to be expected in the field, the dome was erected.

▲ Figure 4. W16x31 rafter frames into column with welded tube connections on both sides (model above, field below).

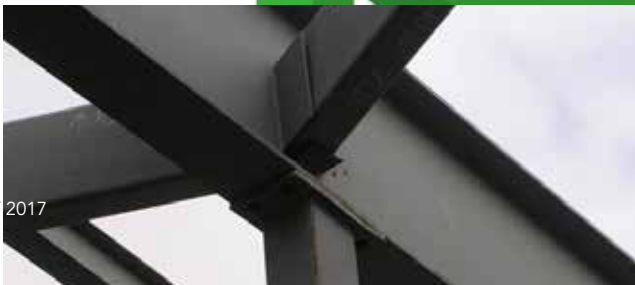
▼ Figure 5. Typical tube connection for W30x108 rafter.

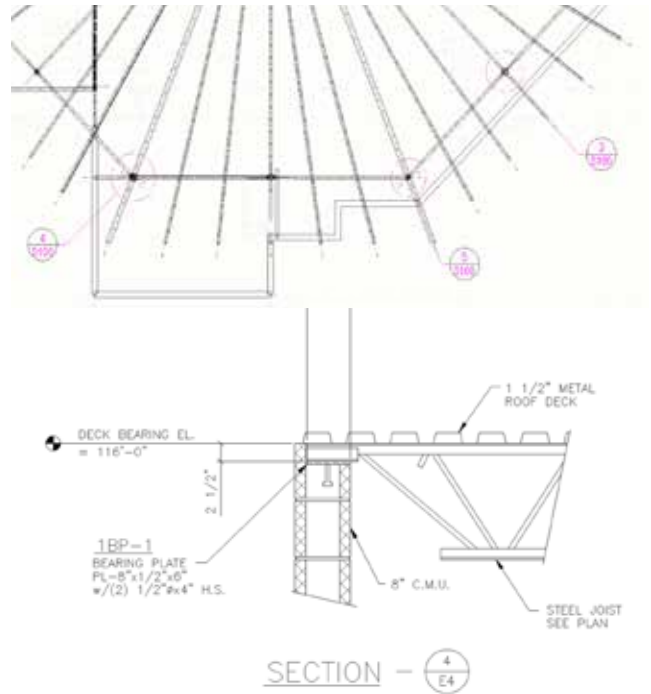
Lastly, the structural engineer's approval process was somewhat dubious. Inconsistencies exist when comparing the erection documents to the contract documents. Figure 6a depicts the design detail for the connection of the metal roof deck diaphragm to the shear wall. As we know, this detail is critical to the lateral stability, since the deck acts as the primary diaphragm element for the structure.

▲ Figure 6a. Details from the erection drawings.

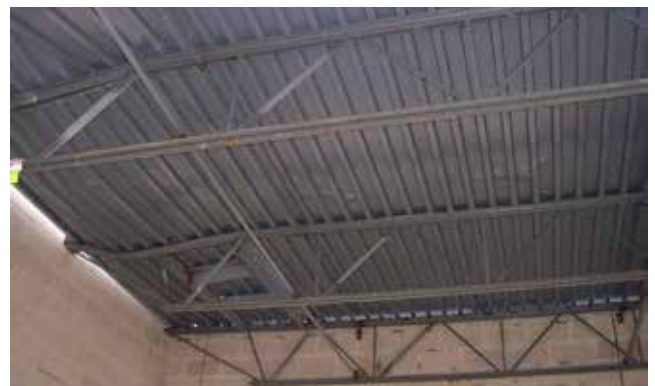
The photograph of the as-built connection after the collapse shows a separation between the wall and the roof deck (Figure 6b). This design detail was not included in the metal deck or structural steel installation drawings as submitted by the fabricator.

▼ Figure 6b. Separation between wall and roof deck.

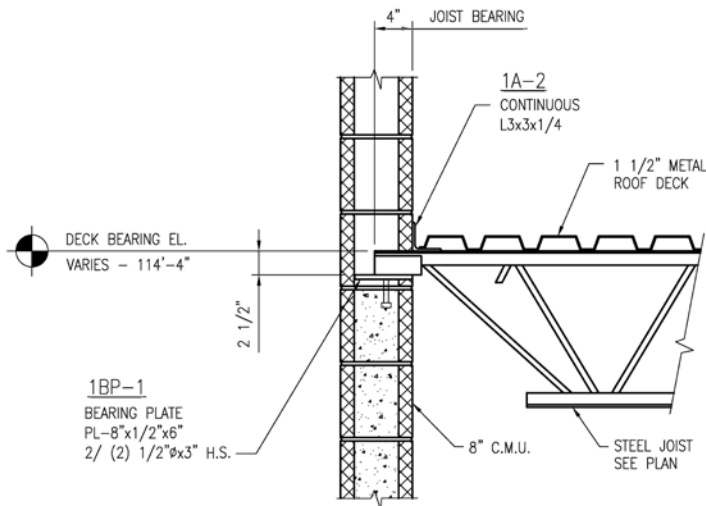
▲ Figure 7a. Detail from the erection drawing.

Similarly, the detail (Figure 7a) depicts a continuous angle spanning the length of the wall connecting the roof deck to the shear wall and effectively completing the diaphragm. Once again, the photograph (Figure 7b) displays the absence of any such connection, as light can be seen pouring through the gap between the deck and wall. Though each case admittedly displays a lack of quality control and poor construction practice, an overriding concern is the lack of a thorough shop drawing approval by the structural engineer and an apparent disregard for the importance of the metal deck connection in effectively distributing the lateral load to the shear walls.

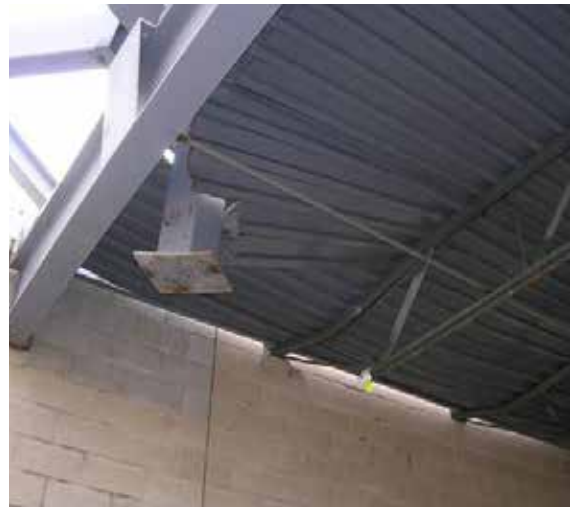
▲ Figure 7b. As-built construction.

In addition, note the stub in Figure 7b, which shows a support post for the dome roof structure that translated during the collapse. The dome rested on short posts without any provision for lateral load transfer to the metal deck diaphragm or subsequently to the reinforced masonry shear walls. All the components were there in some fashion, but the interdependence on the structural steel and nonstructural steel elements were totally undefined in the contract documents and therefore did not become an integral part of the installation documents.
