# Study of Corrosion Performance of Weathering Steel Bridges

## State Project No. 170-3301

CHA Companies, Inc.  
101 East River Drive, 1<sup>st</sup> Floor  
East Hartford, CT 06108  
Phone: (860) 290-4100

*May 24, 2021*

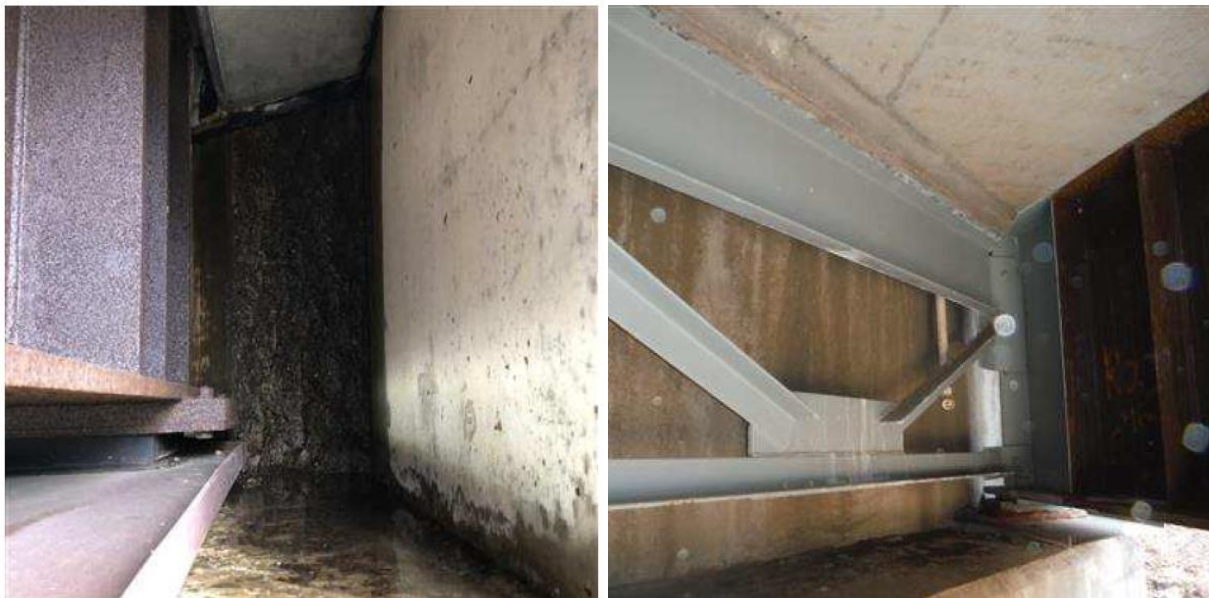
**Figure 9. Examples of the Two Types of Beam End Leaking**

Figure 8 shows the proportion of each beam end detail that has either active leaking or evidence of past leaking noted in the most recent inspection report. Two types of leaking were able to be identified from inspection reports at the beam ends: leaking through the deck joint and leaking through a weep onto the structure. Figure 9 shows examples of these two types of leaking, with leaking through the joint visible in the left picture, and a weep pipe aimed and the end diaphragm on the right picture. Evidence of corrosion can be seen in both examples, with scaling occurring in the left figure and painting of the structure due to corrosion in the right figure. The data shows that no beam end details are immune from leaking, although integral abutments are significantly less likely to leak, with only 17% of details exhibiting evidence of leaking. Of the other three identified details, all three have over 60% of the details experiencing leaking. Slab to the back of backwall has the best performance of the three remaining details with 36% of the details not showing evidence of leaking, compared to 13% for slab on a flat/stepped backwall, and 14% for a slab in front of backwall detail. Three of the structures with leaking were caused by a weep at the

beam end leaking onto the structure, rather than from leaking through the abutment. Two of these occurred in a structure with the slab to back of backwall, and the third was with a slab to front of backwall detail.

For beam end details prone to leaking, three types of leaking were identified: leaking from the joint, leaking from a weep onto the structure, or both. Figure 11 shows the maximum amount of section loss noted at the beam end based on the type of leaking noted at the beam ends. These results are not unexpected, showing that 98% of structures have no or negligible section loss if no leaking is present. The only structure showing measurable section loss at a beam end (Bridge No. 01077, 1/16") [3] has the section loss at the bottom of the web extending on a single side from the beam end to midspan. The average section loss at the beam end was 0.041 inch if only joint leaking was noted, it was 0.050 inch when leaking was occurring from a weep onto the structure and was 0.080 inch for evidence of both types of leaking. This is expected as joint leaking does not necessarily deposit water onto the structure as having a weep directed onto a structure would.

Though it does show that leaking has a measurable effect on the amount of section loss measured at beam ends, and therefore any leakage should be addressed as soon as possible. If section loss is to be reduced, using joint details that minimize the potential for leakage should be implemented.

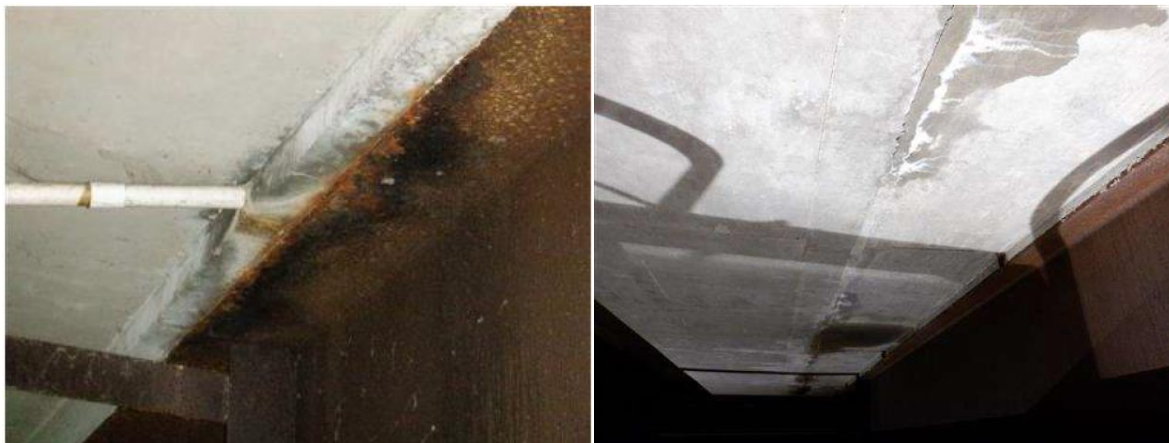
**Figure 13. Examples of In-Span Leaking Noted in Bridges**

As with the beam ends, the observed maximum section loss is often higher when leaking is present. Figure 12 shows the extent of in-span section loss separated into six types of leaking identified from inspection reports. 96% of structures with no in-span leaking do not show any measurable in-span section loss, as do 75% of structures with short weeps, and all structures with leaking from conduits. This compares to 50% to 54% of structures without measurable corrosion with some type of detrimental in-span leaking. These sources of leaking are identified as leaking from scuppers/weeps onto the structure, leaking through the deck or stay-in-place (SIP) forms onto the structure, and leaking through construction joints. 40 structures have one of these forms of leaking. The average section loss in structures with leaking from a scupper/weep onto the structure is 0.063 inches, the average loss for structures with leaking through the deck/SIP forms is 0.072 inch, and the average section loss with leaking through a construction joint is 0.081 inch. This compares

to an average section loss of 0.005 inches in structures either with no in-span leaking or leaking that isn't directed onto the structural steel. Similar to beam end details prone to leakage, the evidence shows that any mid-span leakage of water onto the structural steel is a direct cause of section loss. Figure 13 shows some examples of in-span leaking noted within the bridges.

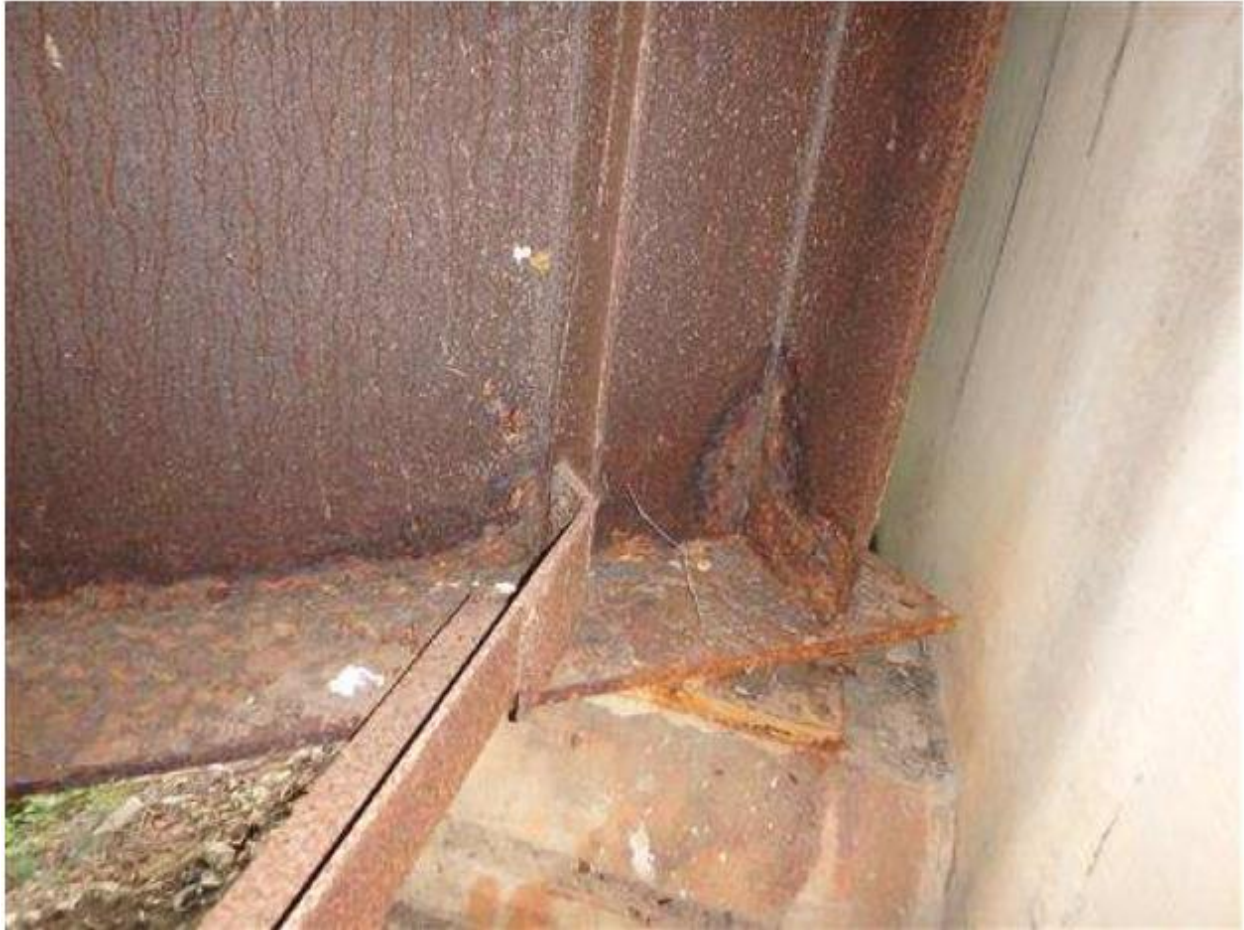
**Figure 15. Example Section Loss at the Beam End**

In the previous section, the beam end leaking was compared to the detail used. Figure 14 shows the maximum beam end section loss noted in the latest inspection report. This shows that the maximum beam end section loss was significantly lower in beam ends with integral and slab to back of backwall details. Over 90% of integral and slab to back of backwall have no noted or negligible section loss, compared to 75% of slab on stepped backwall, and 52% of slab in front of backwall showing no or negligible section loss. The average section loss was 0.005 inch for integral abutments, 0.004 inch for slab to back of backwall, 0.063 inch of slab on flat/stepped backwall, and 0.074 inch for slab in front of backwall. Figure 15 shows sample corrosion at the beam end.

- If the beam ends are not painted initially, then they should be painted when leaking is noted in abutment joints.
- The beam ends of structures utilizing the slab to back of backwall should be painted, as 64% of structures with the detail exhibit leaking, and no structures with their beam ends initially painted exhibit section loss.
