# NC State Research Report on Single Plate Shear Connections

September 8, 2003

## Single Plate (Shear Tab) Connection Test Summary Sheet

**Test ID:** Test 3A (Flexible, Slotted)  
**Test Date:** May 23, 2003  
**Sponsor:** W & W Steel Company  
**Tested By:** N.C. State University

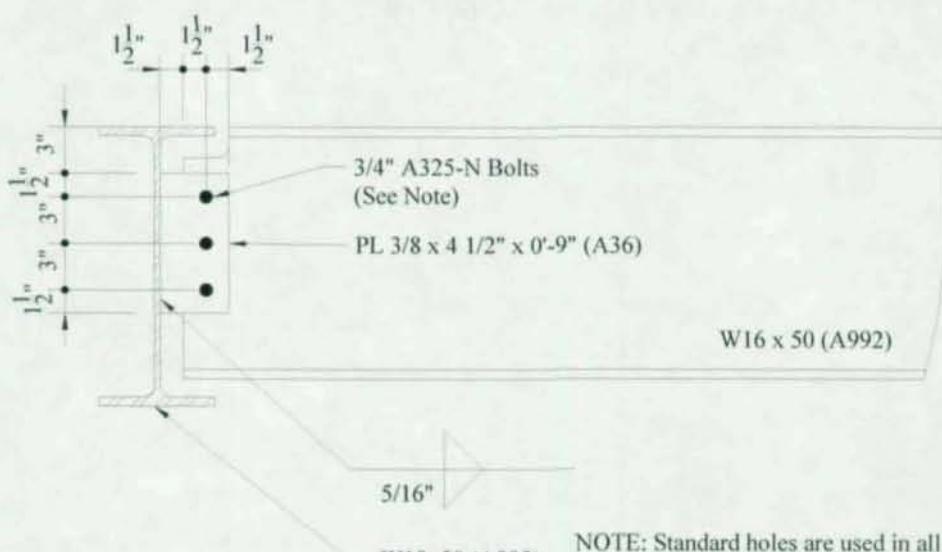
Three bolt single plate connection with a flexible support condition, short slotted holes, and snug tight bolts.

<b><u>Shear Tab</u></b>	Plate Size: PL 3/8" x 4 1/2" x 0'-9"	Fy = 43.2 ksi
	Steel Grade: A36	Fu = 63.4 ksi
<b><u>Bolts</u></b>	Diameter: 0.75 in.	
	Bolt Grade: A325	
	Ft = 106.4 ksi	(Measured)
	Pretension: 10 kips	(snug-tight)
	Thread Location: Included in shear plane	
<b><u>Beam</u></b>	Section: W16x50	Fy = 54.1 ksi
	Steel Grade: A992	Fu = 69.3 ksi
<b><u>Girder</u></b>	Section: W18x50	
	Steel Grade: A992

Maximum Applied Shear at Connection =	71.8 kips
Maximum Beam End Rotation at Connection =	0.039 rad
Maximum Girder Rotation at Connection =	0.114 rad
Maximum Vertical Beam Deflection at Connection =	1.12 in.
Maximum Vertical Girder Deflection at Conneciton =	0.16 in.

- Elastic rotation of the supporing girder observed at 30 kips.
- Beam yielding at quarter points and midspan observed at 56 kips.
- Severe yielding of beam at quarter points and midspan, observed at 60 kips.  
Large rotaion and small yielding of the top flange of the girder was observed at 62 kips. The test was paused and braces were installed adjacent ot the connection region to restrain the lateral movement of the girder top flange.
- At approximately 64 kips and 0.038 rad beam rotation, the test was paused and additional load was applied adjacent to the connection region using a hydraulic ram.
- Continued beam yielding and lateral torsional buckling of the beam between lateral brace points was observed.
- Shear rupture of the connection bolts was observed at 71.8 kips.
- Failure of the a lateral brace mechanism located at the 3/4 load point was observed at the time of bolt failure.

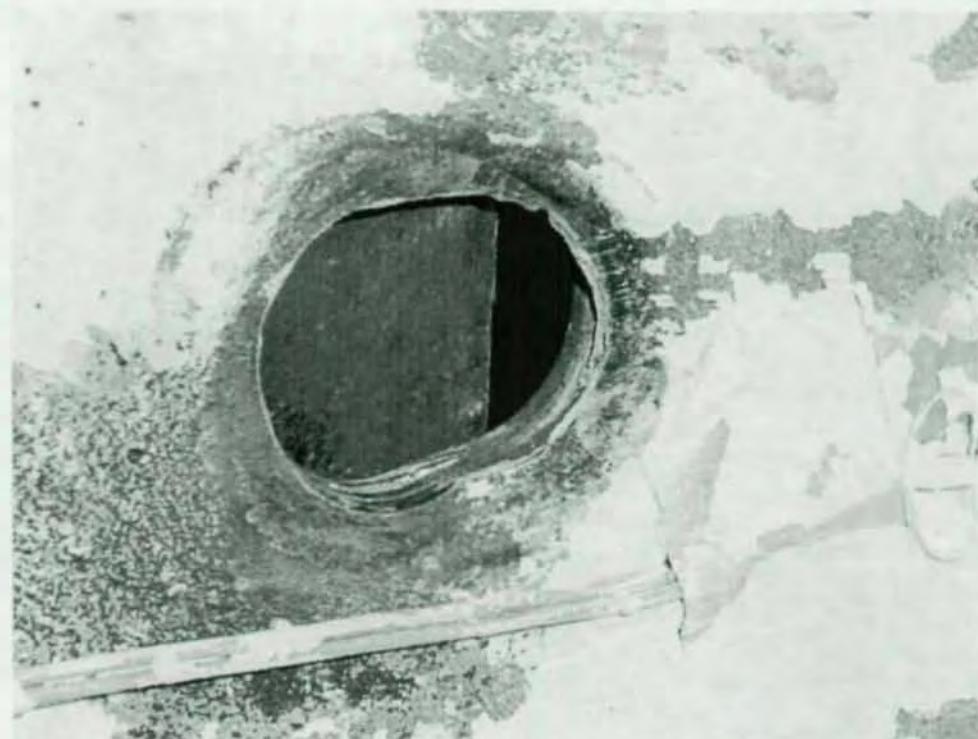
Test 3A – Bottom Bolt Hole in Shear Tab After Test

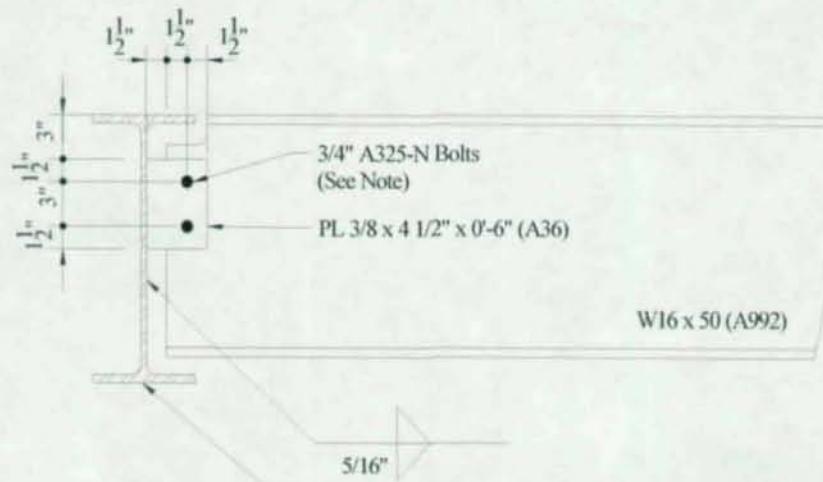
Two bolt single plate connection with a flexible support condition, standard holes, and snug tight bolts.

Maximum Applied Shear at Connection = 44.2 kips  
Maximum Beam End Rotation at Connection = 0.012 rad  
Maximum Girder Rotation at Connection = 0.083 rad  
Maximum Vertical Beam Deflection at Connection = 0.78 in.  
Maximum Vertical Girder Deflection at Conneciton = 0.09 in.

- At service load conditions, 18kips, girder experienced some elastic rotation.
- At 30 kips, first appearance of concentrated yielding near brace at midspan.
- At 40 kips, the test was paused and a visible increase in girder rotation as well as slight curvature of beam was noted. Data indicated a leveling slope in connection rotation, suggesting approach of failure
- Testing resumed and shear rupture of the connection bolts was observed at 44 kips. The beam was unyielded from test.

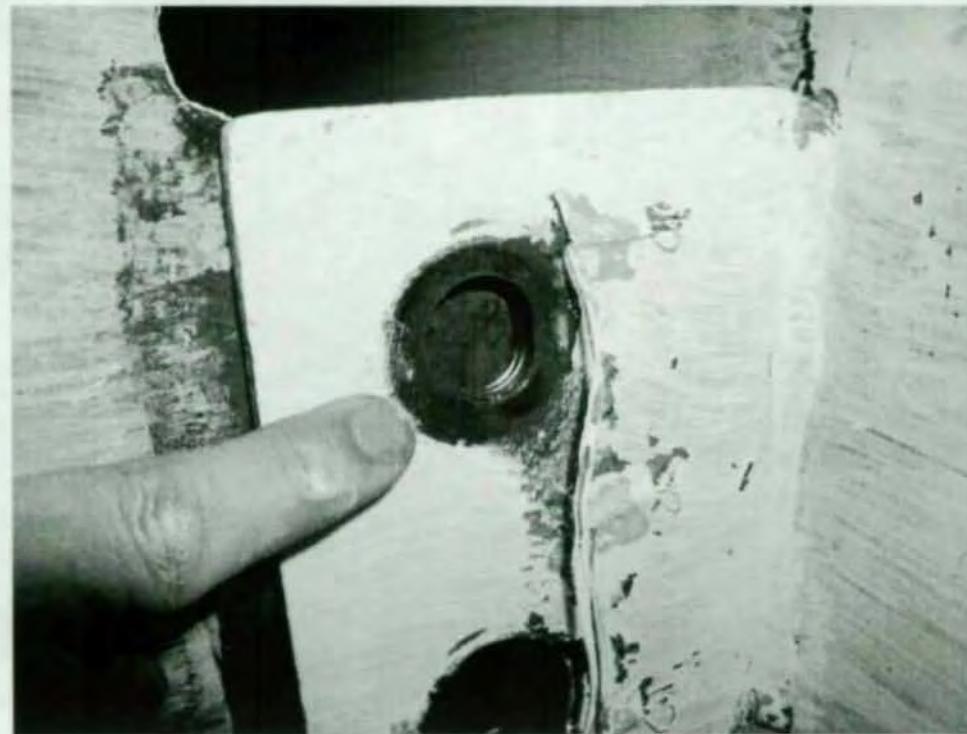
Test 6A – Top Bolt Hole in Shear Tab at End of Test

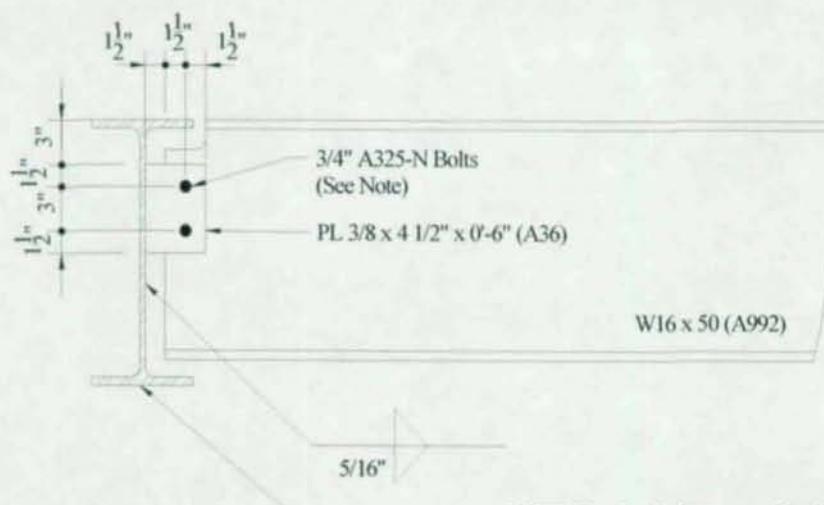
Two bolt single plate connection with a flexible support condition, slotted holes, and snug tight bolts.

Maximum Applied Shear at Connection = 45.45    kips  
Maximum Beam End Rotation at Connection = 0.011    rad  
Maximum Girder Rotation at Connection = 0.099    rad  
Maximum Vertical Beam Deflection at Connection = 1.11    in.  
Maximum Vertical Girder Deflection at Connection = 0.07    in.

- At service load conditions, 18kips, the connection exhibited slight rotation. The first appearance of concentrated yield marks at midspan of top flange was noted.
- At 30 kips, an increase in concentrated yielding at midspan of beam as well as an increase in rotation at connection was observed.
- At 40 kips, yielding of the shear tab and localized yielding on web near all stiffeners was noted.
- Shear rupture of the connection bolts was observed at 45 kips. Upon examination of the connection, failure of the top portion of the shear tab weld was noted. Although the beam underwent localized yielding, overall, the beam was relatively unyielded.

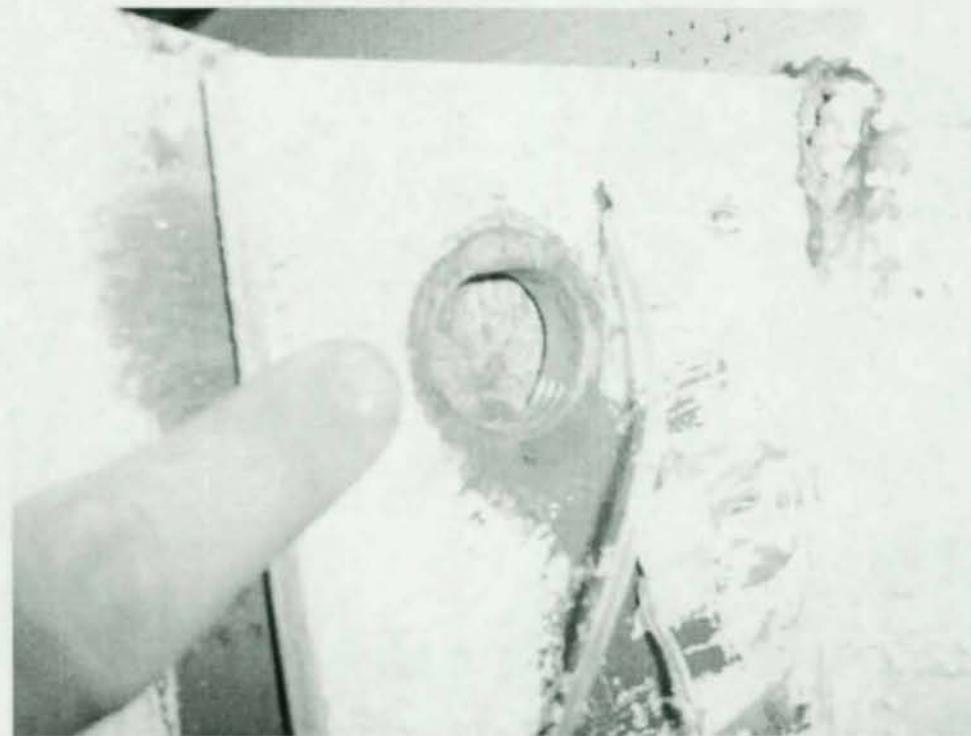
Test 7A – Top Bolt Hole in Shear Tab at End of Test

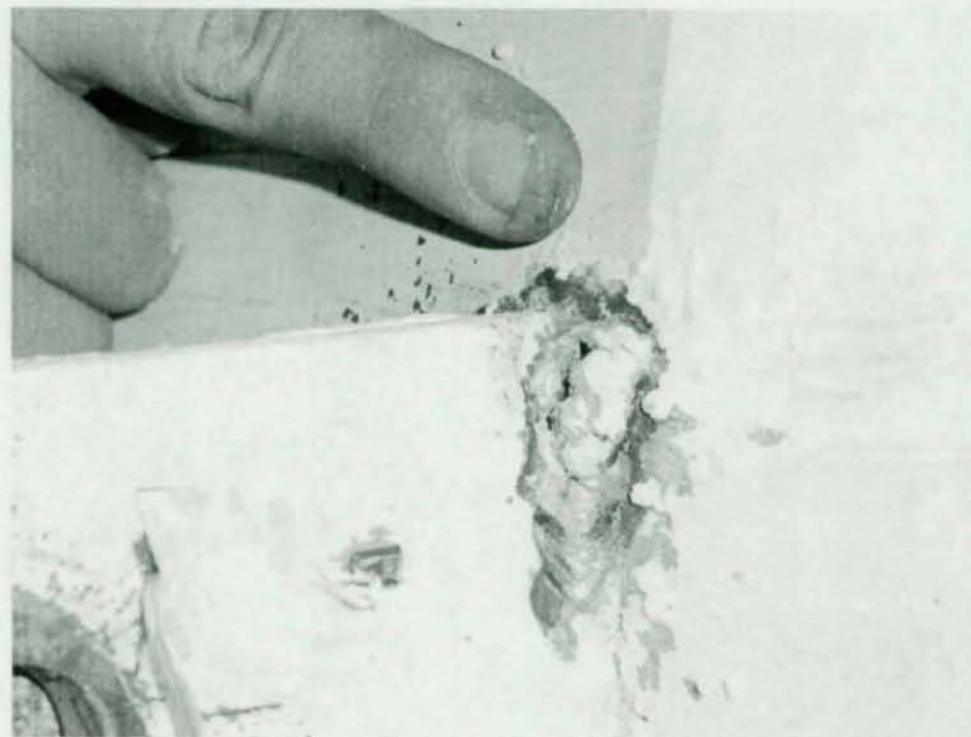
Test 7A – Failure of Shear Tab Weld at End of Test

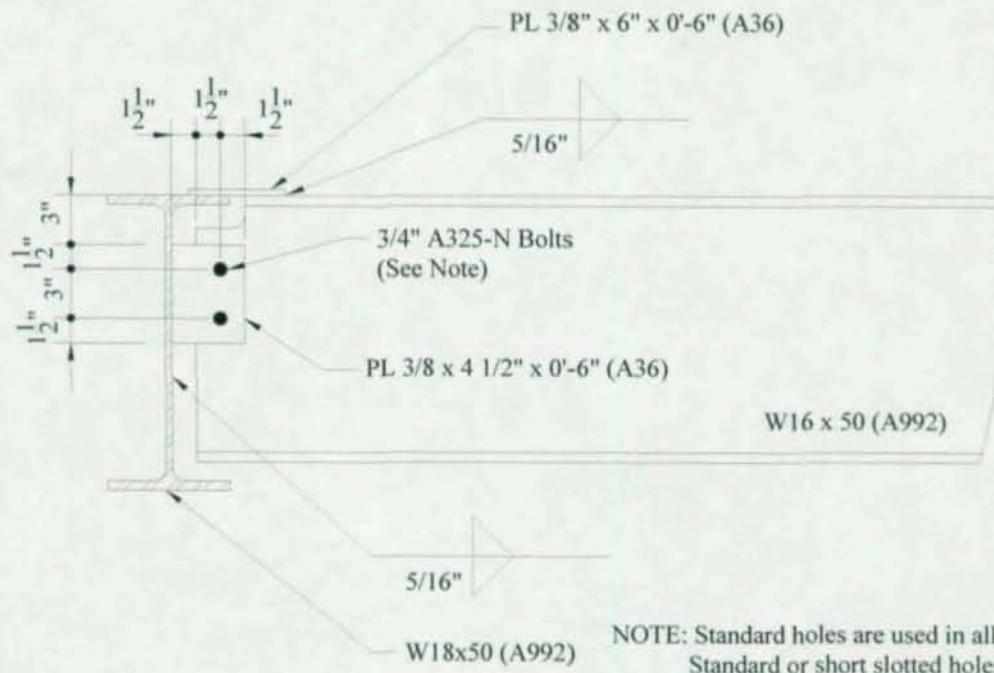
Two bolt single plate connection with a flexible support condition, slotted holes, welded tie plate between top flange of girder and beam, and snug tight bolts.

Maximum Applied Shear at Connection = 47.93 kips  
      Maximum Beam End Rotation at Connection = 0.013 rad  
      Maximum Girder Rotation at Connection = 0.032 rad  
      Maximum Vertical Beam Deflection at Connection = 1.08 in.  
      Maximum Vertical Girder Deflection at Conneciton = 0.15 in.

- At 11 kips, a shift at the connection was noted, resulting in an increase in beam deflection and connection rotation.
- At service load conditions, 18 kips, there was slight rotation at connection with minimal girder rotation due to restraints.
- At 30 kips, a visible rotation at connection was noted.
- The connection sustained loading up to 46 kips. After which a weakening of connection was noted as the load dropped slightly.
- Connection sustained an increase in load. Failure occurred at 48 kips when the bottom bolt sheared and the top portion of the shear tab weld failed. The top bolt was reasonably straight and the beam was relatively unyielded.

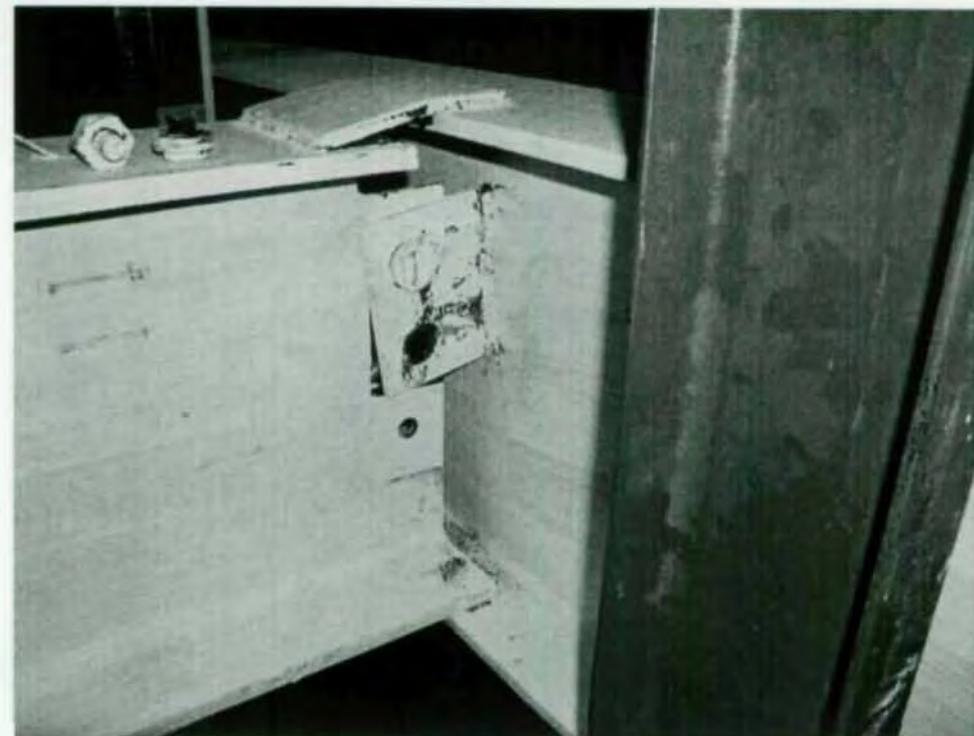
Test 8A – Connection Region at End of Test

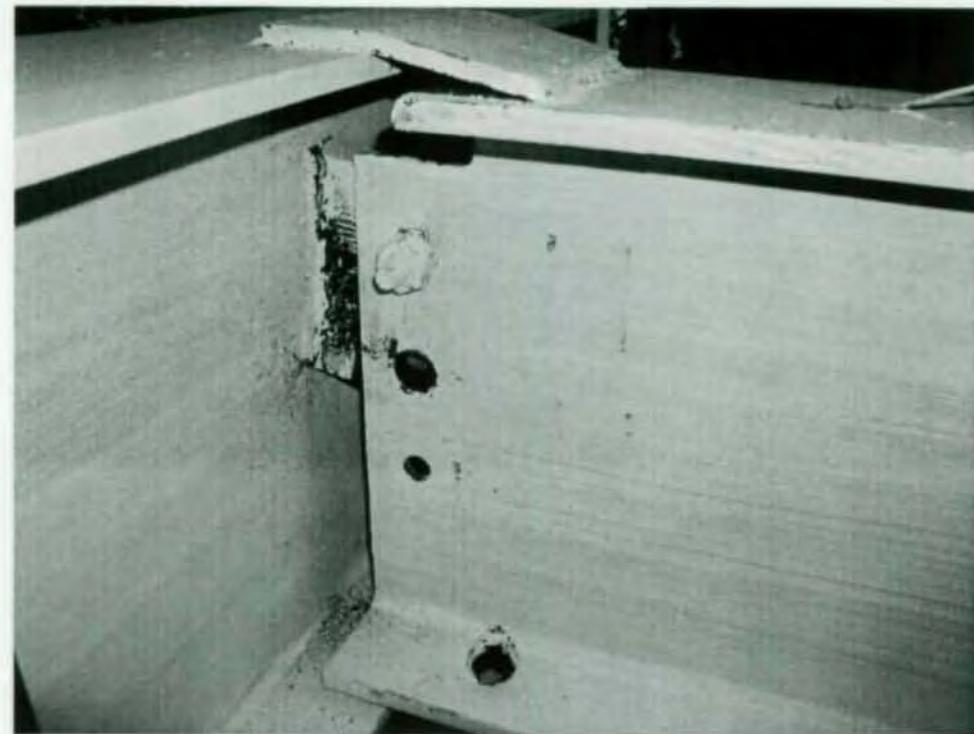
Test 8A – Connection Region at End of Test

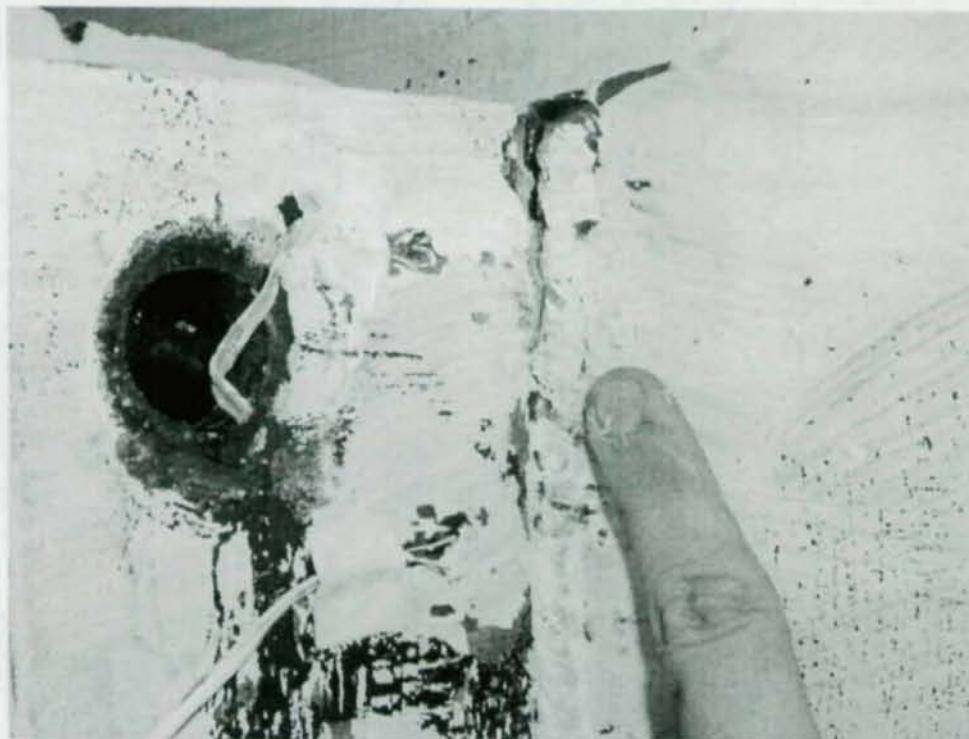
Test 8A – Failure of Shear Tab Weld at End of Test
