Prevent Decking Incidents

Targeting the Deadly Dozen Hazardous Activities that Lead to Fatalities and Disabling Injuries

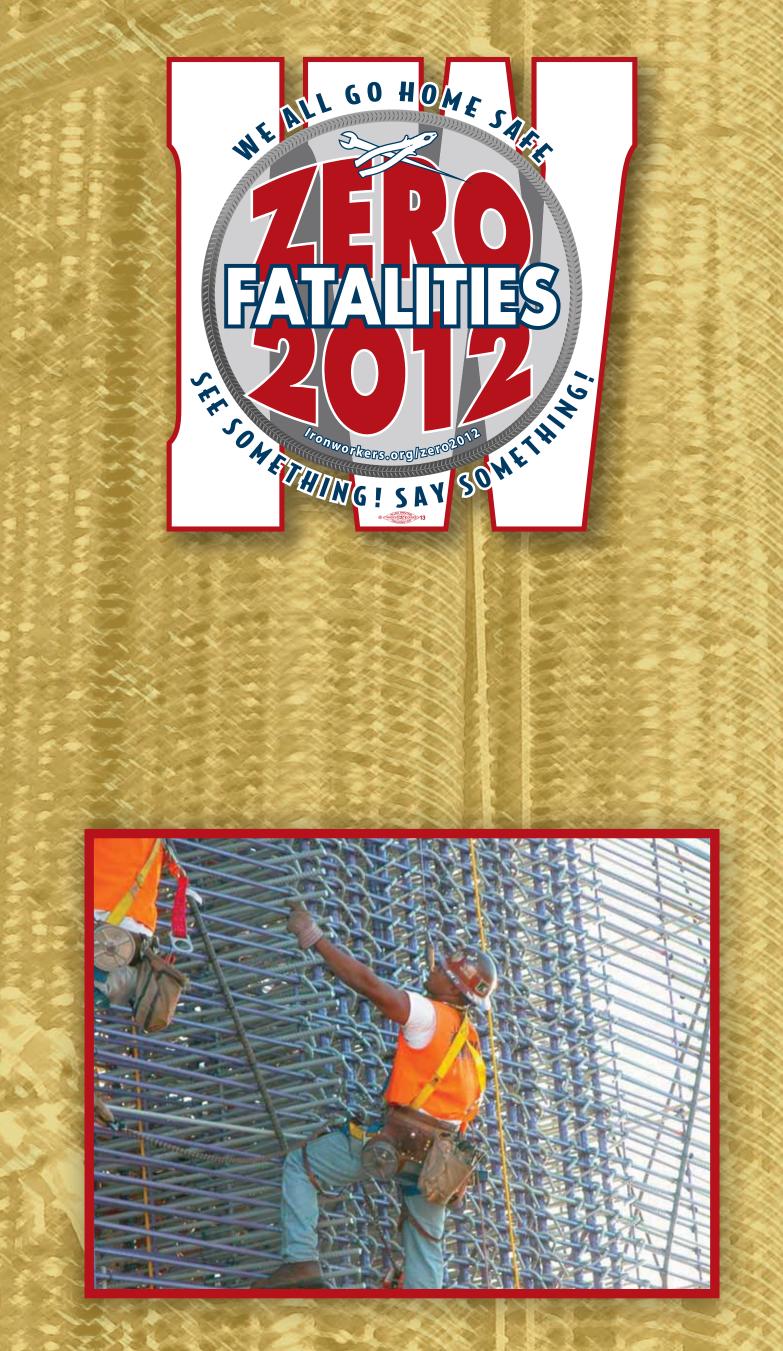
Rebar Columns and Walls Must be Adequately Guyed or Braced Horizontal Columns Must be Fabricated

with Internal Bracing to Prevent "Racking"

Column Components and Joint Connections Must Integrate Bracing, Template Hoops and Pick-Up Bars to Ensure Stability

Column Guying and Bracing Systems Must be Designed by a Qualified Person

Rebar Curtain Walls Must be Adequately Braced and Secured

- Structural Collapse of Vertical Columns Due to Inadequate or Lack of Guying and Bracing Systems.
- Racking of Horizontal Columns Due to Lack of Internal Bracing.
- Curtain Wall Collapse Due to Lack of Bracing or Securing to Formwork.
- Lack of Preplanning and Assignment of Responsibilities to Prevent Collapse Hazards.

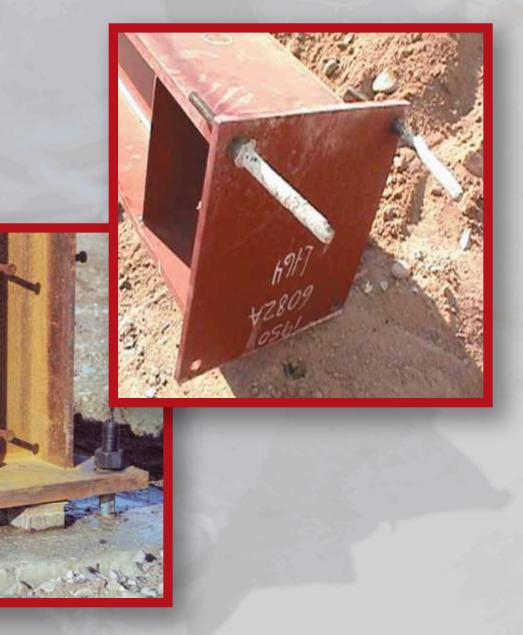
All Columns Must be Anchored by a

Minimum of 4 Anchor Bolts

Columns Must Not be Erected until Written Notification of Sufficient Concrete Strength

Anchor Bolts Must Not be Repaired, Replaced or Field-Modified Without the Approval of the Project Structural Engineer of Record

All Columns Must be Evaluated by a Competent Person to Determine Whether Guying or Bracing is Needed

- Structural Collapse Due to Using "Two-Bolt" Columns.
- Insufficient Concrete Strength and Failure to Receive Written Notification from the Controlling Contractor.
- Anchor Bolts that have been Incorrectly Repaired, Replaced or Field Modified Without the Approval of the Project Structural Engineer.
- Lack of Column Guying and Bracing to Maintain Structural Stability.

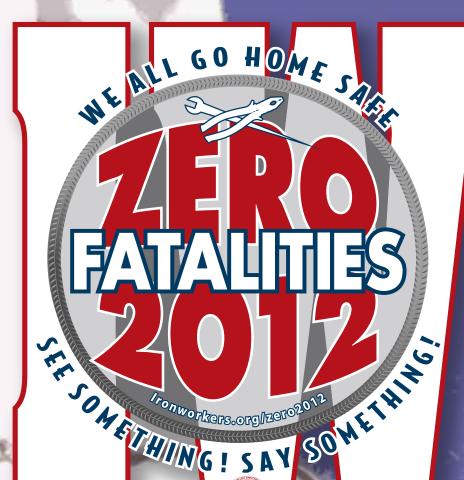
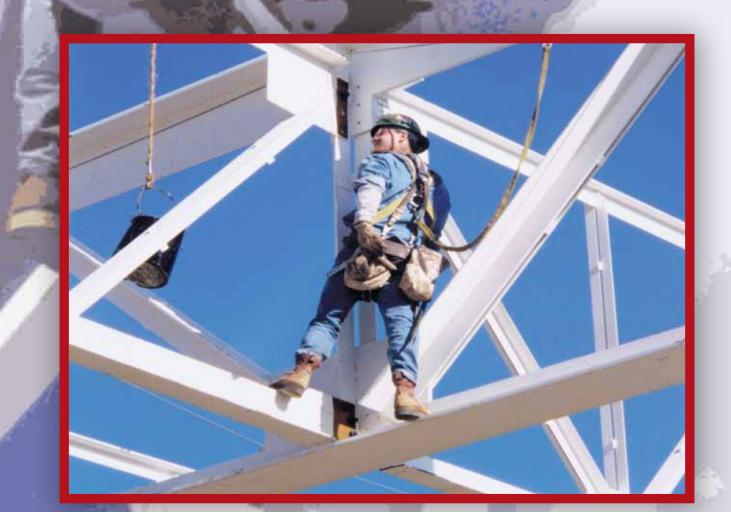
Recognize and Avoid Potential Fall Hazards

in Your Work Area Inspect and Use Fall Protection Equipment and Systems Determine the Appropriate Anchorage Point Receive Training at

Your Local Training Facility

- Failure to Recognize Potential Fall Hazards in the Workplace.
- Misuse and Failure to Use Fall Protection Equipment.

- Use of Inadequate Fall Arrest Systems That Were Not Engineered.
- Lack of Training on the Inspection and Use Fall Protection Equipment.

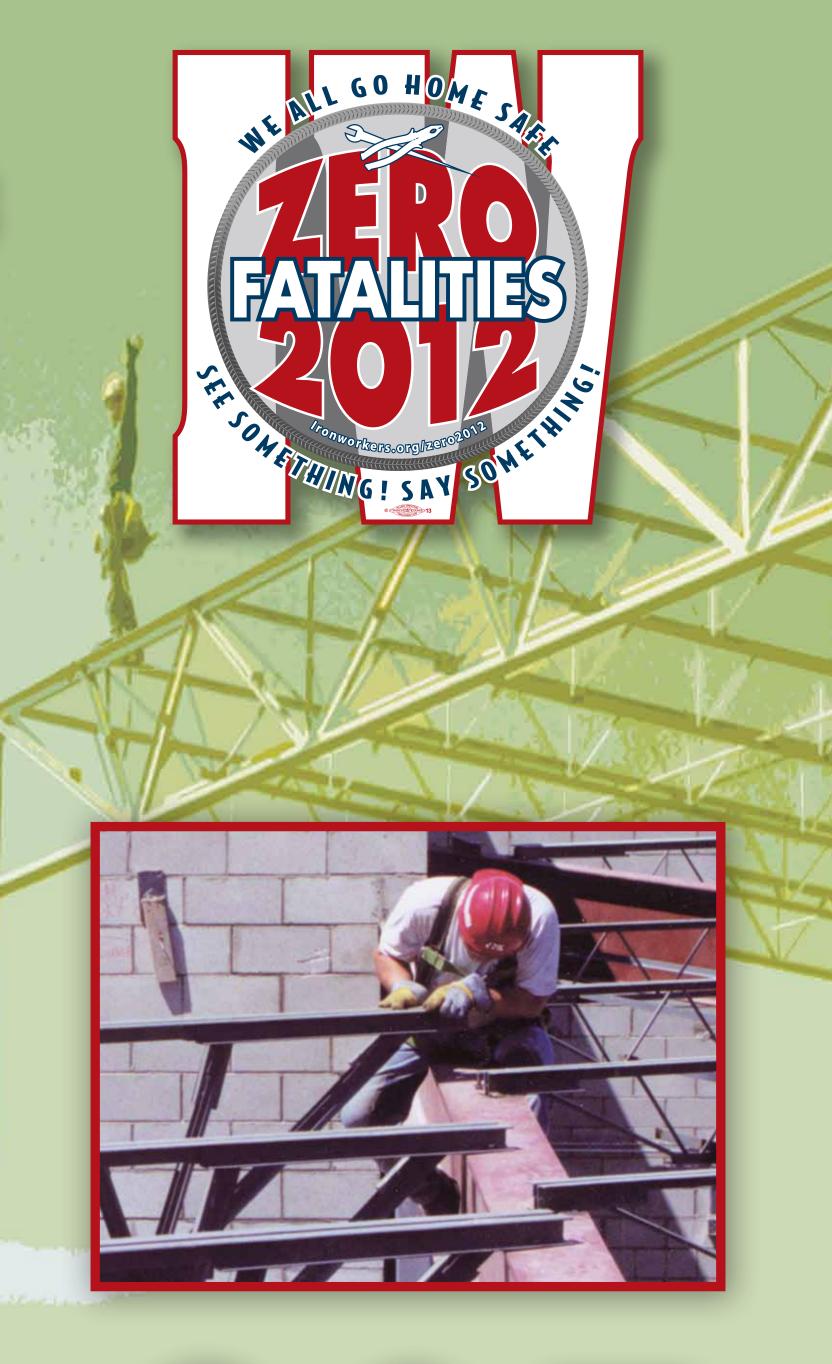
Preventing Steel Joist Incidents Field-Bolting and Welding Joists Joist Ends to Prevent Collapse

Recognize Requirements for Bridging and Diagonal Bolted Bridging Special Erection Requirements for Erecting K, LH and DLH Series Joists Special Requirements for Landing Deck Bundle on Joists

- Collapse Due to Lack of Field-Bolting or Welding Joist Ends.
- Collapse Due to Insufficient Bridging or Diagonal Bracing.
- Improper Erection of Long Span Joist.
- Collapse Due to Landing Deck Bundles on Unsecured Joist.

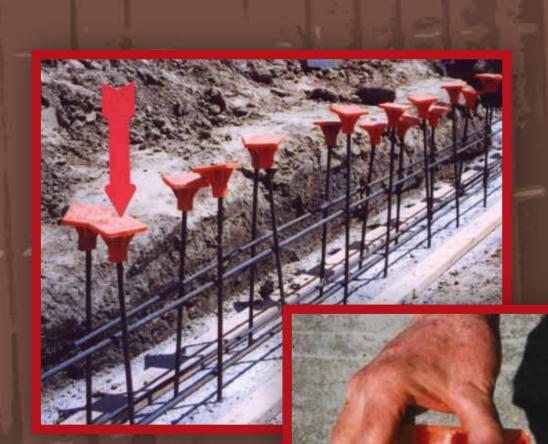
Avoid Potential Impalement Hazards in Your Work Area

Inspect Protective Covers to Verify They are Designed to Prevent Impalement Never Perform Work Over or Near Unprotected Dowels Recognize Impalement Hazards From Other Projections on the Job Site

- Working Above or Near Exposed Rebar Dowels.
- Failure to Provide or Maintain Protective Covers on the Job Site.
- Failure to Inspect and Verify Types of Protective Covers.
- Failure to Provide Instruction on Impalement Hazards.
