# ACHIEVING DUCTILE BEHAVIOR OF MOMENT CONNECTIONS—PART II

The results of additional tests provide further confirmation that weld metal toughness is key in achieving ductile performance of new and repaired moment connections

By Ming Xue, Eric J. Kaufmann, Le-Wu Lu and John W. Fisher

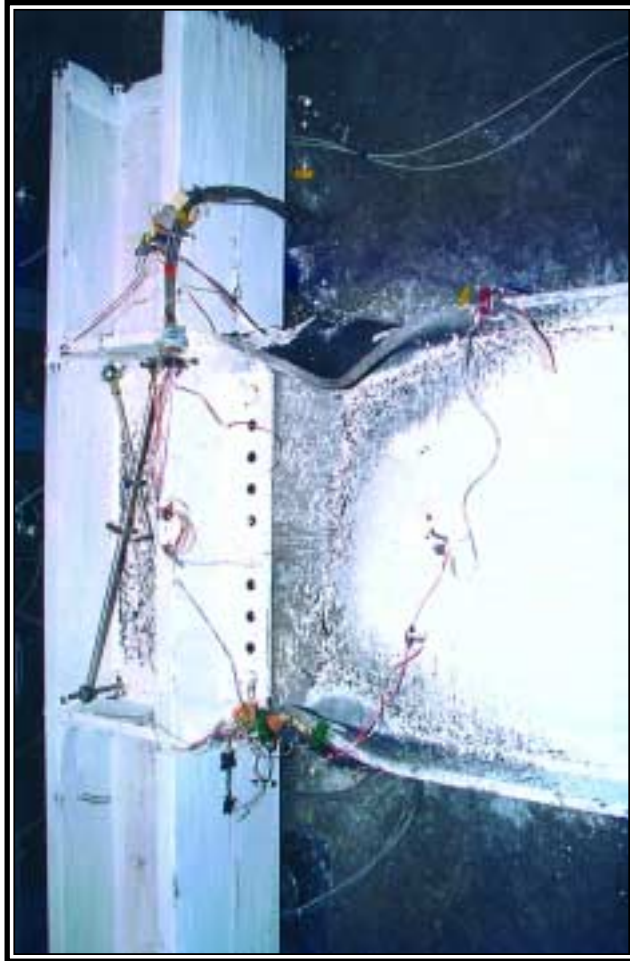
**Figure 2:**  
Beam yielding  
and buckling of  
Specimen A-4  
(E70TG-K2  
electrode)

Specimen A-4 provided excellent plastic deformation and energy dissipation capacity. As shown in Figure 2, extensive yielding and local buckling deformations were observed in the beam web and flanges during the large displacement cycles. Because of inelastic local buckling, the specimen experienced appreciable strength degradation. The test was stopped after three cycles of  $5\Delta_y$ , where  $\Delta_y$  is the yield displacement of the specimen. Near the end of the test, a few small cracks were observed at the weld toes of the beam flange and web connec-

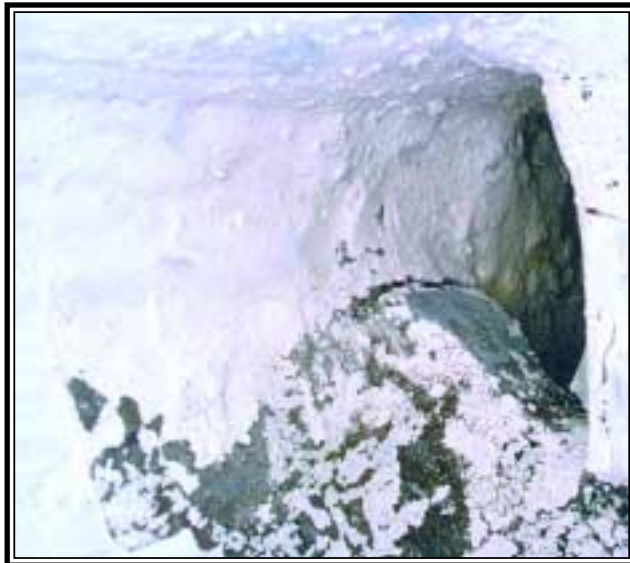
**Figure 3:**  
Stable crack at  
access hole of  
Specimen A-4  
after large rota-  
tion

tions. These cracks were, however, very stable and did not propagate rapidly. Figure 3 shows a crack that formed at a weld access hole.

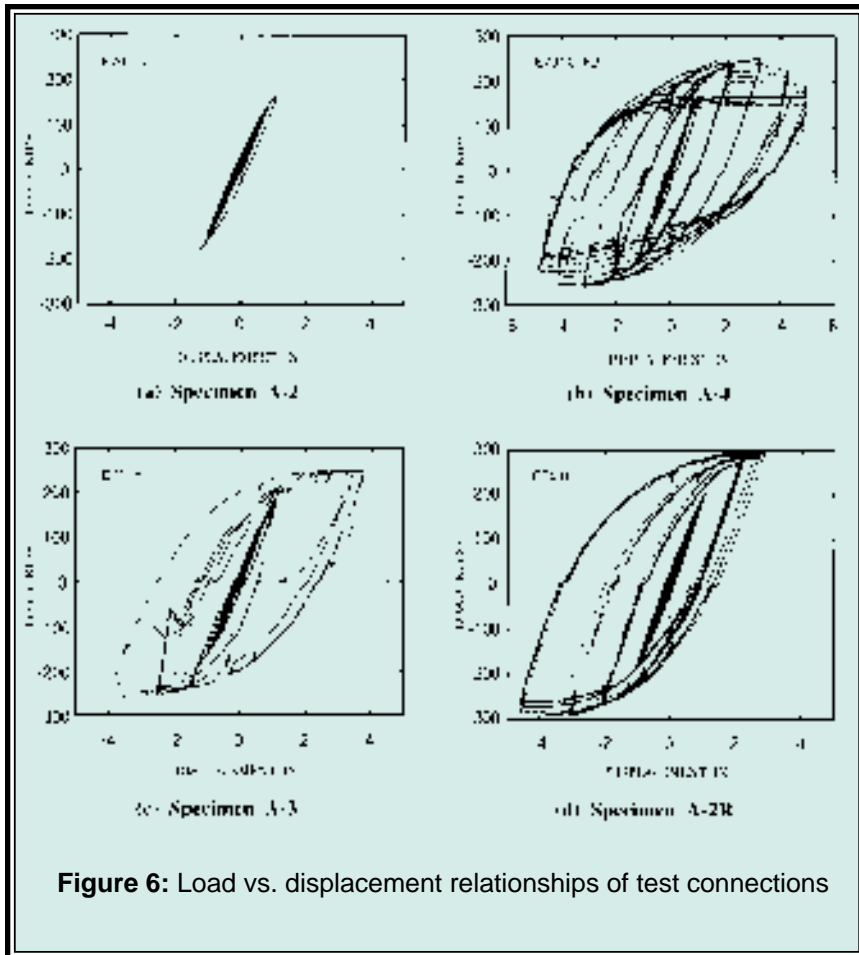
**Figure 6:** Load vs. displacement relationships of test connections

The load vs. displacement hysteresis loops are plotted in Figure 6 for specimens A-2, A-3, A-4 and A-2R. Table 3 compares the maximum bending moment, the maximum beam displacements and the maximum plastic beam rotations of the four specimens. The bending moment at the column face is expressed as a function of  $M_p$ , the plastic bending moment of the A36 W36x150 beam. The displacement is the beam deflection measured at the point of load application. The

plastic rotation was calculated for all the specimens by assuming a plastic hinge formed at a half beam depth away from the column face. The data listed in Table 3 are those obtained just before the final fracture of a flange or the end of a test.
