BRIDGE CROSSINGS

No. 17, June 2000

The Same Old Grind...An Investigation of Zinc-Rich Primer Performance Over Steel Corners

By William D. Corbett

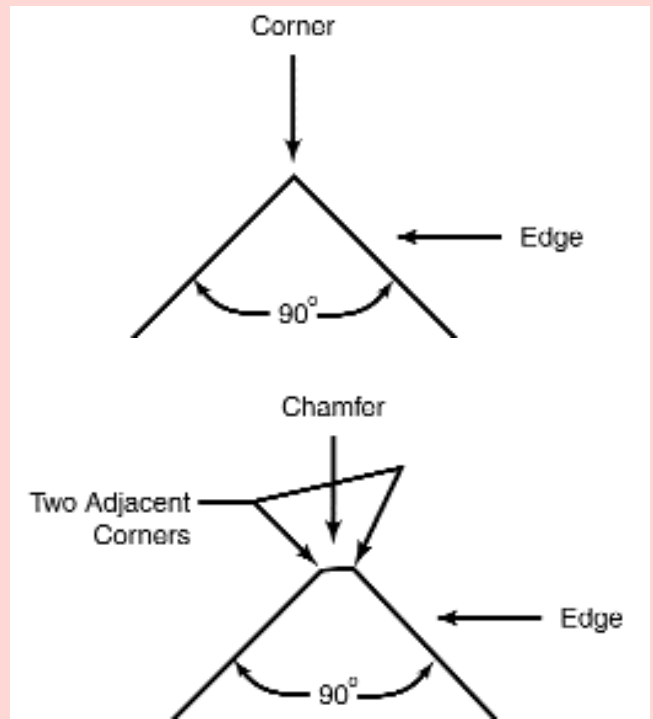
Figure 1: Illustration of corner and edge terminology

Throughout this article, the terms "corner" and "edge" are used to describe specific surfaces on structural steel members. It is acknowledged that the industry uses these terms interchangeably. However, for the purposes of the study, the term "corner" was used to describe the apex where two edges come together, which is the surface reportedly requiring preparation prior to coating. The term "edge" was used to describe the surface adjacent to the corner. Figure 1 illustrates corner verses edge.
