OLD meets NEW

A series of three vintage masonry, cast iron and timber-framed buildings were combined to create contiguous retail spaces through the use of structural steel.

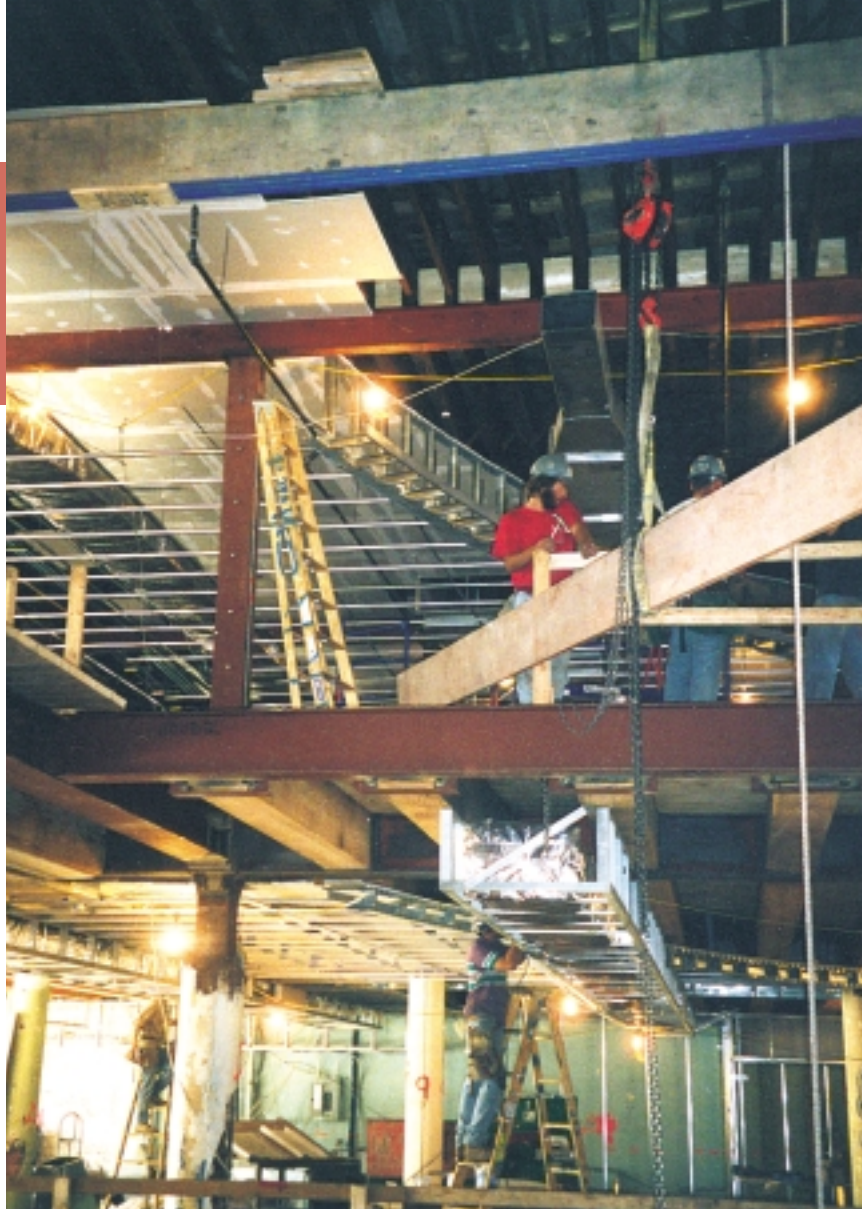
Steel members were used to create large openings in the existing bearing walls. Note the timber column, upper left, reinforced with channels bolted to both sides. Existing timber beams are supported with special seats welded to the steel girders.

The existing top floor columns were reinforced by installation of steel channels sandwiching the wood columns and extending up from the roof structure for the support of the new roof dunnage, sustaining the new mechanical units. The new elevator required cutting corners of the large granite pile caps to provide clearance for the 14'-deep elevator pit. Pressure grouting techniques were used to strengthen the soil, prevent and reduce excessive settlement and control seepage around the elevator pit area.

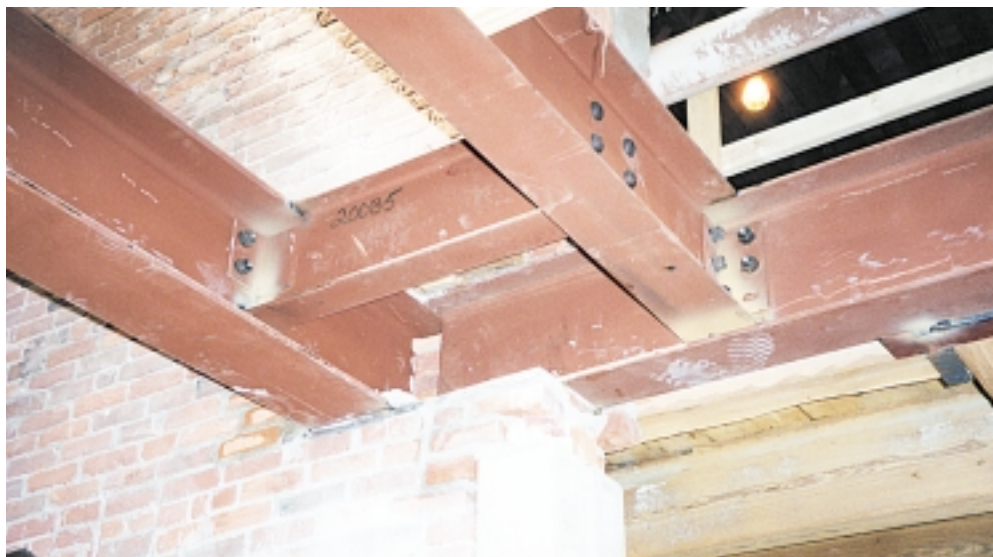
New escalator support beam (left). A "backup" beam, running parallel to the escalator support beam, helps resist torsion with a short, moment-connected filler beam.

An important issue was to overcome the torsion created in the girders from the eccentric connection configuration of the escalator trusses at the support girders. As the large supporting escalator girders were free to rotate at the ends, and minor torsional resistance was inherent in the wide flange girders, it was decided to brace the girders by welding horizontal beams to them with moment connections and extending and tying the beams to a distance beam installed parallel to the main girders. The torsion, which

caused an uplift in the distance beam, was balanced by the vertical uplift reactions introduced in the distance beam. The same criteria were used for all escalator girders through all floors.

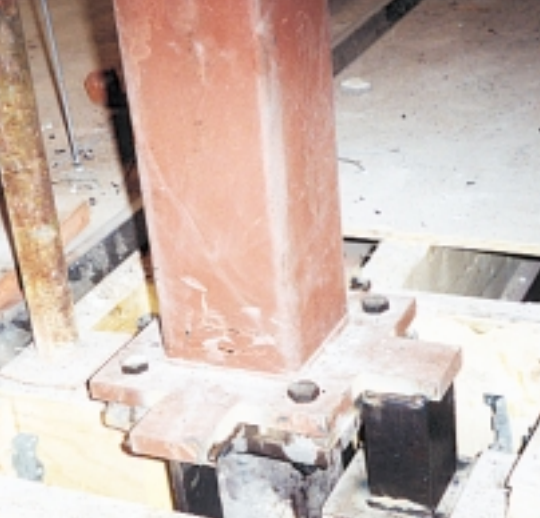
Left and Above: Detail of connection of new HSS columns to existing cast-iron columns. The existing columns (below the base plate with tabs) have connection seats and web connection plates cast integrally with the column.

Also, where steel columns had to be installed at upper floors replacing existing closely spaced wood columns, attaching the new steel columns to the top of existing cast iron columns below became a problem. The cast iron columns had specially cast head plates with small dimensions for supporting upper floor wood columns.

Due to the small dimension of the cast iron column head plates, a larger size steel plate had to be welded to the new steel column bases. The steel plate was bolted to the existing cast-in-place cast iron plate and extended and welded to the lower floor beams. Because the cast iron plate was at a higher elevation than the floor level, the above procedure created a large size column base resulting in a larger finished size for the columns.

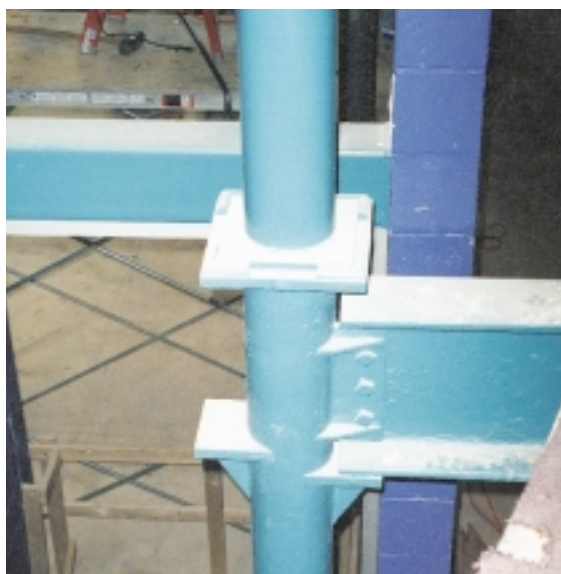
View of an existing cast-iron column-top connection. The existing columns have connection seats and web connection plates cast integrally with the column. The cast-iron cap plate has a cast "recess" to accept the column above.
