STEEL and STONE

Shop-fabricated steel frames with shop-attached granite facing restore an intricate stone façade in Manhattan.

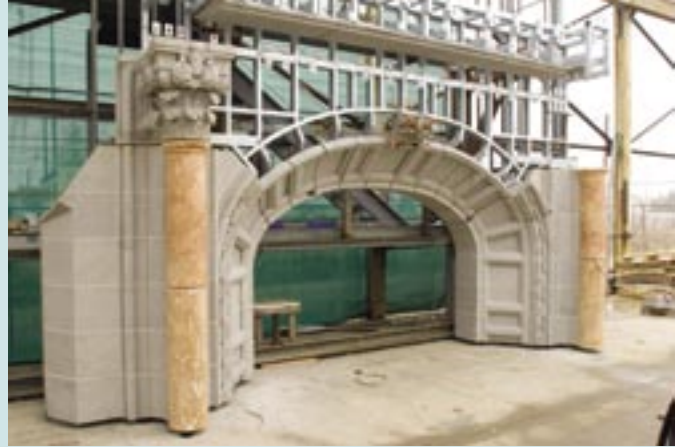
The damaged grand arch at the main entrance (shown on previous page) was reconstructed using original and new stones attached to steel truss panels. Note that the center of the arch is part of the unfinished section.

The crowning arch provided one of the greatest installation challenges, on top of its fabrication challenges. The complex arch panel weighed over 20,000 lb and integrated numerous highly detailed carvings of both historic and new granite. Due to the importance of this particular panel, and because it had to be erected in between the sky climber mast units, meticulous planning of crane placement was essential. The crane had to effectively reach between mast units carrying a granite-clad steel truss panel with a spreader bar in place, while keeping the boom of the 35 ton crane under the overhead work.

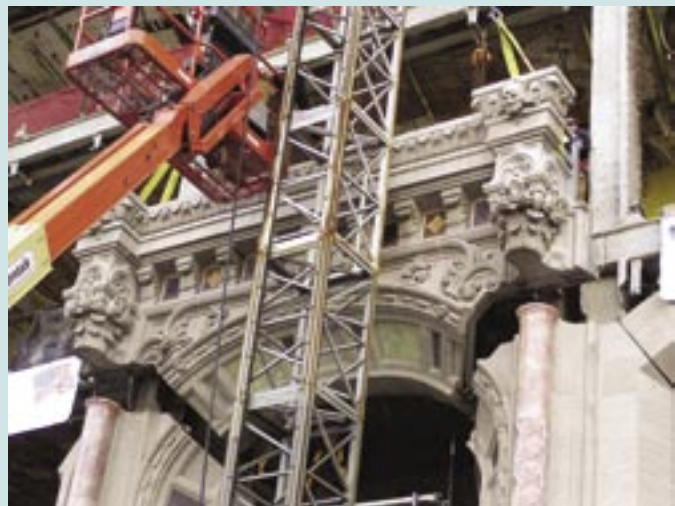
The restored center panel of the grand arch is lowered into place above the main entrance. This panel weighed over 20,000 lb.

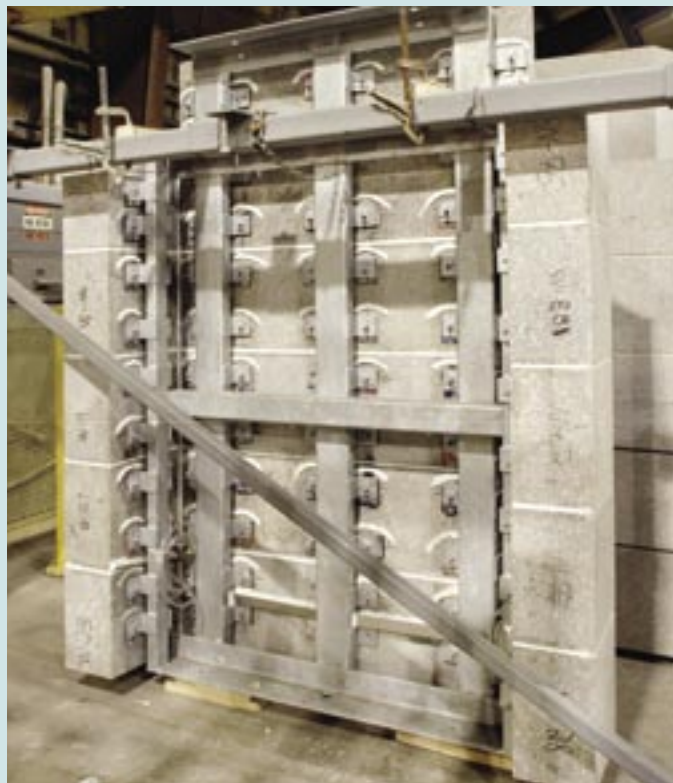
A washer, lock washer, and nut secure the stainless steel anchors to the clip angles. Shims accommodate frame tolerances and ensure the face of the stone is in the correct finished plane. Silicone in and around the anchor holes and in the steel connection slots keeps the crevices from being filled with debris and damaging moisture.

Instead of using large cubic pieces for the simple stone elements, a stone veneer was implemented. The typical veneer stone averaged about 3” in thickness, with some as thin as 2”, and was attached to the steel panels using a mechanical #31 or T31 anchor. The T31 anchor was inserted into a curved slot routed into the back of the stone using a diamond encrusted rotor bit. Three inch to 4”-long steel angle clips were carefully located and welded to the frame. The angle clips had access holes for the mechanical anchors and were welded in place on the frame prior to setting the stone.

Once all welding was completed, the finished frames were hot-dip galvanized to prevent rust and deterioration. A washer, lock washer, and nut secured the stone anchors to the clip angles. Shims between the angle clips on the back of the stone could be adjusted to accommodate frame tolerances and to ensure the face of the stone was in the correct finished plane. Silicone was inserted into the anchor holes and the mechanical connection anchor slots to keep them from being filled with debris and moisture from condensation—moisture that, if not prevented, would lead to long-term deterioration. Stone assembly was completed in three and a half months.

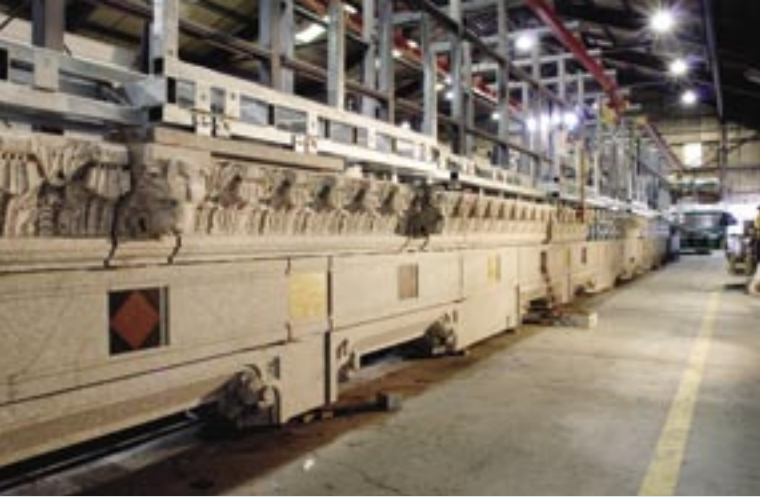
All panels were “pre-registered” prior to shipping. Pre-registration is KEPCO+’s process of pre-installing each panel in the shop to ensure the finish materials align with the adjacent panels.

All panels were “pre-registered” in KEPCO+’s shop prior to shipping. Pre-registration is KEPCO+’s process of pre-installing each panel in the shop to ensure the finish materials align with the adjacent panels. Then, the building connections that are installed in the panels are adjusted to reduce alignment time in the field. The overall process allows for quicker installation and higher quality control.
