Structural Surgery

Maintaining a functional facility during construction was the top priority at Philadelphia's Pennsylvania Hospital.

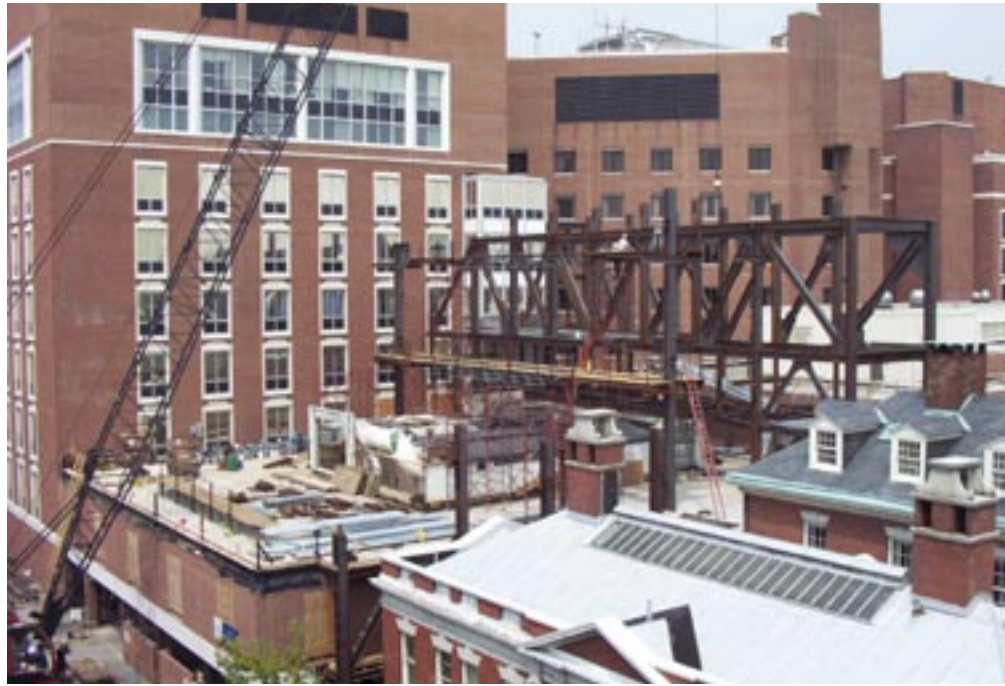
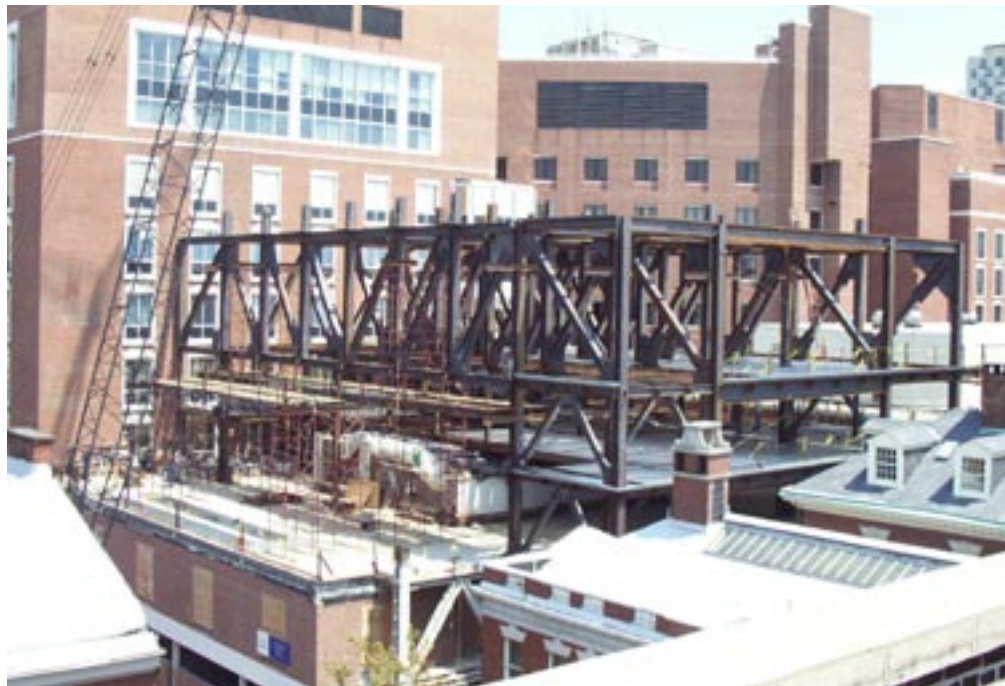
Story-high steel trusses spanning over an existing structure were the only option for expanding on the tight site.

With minimal disruptions to hospital operations in mind, the team further developed the engineering design concepts, constructability issues, and architectural and mechanical planning requirements. The schematic called for six major steel trusses spaced 20 ft apart, bridging an 80 ft clear span over the existing building with an additional 18 ft cantilever at one end. One end of the trusses would be supported beyond the existing building by new steel columns and braced frames straddling the loading dock ramp. At the other end, six new “long” steel columns would be threaded down through small holes placed in the existing building. The new columns were to be situated along a corridor wall, midway between the existing columns to avoid interference with existing foundations.

Six main steel trusses bridge across the existing building, and served as the primary support system for six new floors. To keep the truss diagonal members from interfering with the architectural space requirements, the trusses were placed within the required new mechanical floor at the fifth level. Major mechanical units were laid between the trusses, and the mechanical distribution was coordinated between the diagonals. The new fourth floor, below the trusses, was supported by wide flange shapes hanging from the fifth-floor truss bottom chord. Design provisions allow for up to four floors to be posted directly from the truss top chord panel points.

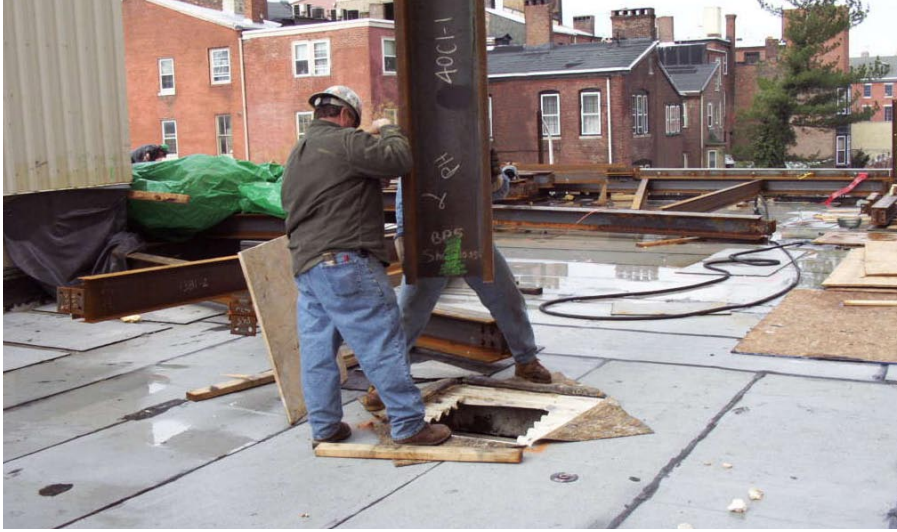
New columns were threaded through small openings in the existing structure.

After the foundations were placed, the long columns would be installed through the existing building and attached to the existing building framing at each floor. Two braced frames in each direction would then be installed to provide lateral stability for the combined new addition and existing building.

At all times, the design was predicated on the need for continuing emergency department operations within the first floor of the existing building. New column locations were selected near the perimeter of the department area. To maintain safety and contain dust, 30-in.-square column enclosures were constructed to create small boxed-out areas around the holes that each of the six new columns would be threaded through. In order to avoid the difficulty of spray-fireproofing the members once they were in place, the new columns were
