You Can't Judge a Cable by Its Cover

"Getting to the heart of the matter" is a good philosophy to adopt when evaluating suspension bridge cables.

Forth Road Bridge

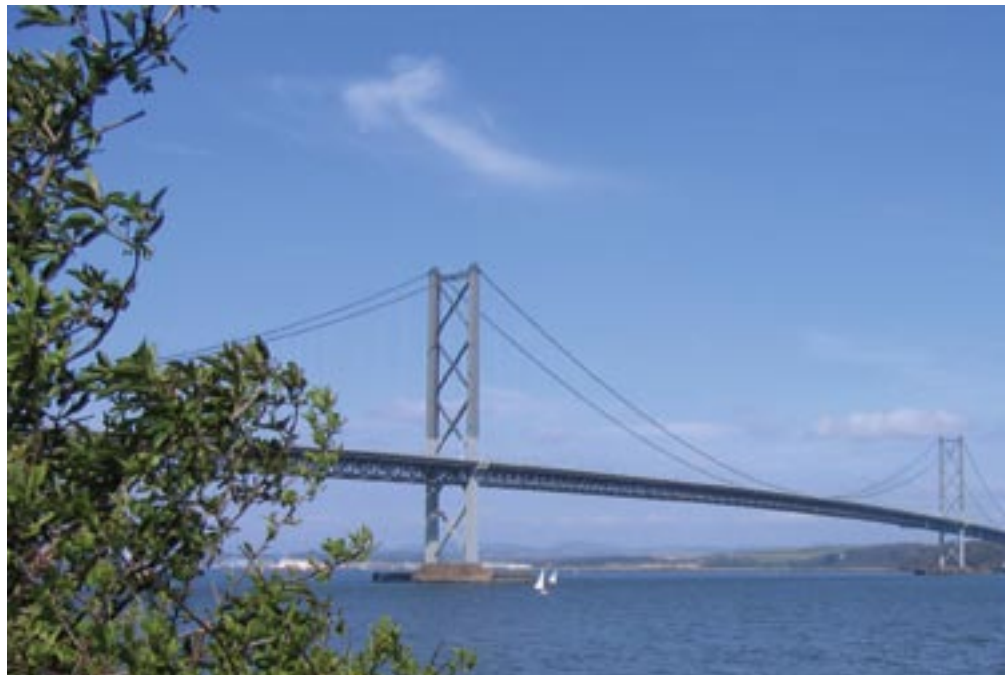
The cables on Scotland's 3,300-ft-long Forth Road Bridge were recently inspected for damage.

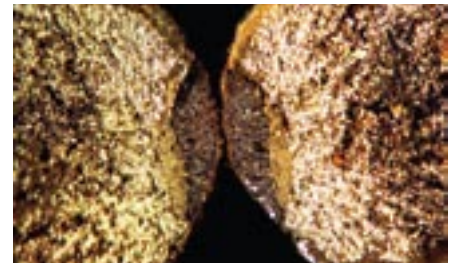
Close-up view of cable corrosion on the Forth Road Bridge.

The process began with a cable walk to observe the condition of the wrapping. The cable appeared to be well maintained: There were no visible water leaks, rust stains, or bulges, although the presence of ridges indicated that wires were crossed and susceptible to rust because of the voids they created. Next, a total of ten cable panels were unwrapped. To be economical, several feet of wrapping wire were left in place at one end of each inspected panel, so that only one machine was required for rewrapping. That still left a generous 55 ft per panel for internal inspection. Eight lines of wedges were driven into the center of the cable, and the condition of visible wires was recorded by inspectors. Much to everyone's surprise, broken wires were found to a six-wire depth, as well as a considerable number of corroded wires. Eighty wires were removed and rigorously tested. The wires were graded according to the cor-

rosion stages developed by Hopwood and Havens (1984), from 1 (wire and zinc coating barely oxidizing) to 4 (more than 30% covered with brown rust). The data were used to estimate how many of the 11,618 wires in each cable were in each stage and how many were cracked.

Analysis confirmed that the cable had lost 8% to 10% of its strength. Early estimates before the number of cracked wires was known suggested almost double that loss, based on experience with other bridges. Testing revealed fewer cracked wires than anticipated and confirmed that every bridge is unique in this regard. Cracked wires are the major determinant in calculating cable strength. Unfortunately, cracks are not visible during inspection. When broken wires are found, cracks are likely to exist in unbroken wires; but they only become evident after testing, when the failure surface is inspected under a microscope. When wire sample selection and testing are as rigorously specified to yield consistent and sufficient data as they were on the Forth Road Bridge, it ensures confidence in the conclusion. An owner armed with a statistically clean set of data and a safety factor rating can plan and budget more efficiently. As more inspections take place, a central database of test results would be invaluable to keep track of cable strength results versus age and help engineers estimate future deterioration rates more precisely.

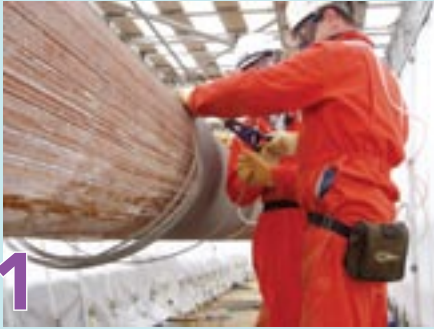
The existing wrapping is removed from the cable.

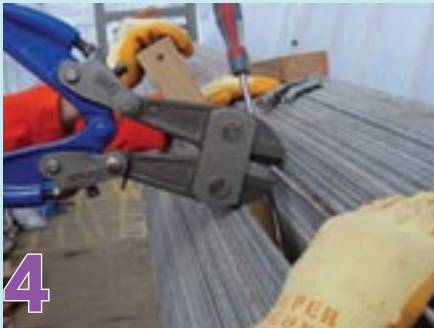
A sample wire is cut and tested.

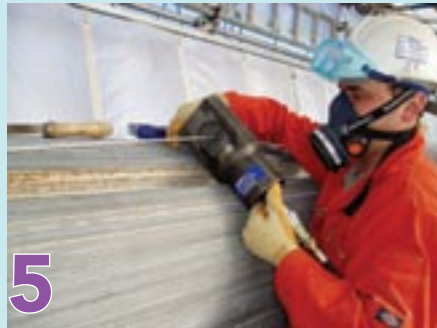
New wires are installed as necessary.

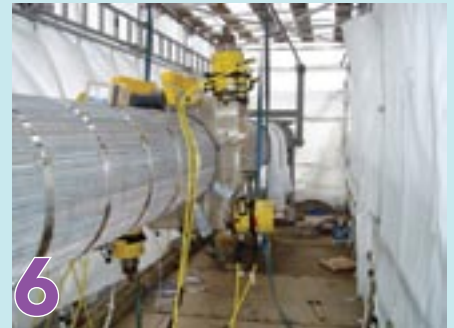
The cable is recompactified...
