## Thanks to a structural renovation in lower Manhattan, a new sports museum comes to life and an historic edifice lives on.

In America, as soon as one season ends, another begins—or is already in progress. In recognition of this love affair with athletic pursuits, the Sports Museum of America last May opened its doors in lower Manhattan as the nation's first museum dedicated to all sports—and as the new home of the Heisman Trophy.

The museum occupies 80,000 sq. ft on the bottom three floors of 26 Broadway, a site with a rich history. It was in this building that John D. Rockefeller made his millions at the helm of Standard Oil, the powerful firm that monopolized America's oil markets and set prices for petroleum for decades. Rockefeller constructed the building in several phases. In 1885, he started with a ten-story building designed by Ebenezer Roberts. In 1895, he expanded the building through the construction of six additional stories and an addition to the northern section, design by Kimball and Thompson.

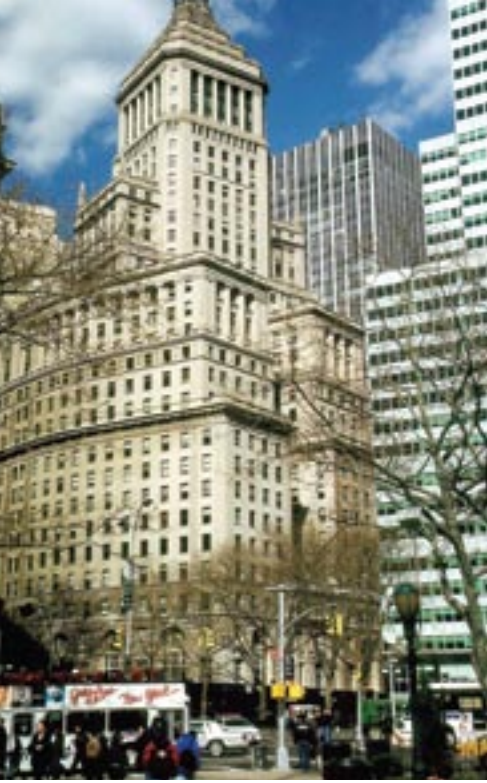
Manhattan's 26 Broadway began as a 10-story office building in 1885. It was expanded by six stories and also received a northern addition in 1895. A 32-story tower was added in several phases during the 1920s. A structural renovation to the building was just completed last year.

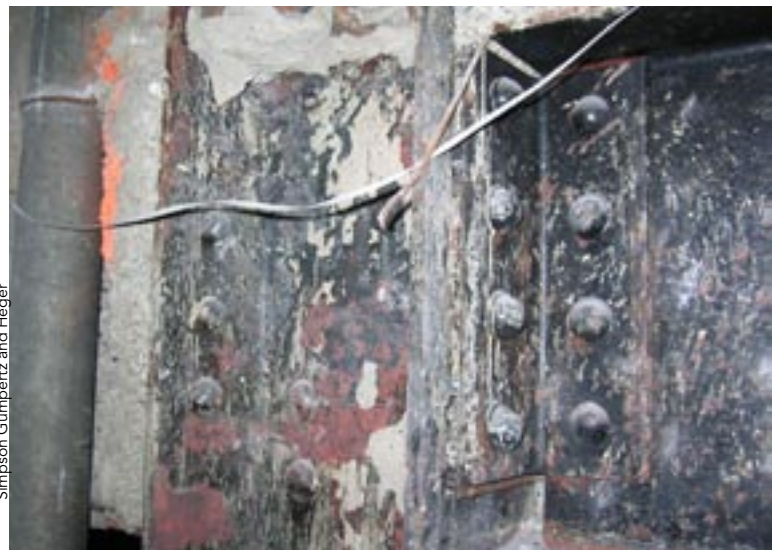
The renovation included structural probes into the older parts of the building, including the steel—still holding up—in the section built in the 1920s.

Hastings portion of the building were available, and we started our structural work with a field investigation program. We systematically probed the older portions of the building for which we had no drawings and we spot-checked the Carrere and Hastings portion to determine whether the structure adhered to the drawings in our possession.

In most of our probes into the 1885 portion of the building, we observed wood sleepers and wood flooring bearing on the top of wrought-iron beams. Between the beams, cinder fill rested on 10-in., terra-cotta tiles that span 4 ft as a flat arch between the beams. The bottom flanges of the beams support the tiles. Thus, the bottom flanges of all the beams are aligned while the top flange elevations vary by the depth of the section. The wrought-iron beams are either supported on 4-ft-thick exterior bearing walls or frame into girders that are supported by cast-iron columns.

When we investigated the 1895 portion of the building, we found similar construction with wrought-iron beams, cast-iron columns, and thick bearing walls. We made extensive site visits to document the steel framing exposed at probe openings, used ground-penetrating radar (GPR) to locate steel framing between probes, and obtained steel coupons for analysis in our Boston lab. We analyzed the live load capacity of the floor system and found that, in general, it was not sufficient for museum occupancy.

To strengthen the beams, we chose to weld WT sections to the top flanges because we were concerned that reinforcing them from below would potentially damage or collapse the brittle terra-cotta tiles. We removed the 4-in. topping slab, which helped to reduce the dead-load stresses in the beams prior to welding the WT's and creating composite action. The contractor, Structure Tone, cast new concrete against the WT's, replaced the topping slab, and coated the WT's with intumescent paint to achieve the required three-hour fire rating.

For the Carrere and Hastings addition—again, from the 1920s—we reviewed the existing structural drawings and made site visits to confirm and update as-built structural information. Here, extracted concrete cores revealed that the floor system consisted of 5 in. of cinder fill above a 5-in. cinder-concrete slab, with a draped mesh spanning 6 ft between concrete-encased steel beams. Analysis

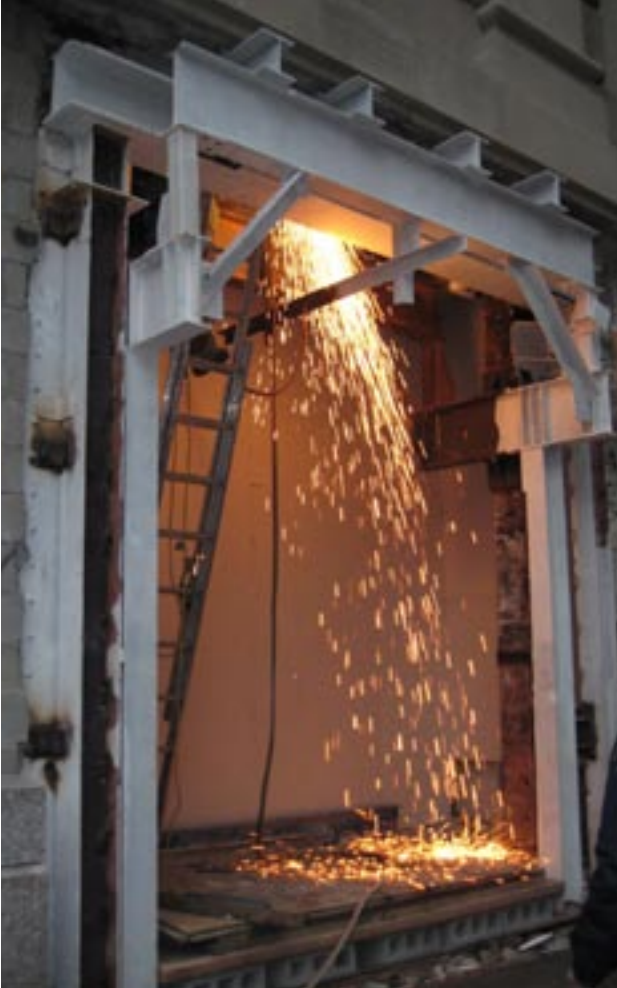
At some of the exterior bays, which were highlighted with limestone blocks, a temporary shoring system was used to support the limestone.

At the three remaining bays, establishing a new load path required a Herculean effort. We had to devise a temporary shoring system to support the limestone, but because of building infrastructure on the floors below grade, we could not place shores to the footings. At one bay, we cantilevered a shoring system from the spandrel beam. At the façade end we installed a post up from the cantilever beam to the underside of the stone, and at the backspan end we installed a post from the shoring beam to the underside of the floor framing. Once the load was

redirected, we removed the brick masonry, installed a series of posts to the underside of the stone, and reinforced the spandrel beam.

At the second bay, the lower spandrel beam was below the elevations of the new windows and had to be removed. To temporarily support the 30-ft limestone piers at this location, we bracketed off the columns and installed an outrigger system. We designed needle beams that penetrated the masonry above the existing spandrel beam and redirected the load to the temporary shoring system. Once the contractor installed the shoring with needle beams, they removed the existing spandrel beam and installed a new spandrel below the needles. At the third bay, the lower spandrel beam was only slightly below the elevation of the new windows, and we were able to strengthen the beam and cut the bottom end that interfered with the window line.
