Steel-framed buildings performed well under significant seismic loading.

Steel Structures in Haiti One Year Later

ARTICLE AND PHOTOS BY
STEVEN M. BALDRIDGE, S.E., P.E., LEED AP

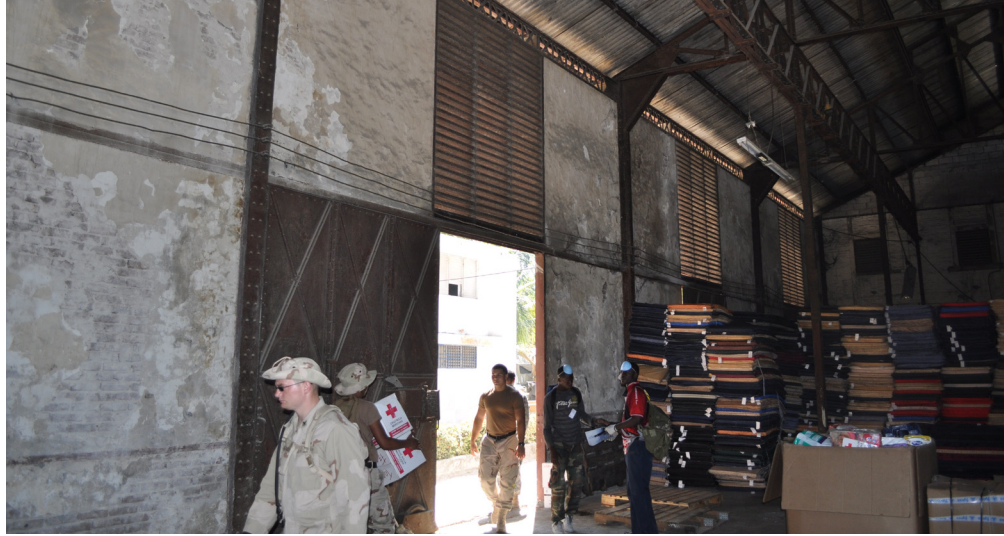
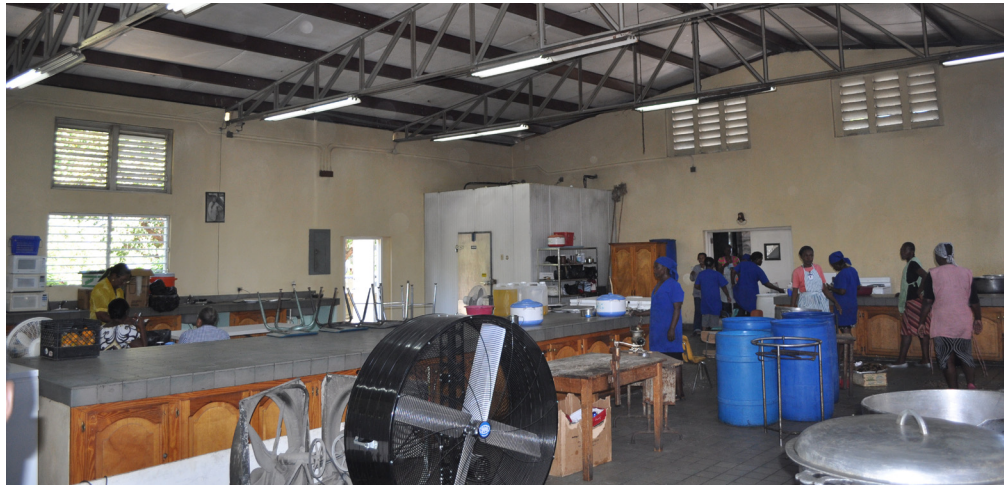
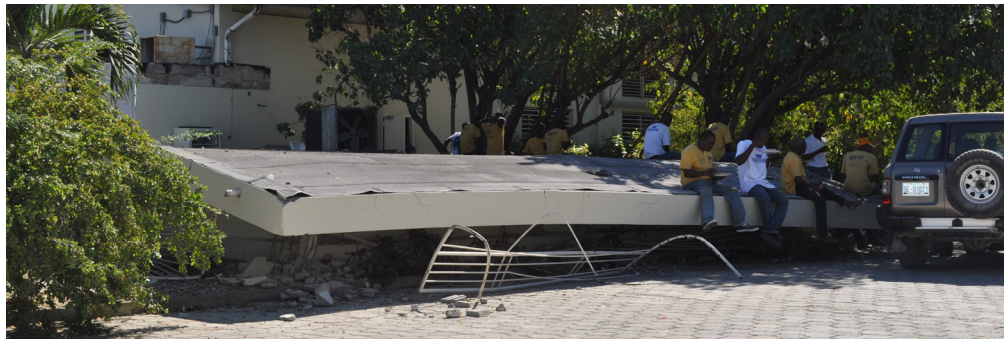
Fortunately in the majority of the steel warehouse buildings where vertical support was provided by steel columns, damage was limited to non-load-bearing masonry walls and the structures were able to continue to play a role in the relief efforts. One such warehouse was an older steel structure with brick infill. This structure was used by the U.S. military to help distribute supplies to rural areas just south of Port-au-Prince that were hit hard by the earthquake. Another was a relief kitchen that had been providing cooked meals to families. An adjacent covered eating area constructed of concrete did not fare as well, collapsing completely onto itself.

▲ In warehouse buildings where vertical support was provided by steel columns, damage was limited to non-load bearing masonry walls and the structures were able to continue to play a role in the relief efforts. The top photo shows an older steel structure with brick infill used by the U.S. military to help distribute supplies to rural areas just south of Port-au-Prince. Another served as a relief kitchen. The bottom photo shows an adjacent covered eating area constructed of concrete that did not fare as well, collapsing completely onto itself.

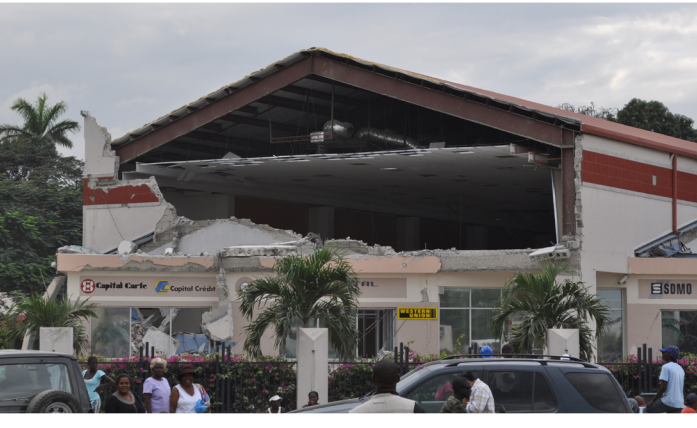
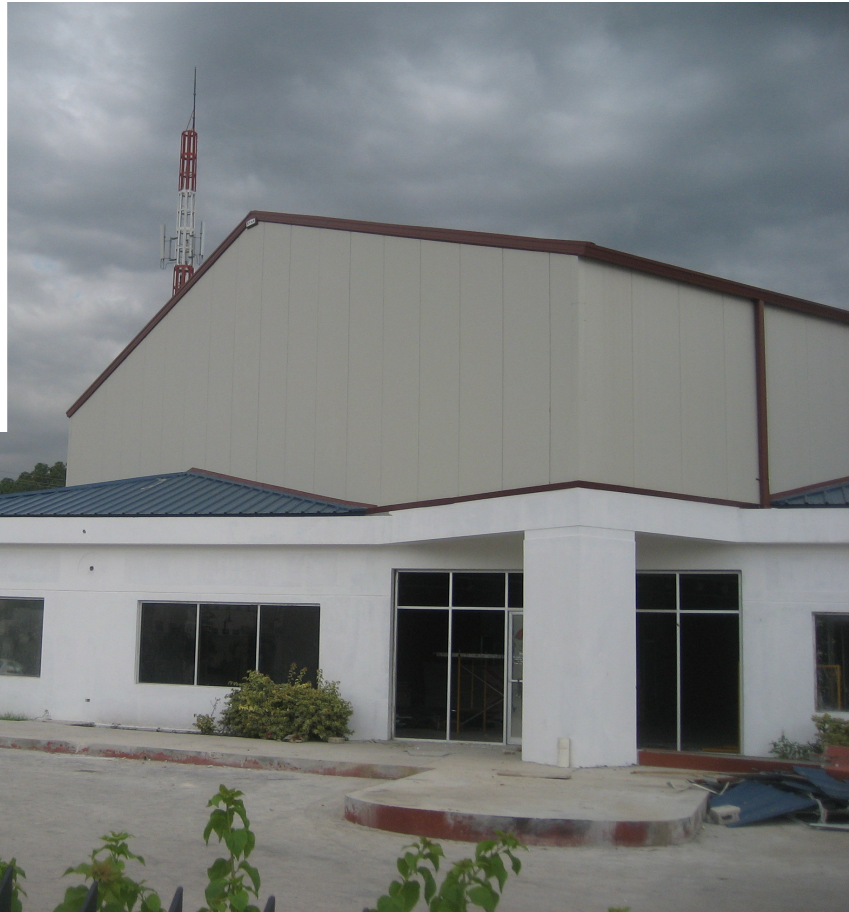
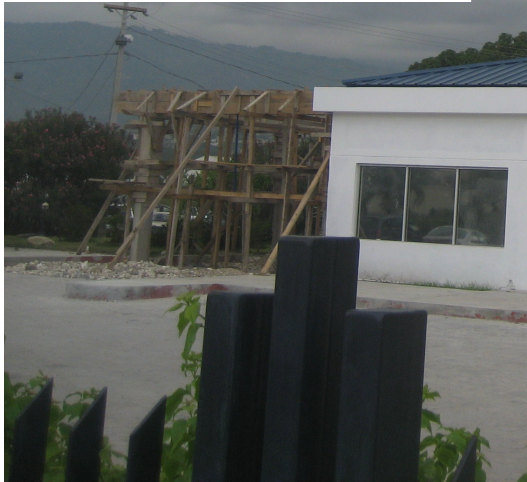
A commercial building near the U.S. Embassy is another example of a structural steel-framed building whose non-load-bearing masonry walls were severely damaged. The renovation and reopening of this building included removing the non-load-bearing masonry walls and replacing them with lightweight metal panels. The renovated building will have a lower mass enabling it to better withstand future seismic events.

- ▲ The non-load-bearing masonry walls of this steel-framed commercial building near the U.S. Embassy were severely damaged. The masonry walls were removed and replaced with lightweight metal panels, resulting in a usable structure with a lower mass that will better withstand future seismic events.

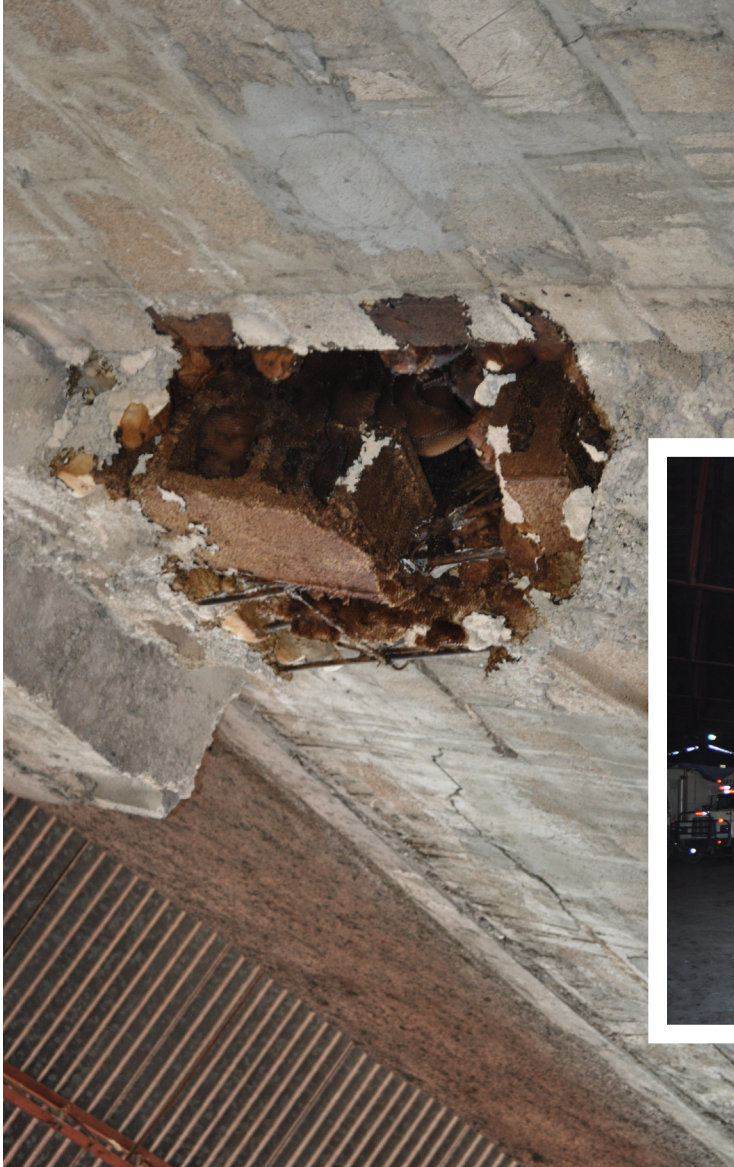
there were instances of portions of load-bearing masonry walls collapsing under seismic loading, much of the roof structure remained relatively intact. That allowed badly needed supplies to be removed from these buildings. Some of these buildings have been investigated for the possibility of shoring back up the existing roof and bringing these warehouses back into operation by replacing load-bearing masonry with steel columns.

▼ Even where masonry walls had collapsed due to the earthquake, in many buildings the roof structure remained relatively intact, allowing the removal of badly needed supplies.

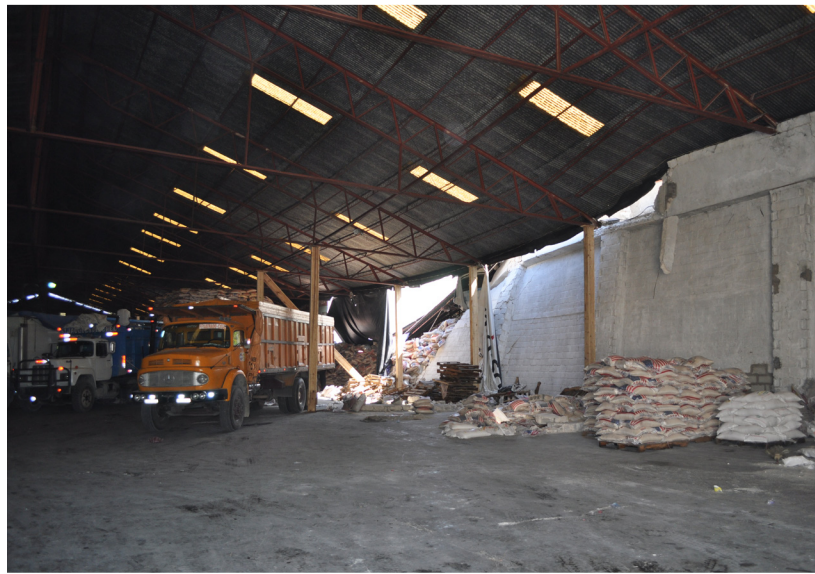
Steel warehouse buildings supported by perimeter masonry walls did not fare as well as their steel-framed counterparts due to weaknesses and poor quality construction in the load-bearing masonry construction. One CMU pilaster we witnessed had so much void space that bees had set up honeycombs within the voids. While

▲ There was so much void space in this pilaster that bees had moved into it.
