Back on the Job

Laser scanning sped the rehabilitation and third deployment of this historic iron and steel bridge.

BRIDGE 5721 IN MINNESOTA recently got its third lease on life. After a high-tech diagnostic survey followed by dismantlement and a thorough refurbishing, the structure, which is now officially identified as Bridge 82524, was reassembled in early 2011, then lifted into place in its third location. This is the second time this early metal bridge, originally constructed sometime in the 1870s, has been dismantled and reconstructed in a new location to serve the changing needs of the area.

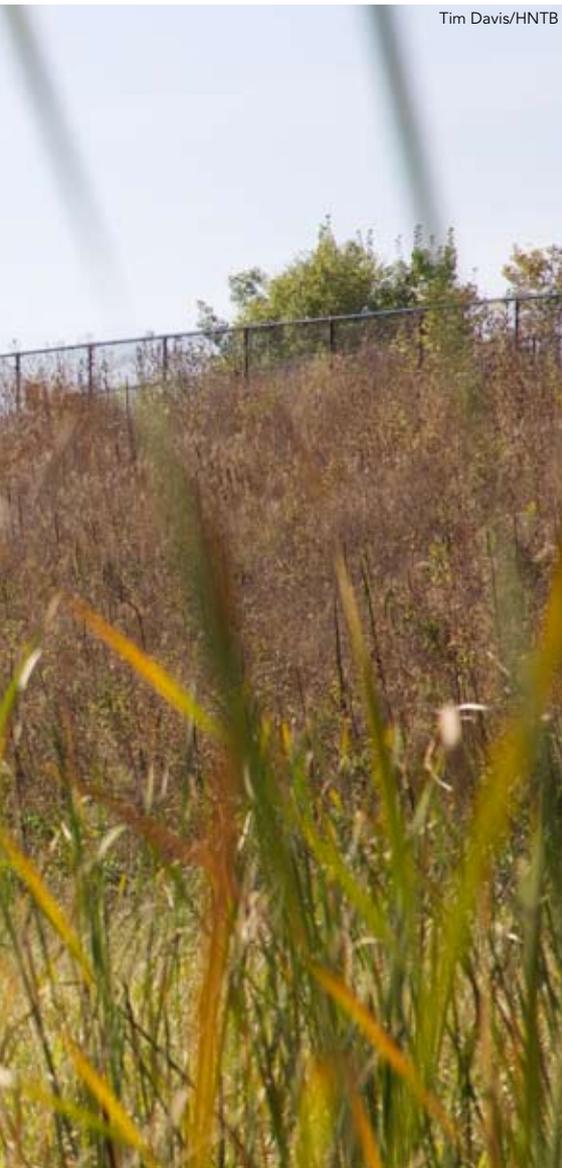
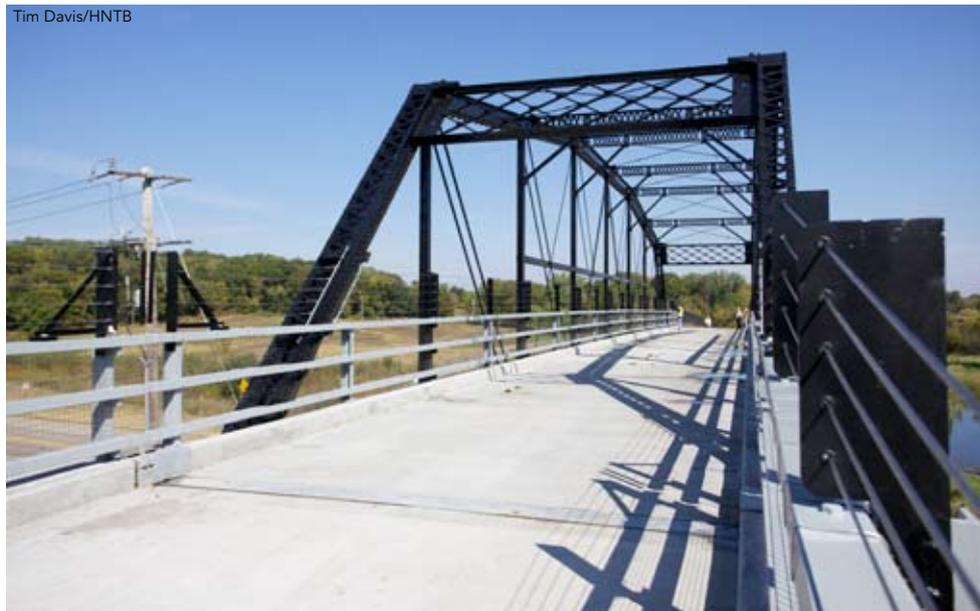
- ◀ ▲ Finished Bridge 82524 at its new site on the Gateway Trail near Stillwater, Minn.
- ▼ Bridge 5721 in its original location, Main Street of Sauk Centre, Minn., circa 1920.
- ▼ Bridge 5721 at its second location, near Silverdale, Minn., where it remained until 2009.

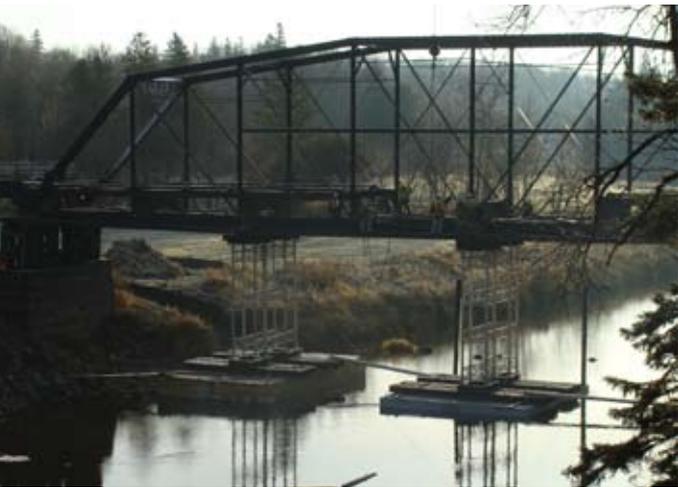
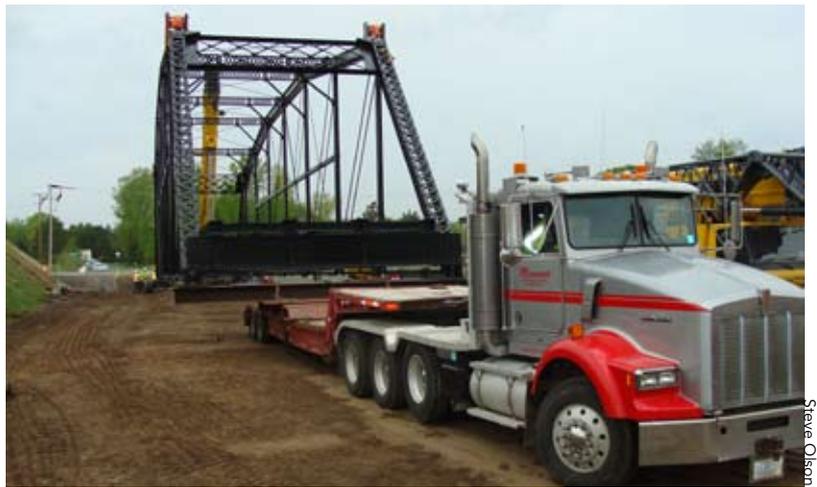
▲ In the spring of 2011 crews reassembled the truss on the ground near its new location, after which it was trucked into position for hoisting into place.

In the spring of 2011 crews reassembled the truss on the ground near its new location. In May two cranes lifted the truss and set it on its new abutments on the Gateway Trail. Final touches included installing the deck, painting and adding the equestrian railing. And with that kind of preparation, perhaps it can last another 135 years.

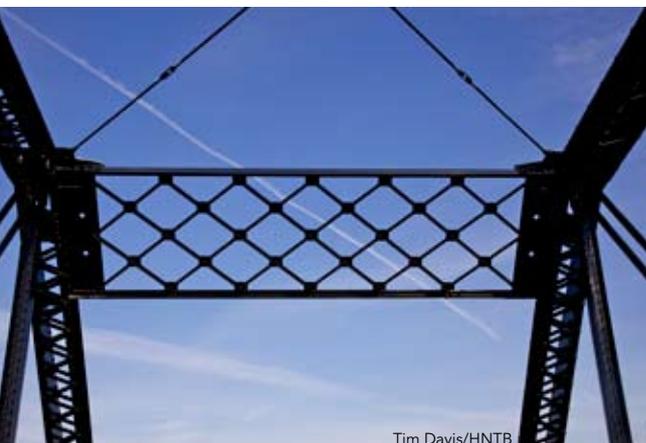
▼ Portal bracing is a lattice of angle sections.

Ornamental touches, which are relatively rare, greatly contribute to the aesthetics of this bridge. The overhead bracing members and their plates are perforated with circles and crosses. Overhead sway bracing consists of four angles with X-lacing and knee braces. The sway bracing also contains ornamental plates, each punched with four circles and a cross. Portal bracing is a lattice of angle sections.

Photos taken in the early 1900s show that the original portals differ from the 2009 configuration. The project historians decided to more closely match the earlier configuration by going back to portals with lower clearance. “Laser scanned data of the fastener patterns of the existing portals helped us to detail replacement portals and return the portal clearance back to 14 ft from 16 ft,” Olson said.

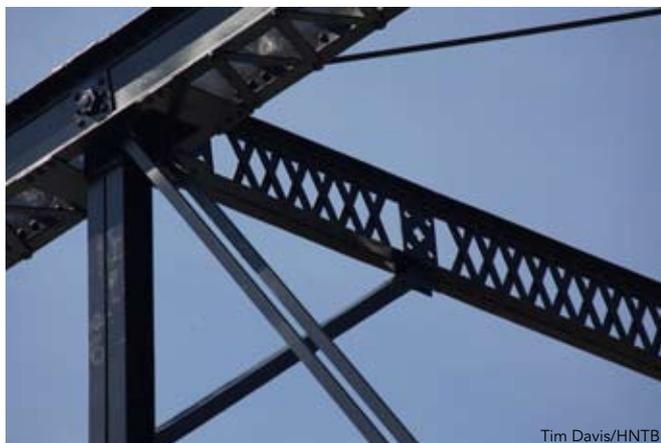
▼ Overhead sway bracing consists of four angles with X-lacing and knee braces. The sway bracing also contains ornamental plates, each punched with four circles and a cross.

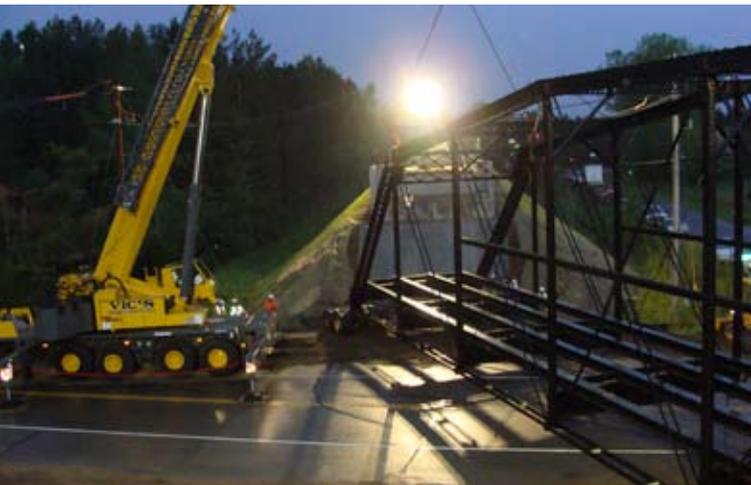
▲ In May 2011 two cranes lifted the truss and set it on its new abutments on the Gateway Trail.

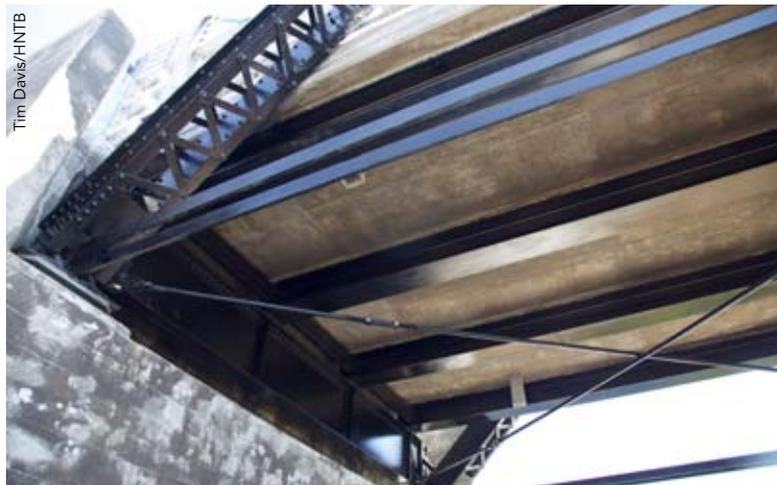
▲ At the bridge's new home on the Gateway Trail, a lightweight concrete deck is supported by new steel stringers.

Today the bridge has a completely new floor system, from the stringers up. “At the Silverdale site, the roads on both ends drained toward the bridge,” Olson said. “Drainage through the timber deck caused the paint system on the steel stringers to fail. As a result, all 10 steel stringers added in 1937 and bolted to the top of the floor beam flanges had extensive corrosion and

required replacement. Additionally, a lightweight concrete deck replaces the original timber deck to minimize the dead load.”

The use of lightweight concrete for bridge decks in Minnesota is rare. However, a conventional concrete deck would have weighed enough to require that several truss members be strengthened with additional steel components. Because adding components would have altered the look of the bridge members and detracted from their historic character, the lightweight option was selected.

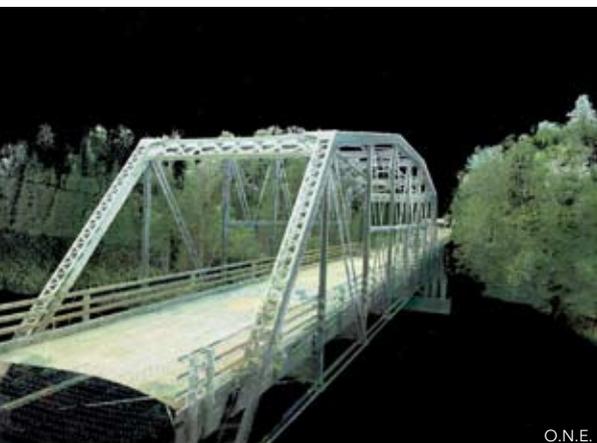
▼ Two and a half days of laser scanning, plus some time to process the data, produced a registered “point cloud” image of the bridge consisting of 13 million points, each with x, y and z coordinates.

The 3D laser scanner collects data by firing a laser 50,000 or more times per second and monitoring the reflections. The equipment can concurrently take associated photographs of structures. To assemble the scan data for the full bridge, MnDOT surveyors set up the scanner in nine different locations prior to disassembly of the structure. After two and a half days of scanning, they used software to stitch together the data to create a registered “point cloud” consisting of 13 million points, each with x, y and z coordinates.

A point cloud is a geometrically correct digital representation of the bridge that can be viewed from any angle. This detailed representation of the bridge can be readily used for engineering work, as well as for historical records.

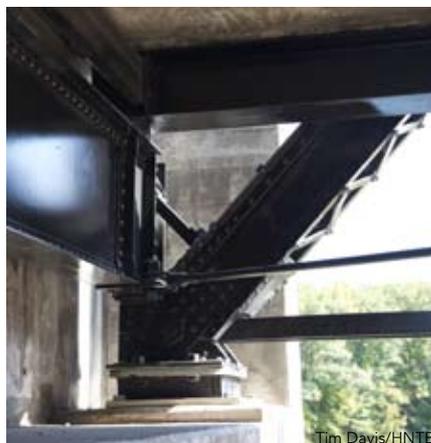
▼ A replacement floor beam for each end of the bridge was fabricated using data from the laser scanning process; the roller nest bearings also were replaced with elastomeric bearings.

The latest rehabilitation required replacement of only two of the nine floor beams, specifically the beams at each end. “The data from the laser scans data was used to develop detailed drawings which were then used by the fabricator to make the new floor beams that fit the original connections,” Olson said. “We also replaced the roller nest bearings with elastomeric bearings.”

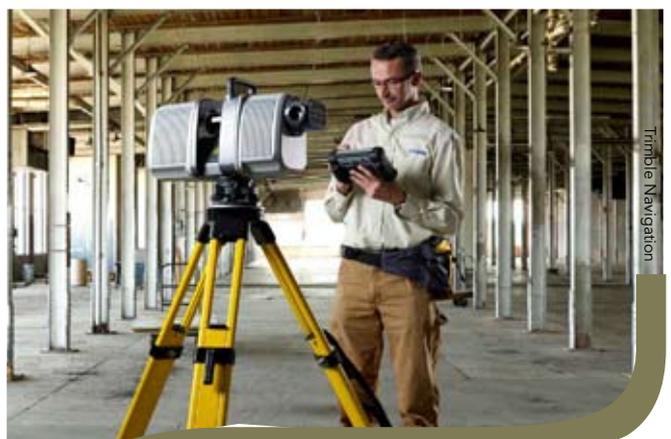
- ▼ Looking very much like a standard surveying instrument, a laser scanner such as this collects huge amounts of data rapidly and accurately.
