Scratching Beyond the Surface

A Georgetown University building's structural system is enhanced to compensate for the shaky ground on which it was built.

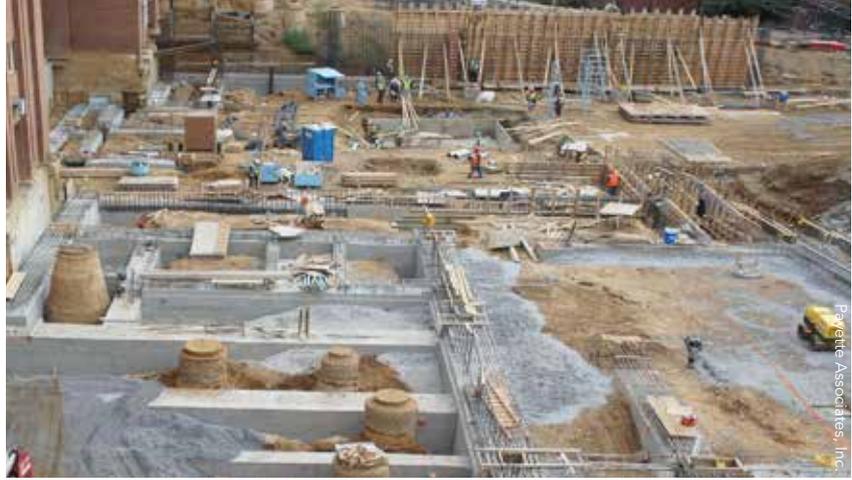
- ▲ View of foundation construction in progress with loading dock in foreground.
- ▼ Ordinary concentrically braced frame facing Georgetown University's Harbin Field/Multisport Facility.

The near-surface soils at the building site consist of 50 ft to 70 ft of urban fill and disturbed natural soils (the area used to be a ravine that was filled many years ago during initial site development). Beneath the layer of fill and disturbed materials is the upper residual natural sandy silt soil of the Piedmont. Considering these factors and the variable thickness of the decomposed, weathered rock in the area, the project's engineer, Simpson Gumpertz and Heger (SGH), considered it likely that caisson drilling would encounter obstructions and variable bearing conditions that could lead to budget overruns and schedule delays.

addition to the manholes that needed to remain at the proposed loading dock area, a 21-in.-diameter pipe and a 96-in.-diameter sewer line running through the site posed yet another obstruction to the caisson installation. For the ground-level structure, SGH elected to use a structural two-way reinforced concrete slab-on-grade bearing on the caissons. The weight of these foundations increased with a large number of grade beams that were required to bridge over existing utilities and to support heavy CMU walls, dock leveler pits and other features. With these baseline loads, SGH felt that avoiding additional demands on the foundations would be essential to reducing the diameter and number of caissons.

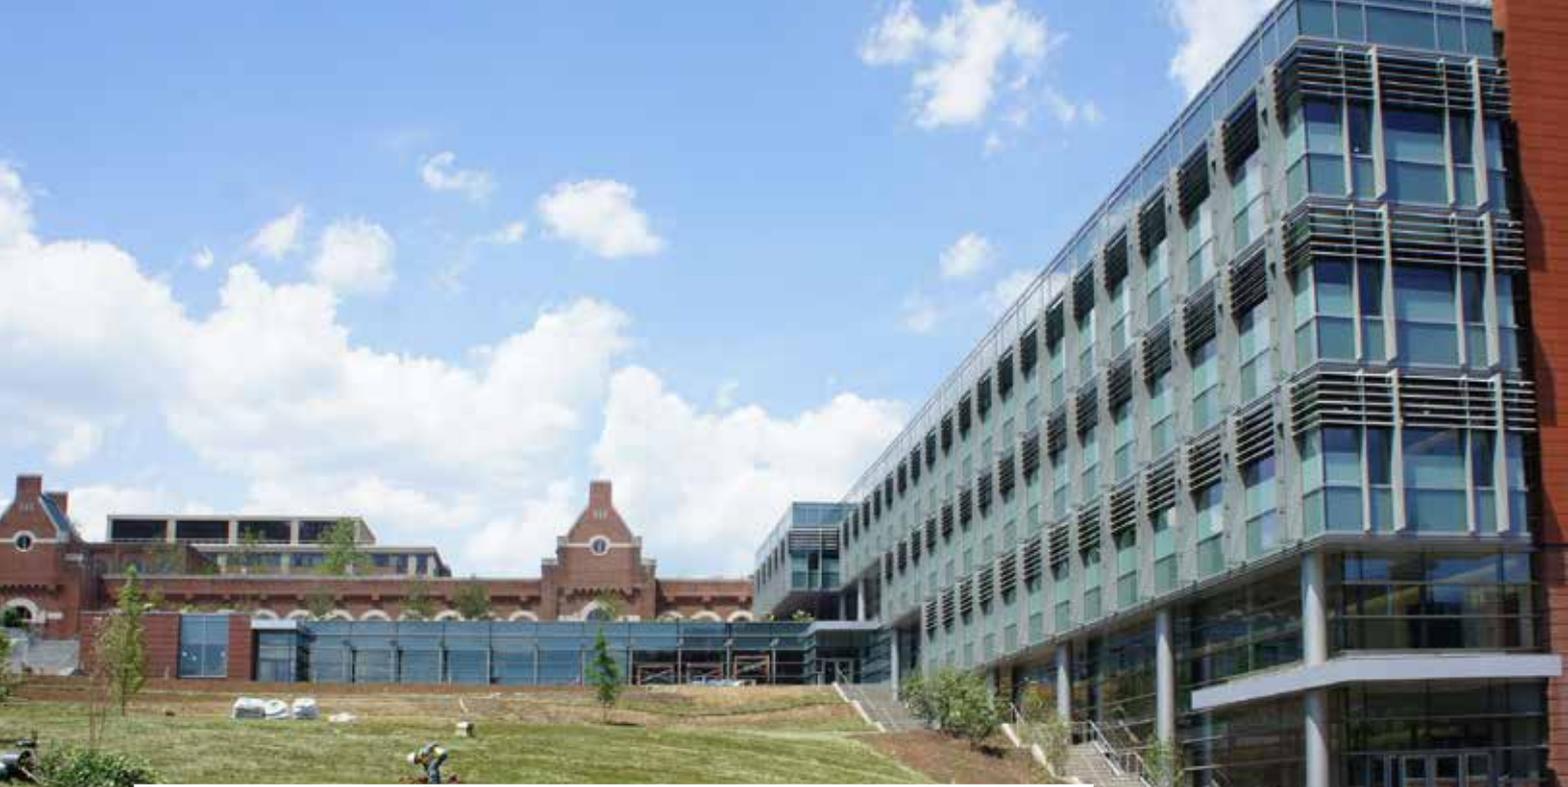
- ▲ View of Regents Hall from the south.
- ◀ View of Regents Hall's west curtain wall façade from Plaza Level green roof.

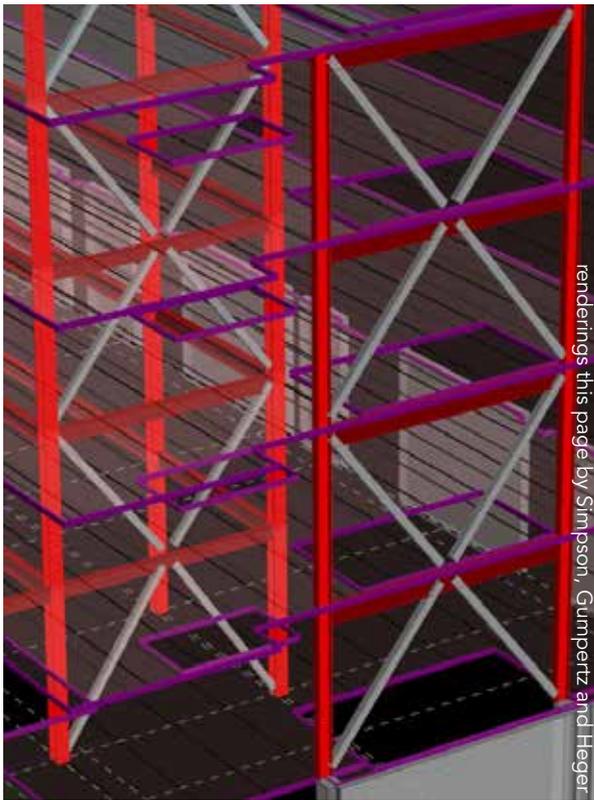
▲ RAM Frame rendering of the lateral load resisting system model.

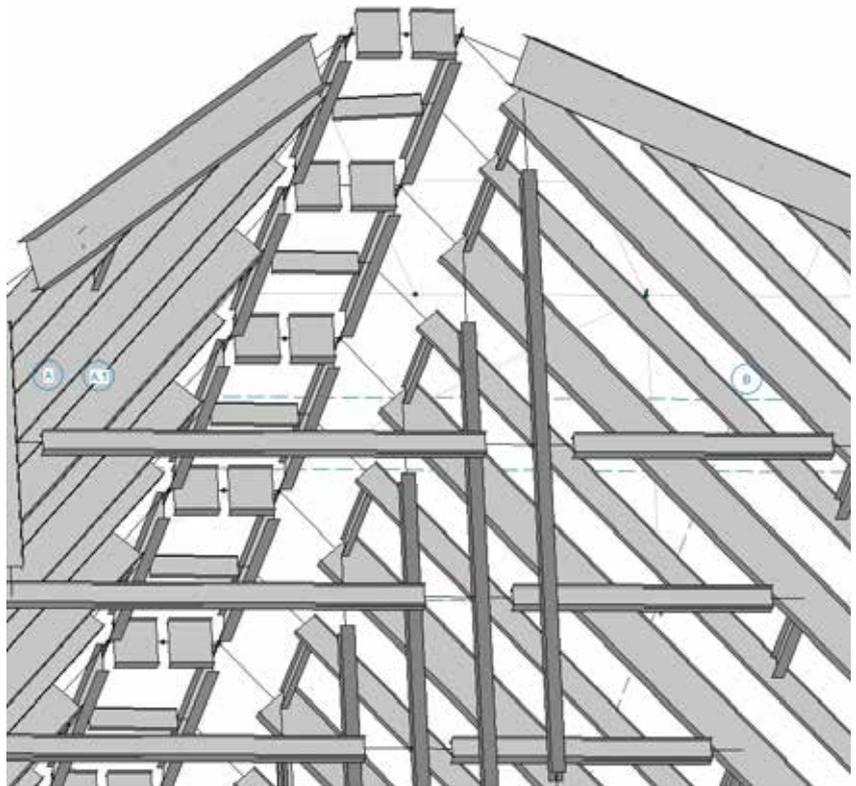
▲ RISA-3D rendering of the penthouse roof framing.
