An industrial facility downsizes
its roof trusses to meet new interior clearance requirements.

Making Room

COMPLETED IN 1956, the Ford Sterling Plant in Sterling Heights, Mich., was originally constructed to house the production of chassis and drive shafts.

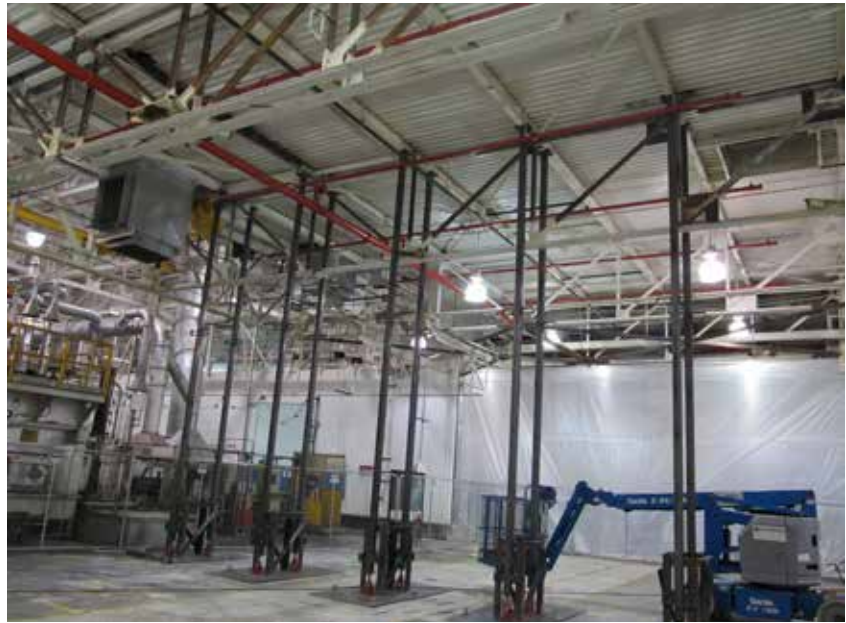
- Shoring of the truss to be modified.

The specific sequence of construction was essential to the structural design approach, especially the jacking procedure, and after all roof live loads and collateral loads were removed from the area of influence, the jacking was performed in two phases. The jacking frames were located at each truss top chord panel point. The first phase was to support the truss in the original position without lifting the truss. In this position the truss was fully shored at the top chord such that the bottom chord could be safely removed. The second phase was to engage the jacks to provide top chord camber meeting the original truss top chord design profile plus additional camber to account for the truss self-weight. In this position the truss was reworked with all necessary steel reinforcements along with the installation of a new wide-flange bottom chord. The bottom chord at this point was still not fully fastened to the jack trusses and the columns, in order to avoid stressing the jack truss verticals and the columns in bending once the jacks were released. After all the steel work was completed, the jacks were released and the truss deflected under the self-weight into the original design shape. At this time the bottom chord was fully fastened to the jack truss verticals and the columns. Once all the trusses were reworked, the bottom chord bracing was installed to complete the construction.

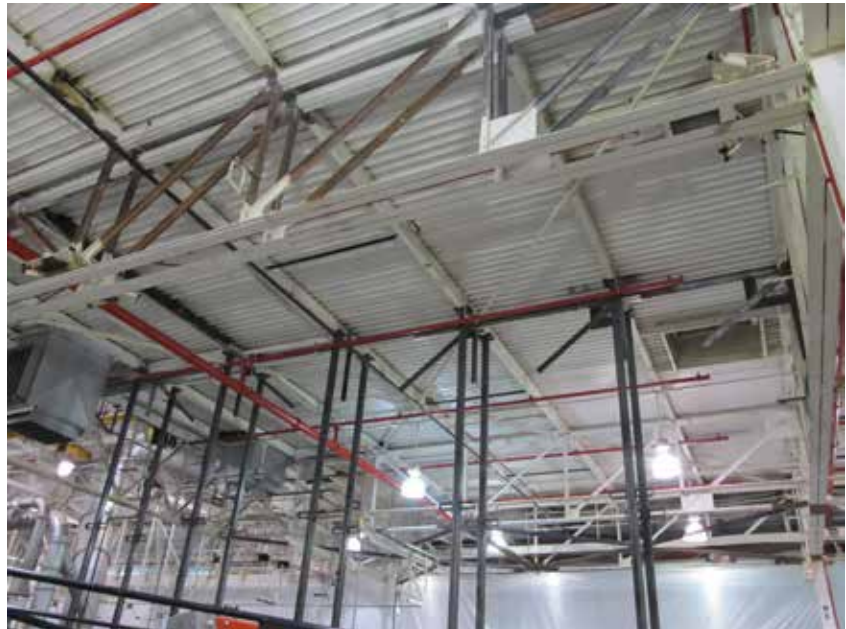
- New bottom chord members with gusset plates, ready to be installed.

The existing carry trusses are Pratt-type trusses, divided into six internal panels. All truss members were made of double angles in A9 steel with riveted and bolted connections. The plan was to replace the double-angle bottom chord with a wide-flange member (W8x28, 45 ft long) at the raised bottom chord height. The truss web members would then be cut to length and reconnected to the new bottom chord. The reworked truss would essentially be a hybrid Vierendeel truss in which web members and their connections would be modified for moment resistance resulting from the new configuration (the Ghafari team performed the analysis using RAM Elements).

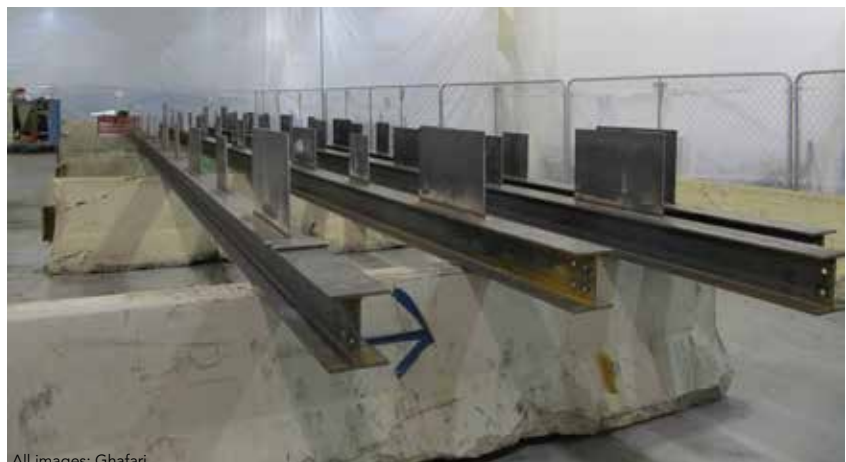
▲ Truss with the bottom chord removed.

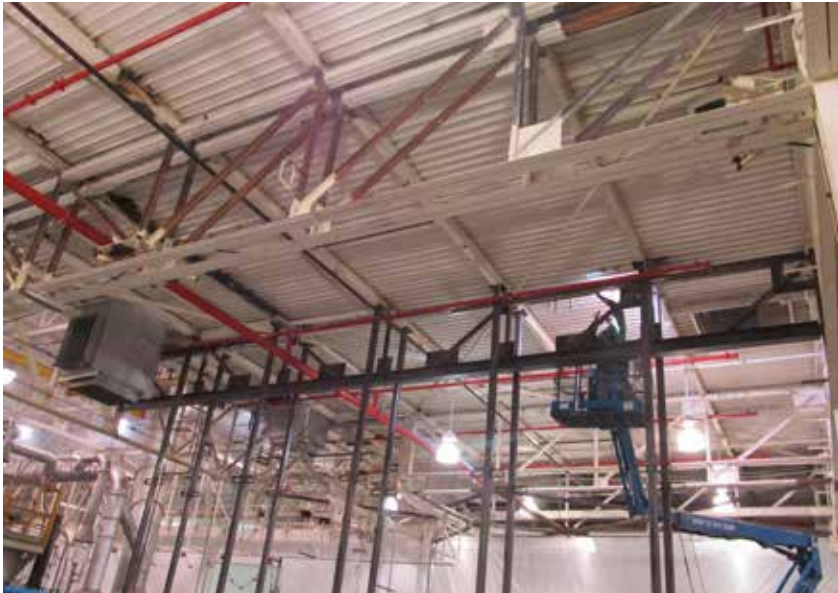
◀ Installation of the new bottom chord.

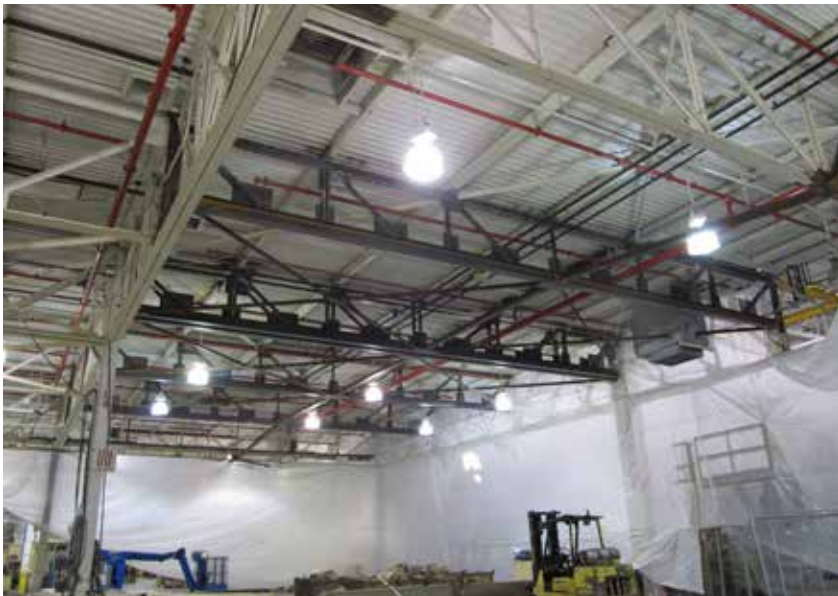
▲ All five trusses are completed.

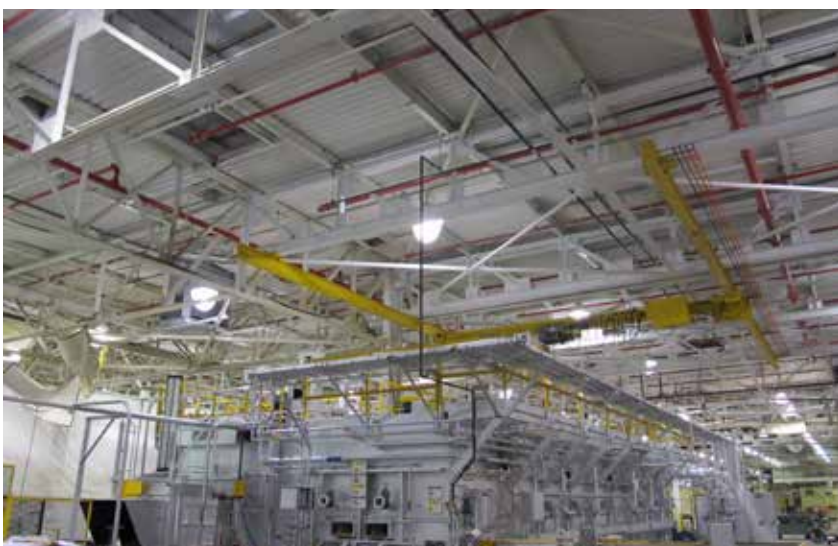
◀ Completed construction.
