Structural renovations brace an iconic museum for the future.

National TREASURE

THE SMITHSONIAN INSTITUTION'S Arts and Industries Building is widely known as the first U.S. National Museum.

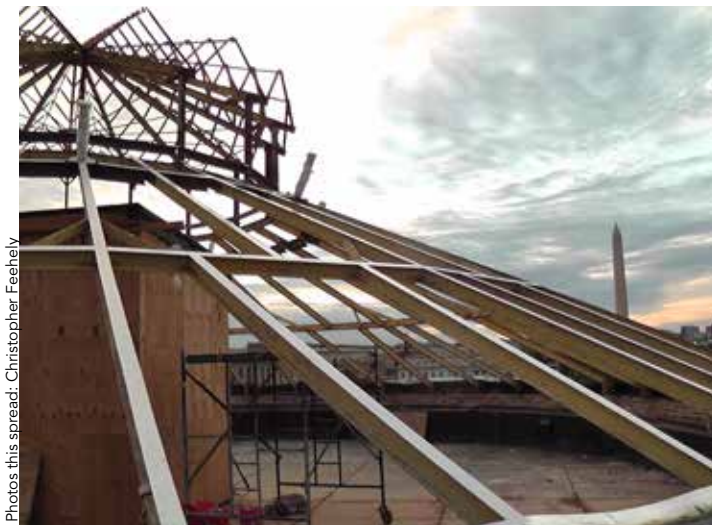
- ▶ Exterior enclosure and structural improvements to the 102,200-sq.-ft Smithsonian Institution's Arts and Industries Building were completed early this year.
- ▶ The four quads were integral to one another and required significant in-house engineering to ensure proper fit-out of new and existing structural members between quads. Each quad consisted of approximately 2,200 pieces of steel weighing approximately 125 tons per quad.

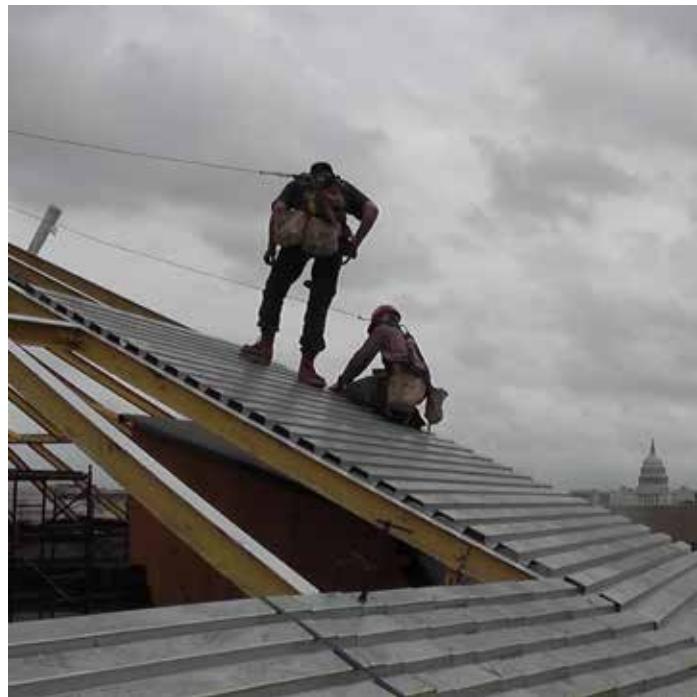
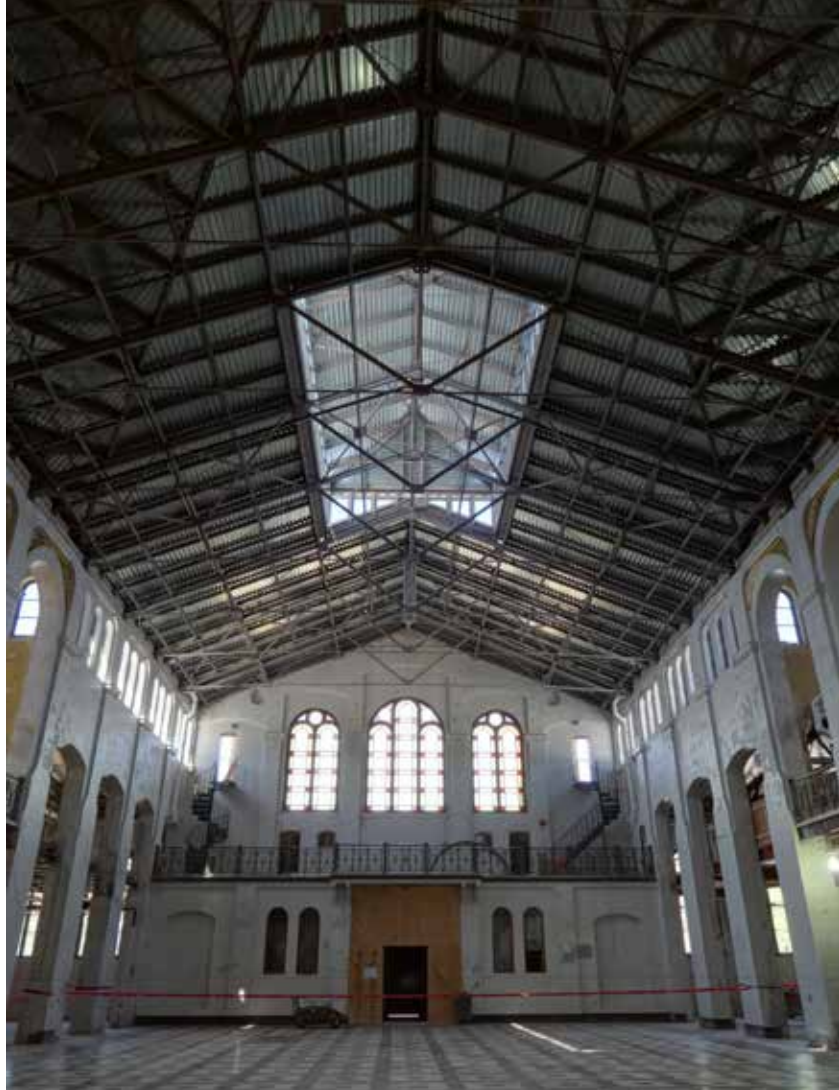
- ▶ Installation of the new structural framing began on the rotunda roof, then moved into the southwest quad hall and continued in a clockwise fashion around the building.

Installation of the new structural framing began on the rotunda roof, then the team moved into the southwest quad hall structure and continued in a clockwise fashion around the building, finishing with the topping out of the roof structure replacement. The

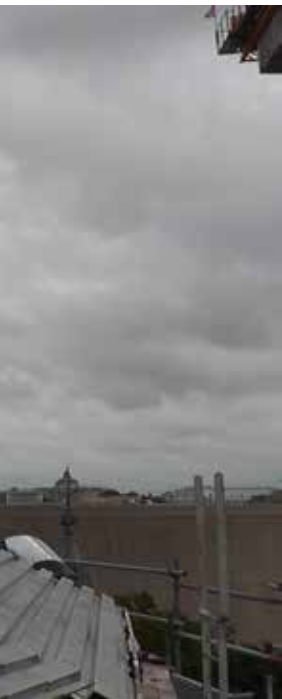
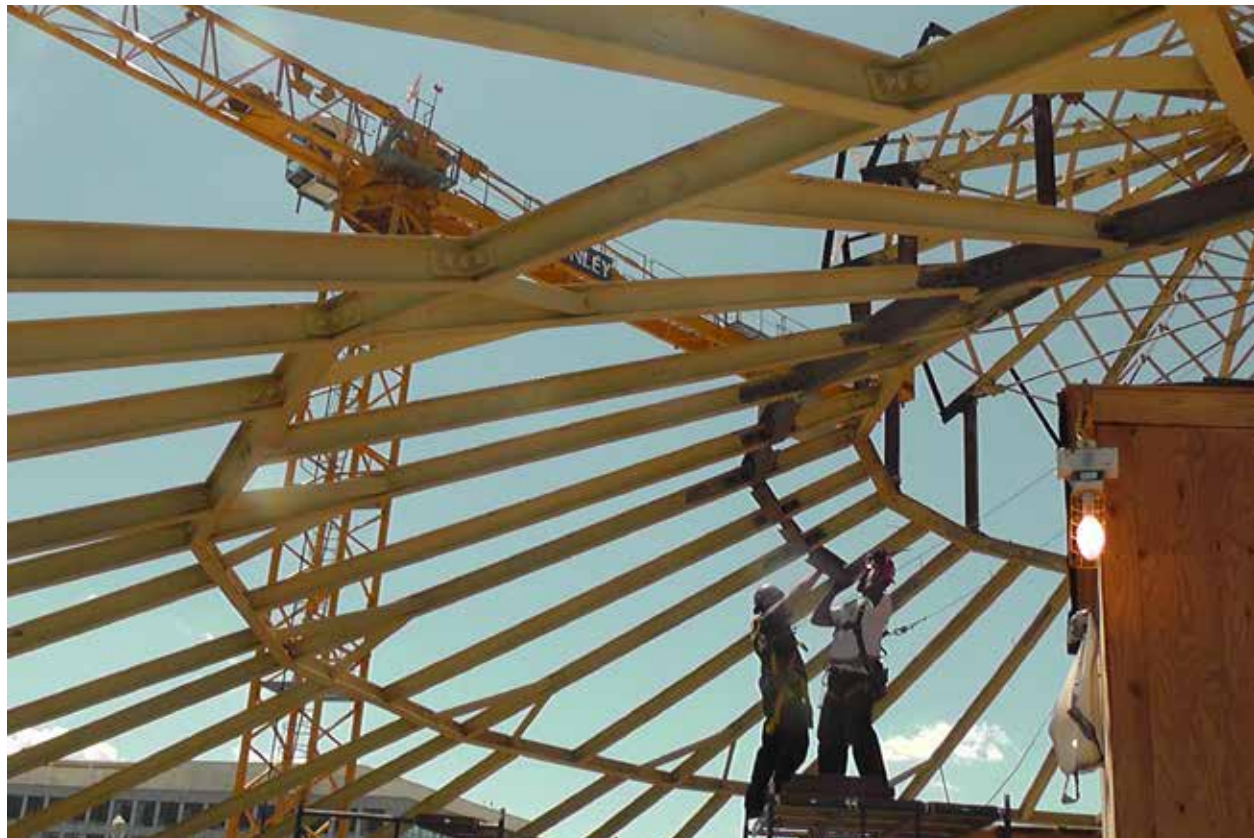
- ▼ Installation of the new structural framing began on the rotunda roof, then moved into the southwest quad hall and continued in a clockwise fashion around the building.

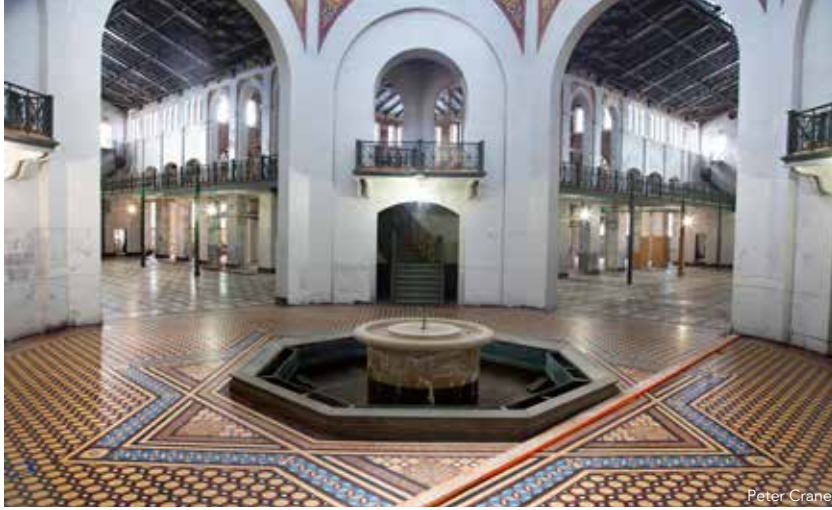
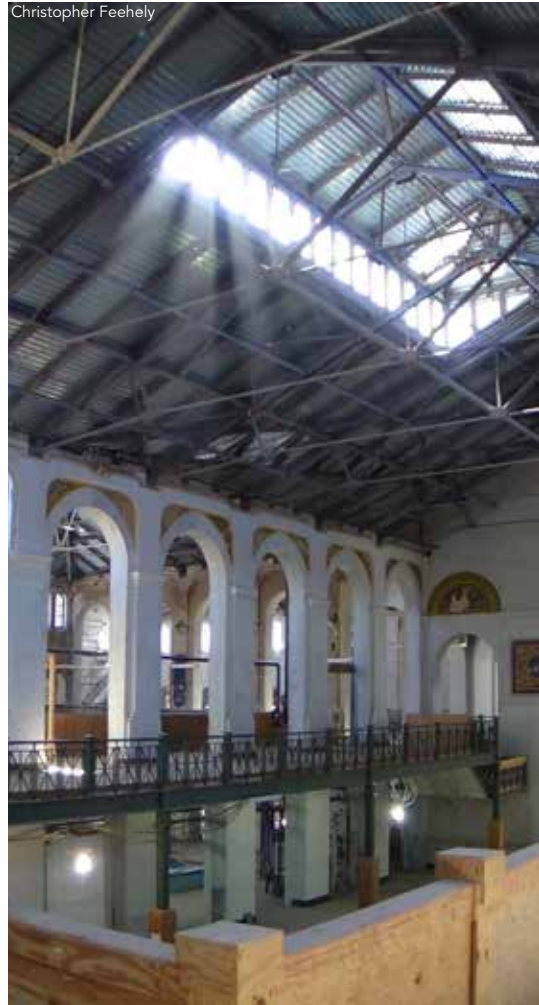
◀ ▶ The building is laid out as four quads around a central rotunda. Each quad consists of six individual structures (hall, court, transition, range, entrance/tower and pavilion) that were systematically demolished and rebuilt using new steel components.

The building is laid out as four quads around a central rotunda. Each quad consists of six individual structures (hall, court, transition, range, entrance/tower and pavilion) that were systematically demolished and rebuilt using modern steel components while matching the fabric of the original design. Each quad was unique in terms of dimension and geometrical configuration, a condition that required each area to be field checked for correct dimensions and elevations; in some cases, 3D sketches were drawn by hand in the field. Our team took this information and loaded it into SDS/2 to develop fabrication and erection drawings, and the field checking and modeling exercise totaled in excess of 3,000 labor hours.

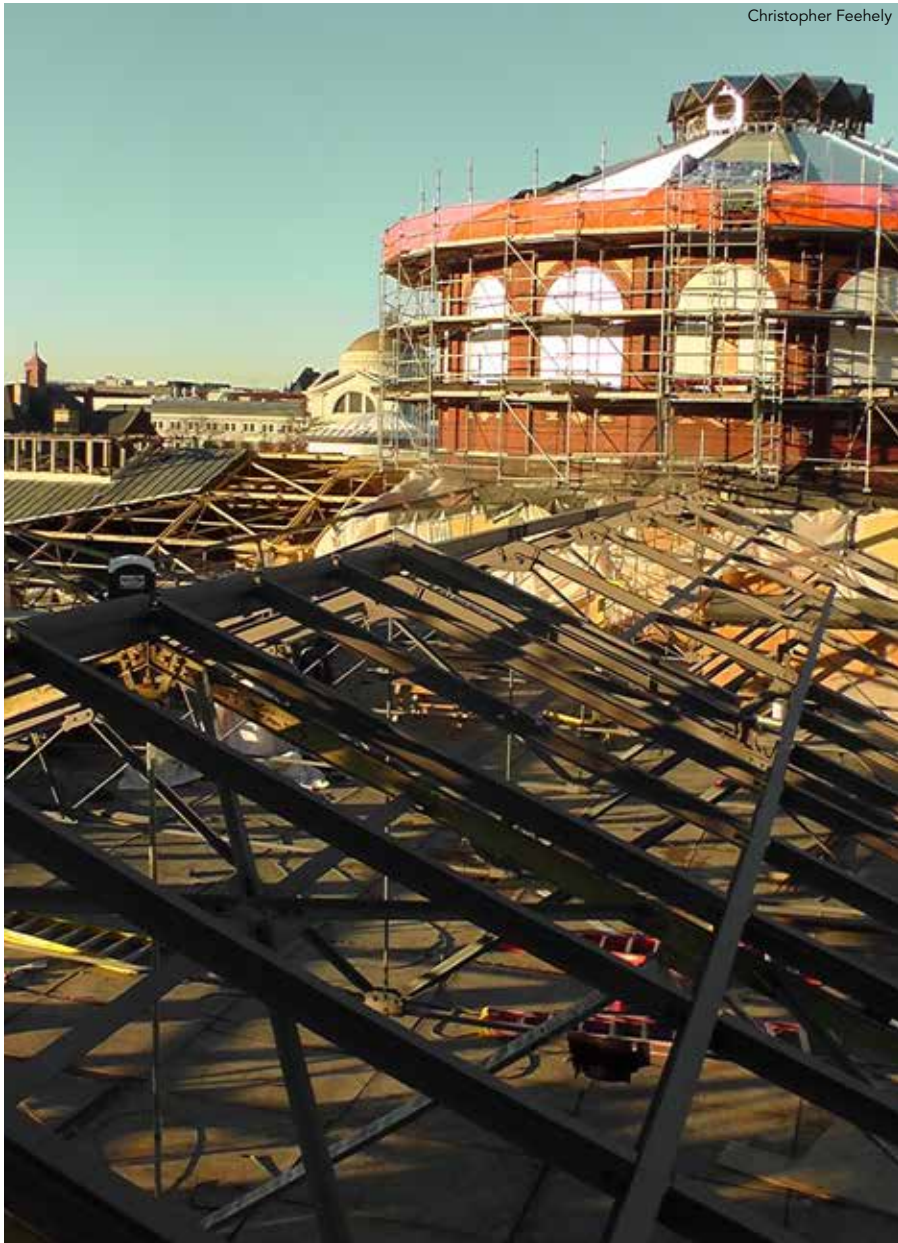
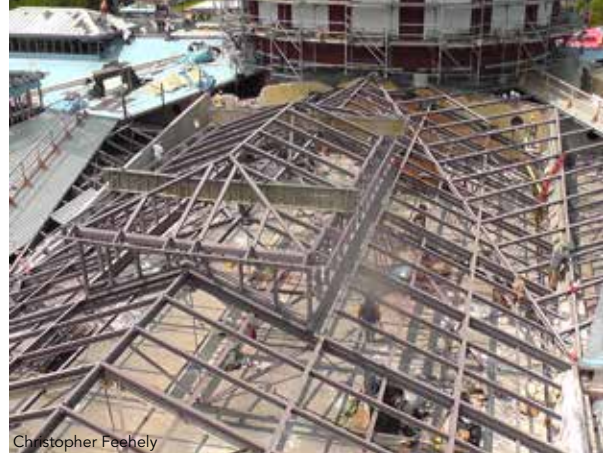
▲ ▼ The new structure needed to not only support the additional weight of the roofing system, but also improve seismic, wind, blast and snow load performance.

replaced with 20-gauge stainless steel and new slate to match the existing patterns, and the new roofing system weighed considerably more than the existing one. The new structure needed to not only support the additional weight of the new roofing system, but also improve seismic, wind, blast and snow load performance.

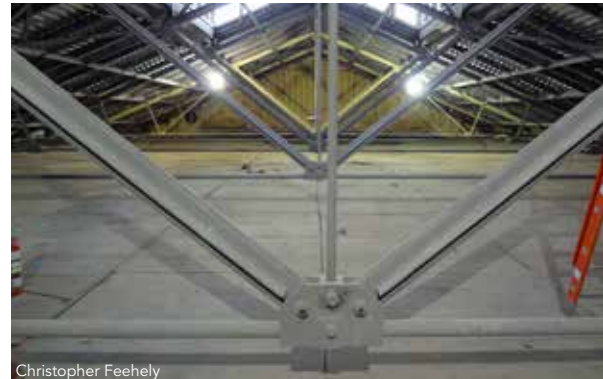
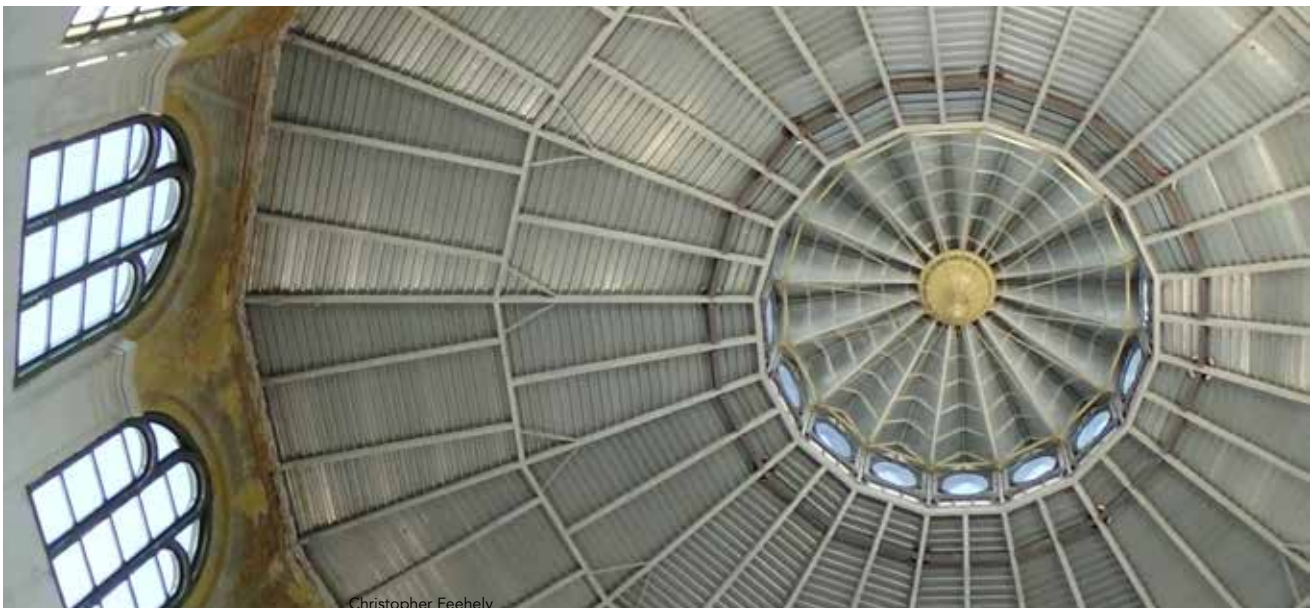
▲ ▼ Each truss was at a different elevation and the required improvements had to be made on a per-truss basis to allow the roof system to be installed properly.

final enhancements were made to existing trusses in the southeast range portion. Each truss was at a different elevation and the required improvements had to be made on a per-truss basis to allow the roof system to be installed properly.
