Learning from a Structural Failure

An inside look at the contributing factors to a South African structural collapse due to weld failure.

By Spencer Erling

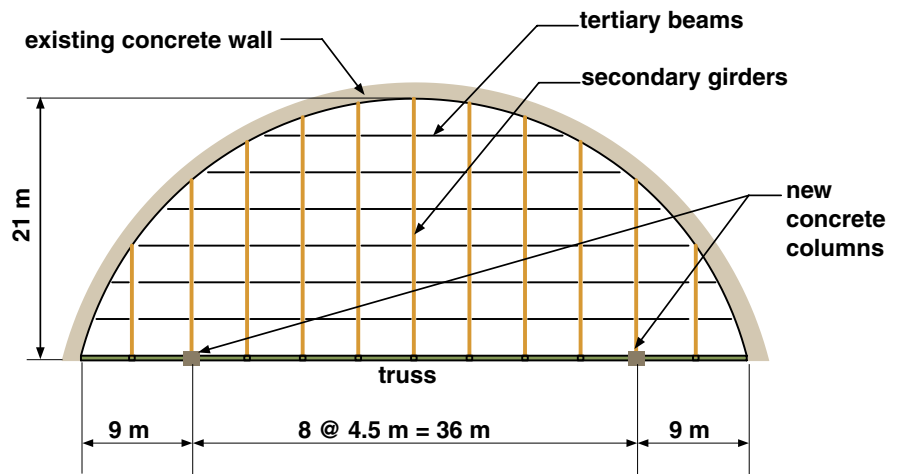
Figure 1. Plan view.

The major component that failed was a two-story high truss girder over 36 m (118') long, designed to carry a composite steel and concrete floor about 2 m (6'-6") above the bottom chord as well as a light-weight trussed roof at the higher level. The loads from the composite floor were transferred to the main girder through secondary girders and tertiary composite floor beams. The concrete was cast into permanent steel decking. See Figure 1.
