# Study of Corrosion Performance of Weathering Steel Bridges

## State Project No. 170-3301

CHA Companies, Inc.  
101 East River Drive, 1<sup>st</sup> Floor  
East Hartford, CT 06108  
Phone: (860) 290-4100

*May 24, 2021*

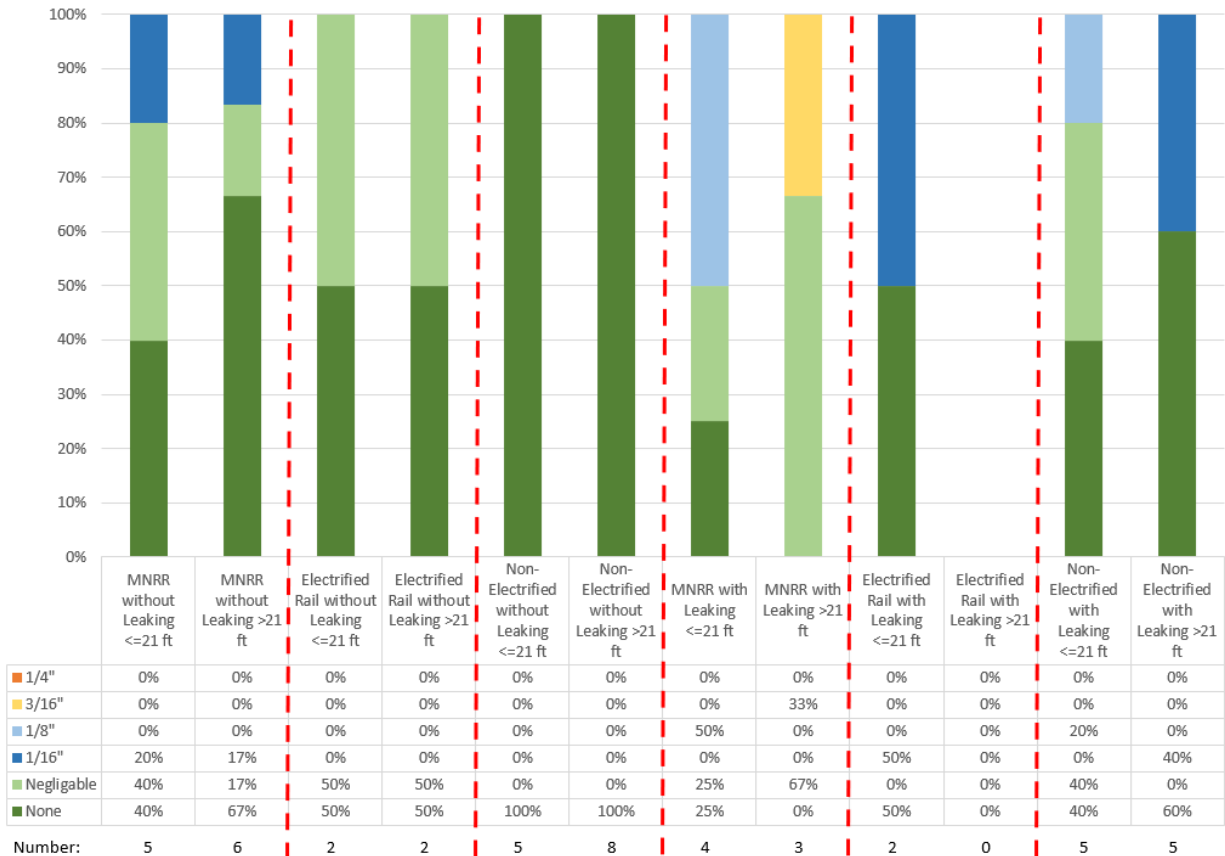
**Figure 25. Maximum In-Span Section Loss Compared to Clearance over Types of Rail Crossing with and without In-Span Leaking**

When comparing the clearance below structures crossing railways, the average clearance below the structure is 20.7 ft. A division is made at 21 ft in Figure 25 when comparing structures with low and high clearance. When comparing these structures, there is some evidence that lower clearance does tend to have slightly more section loss. Between all three types of rail types crossed,

those with clearances less than 21 ft had an average of 0.005 inch without leaking, and 0.040 inch for those with leaking. This compares to an average of 0.004 inch without leaking, and 0.039 inch for those with leaking with clearances over 21 ft.

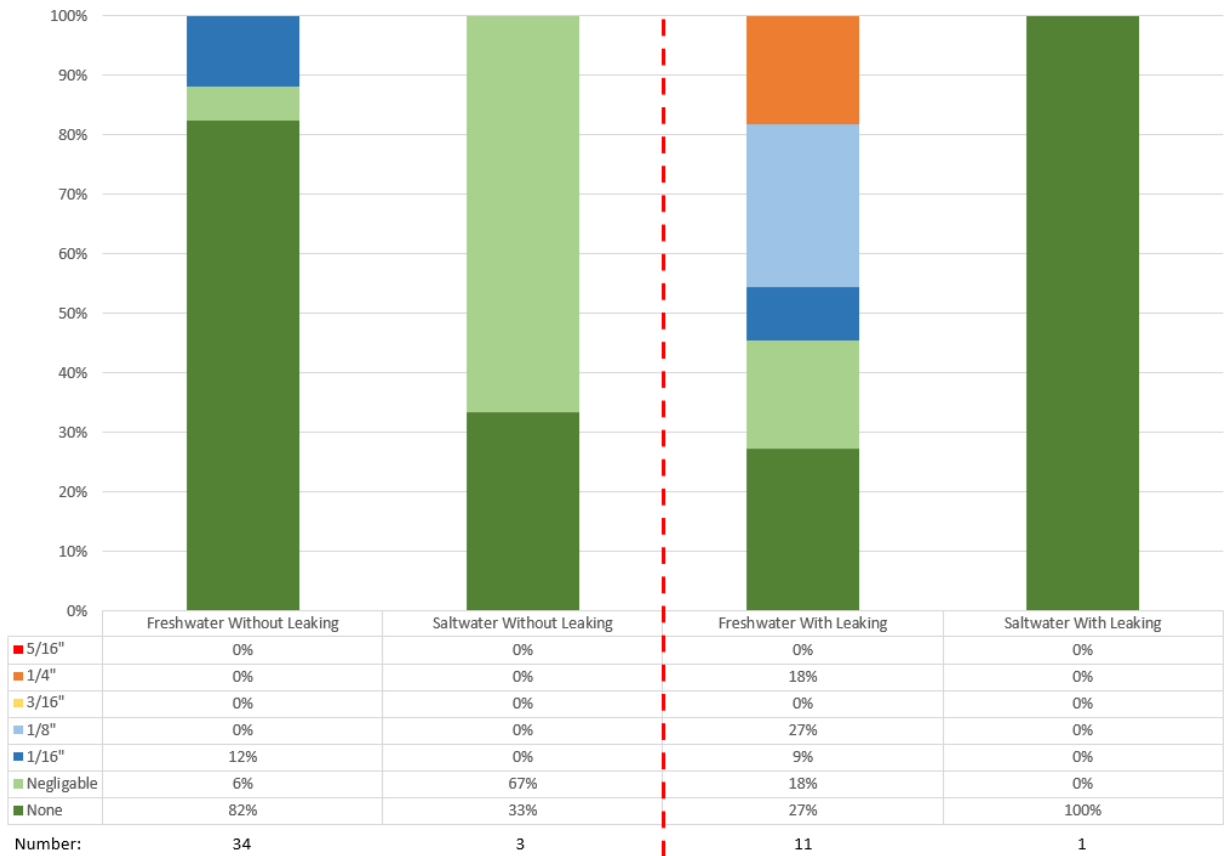
**Figure 26. Section Loss in Structures Crossing Saltwater and Freshwater Bodies**

For those structures crossing bodies of water, the following two variables were considered in the evaluation of section loss: whether the body of water that is crossed is salt or fresh water, and the clearance below the structure. Unfortunately, of the 49 structures crossing bodies of water, only four of these are over salt or brackish water. Therefore, there is not sufficient evidence to determine whether crossing salt water has an appreciable effect on section loss. Figure 26 shows the section loss in structures crossing freshwater and saltwater.

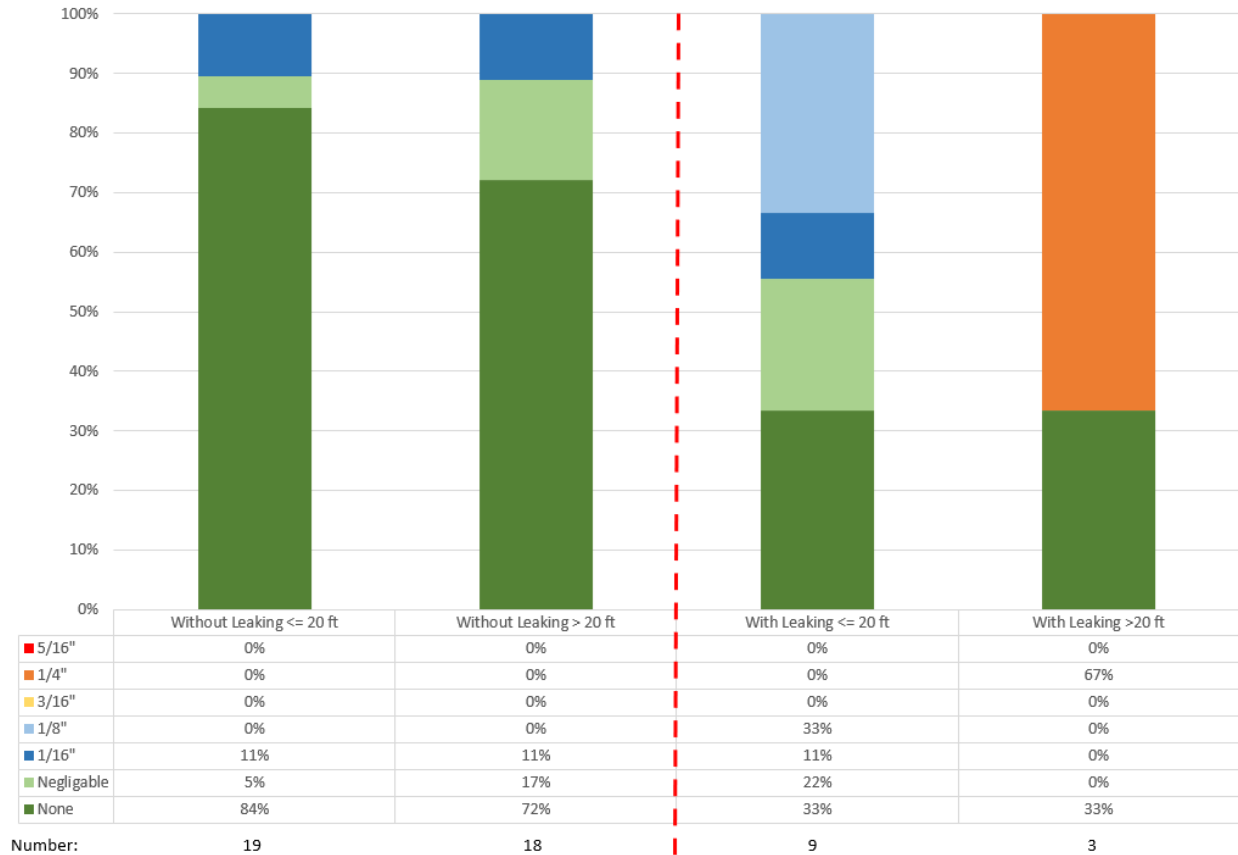
**Figure 27. Maximum In-Span Section Loss in Structures Crossing Bodies of Water Divided by Clearance Below Structure**

For structures crossing bodies of water, the average clearance below the structure is 19.6 ft. Figure 27 uses 20 ft in dividing structures with low and high clearance over bodies of water. Based on the data shown, there does not seem to be a significant link between the clearance below structures to the bodies of water being crossed and section loss.

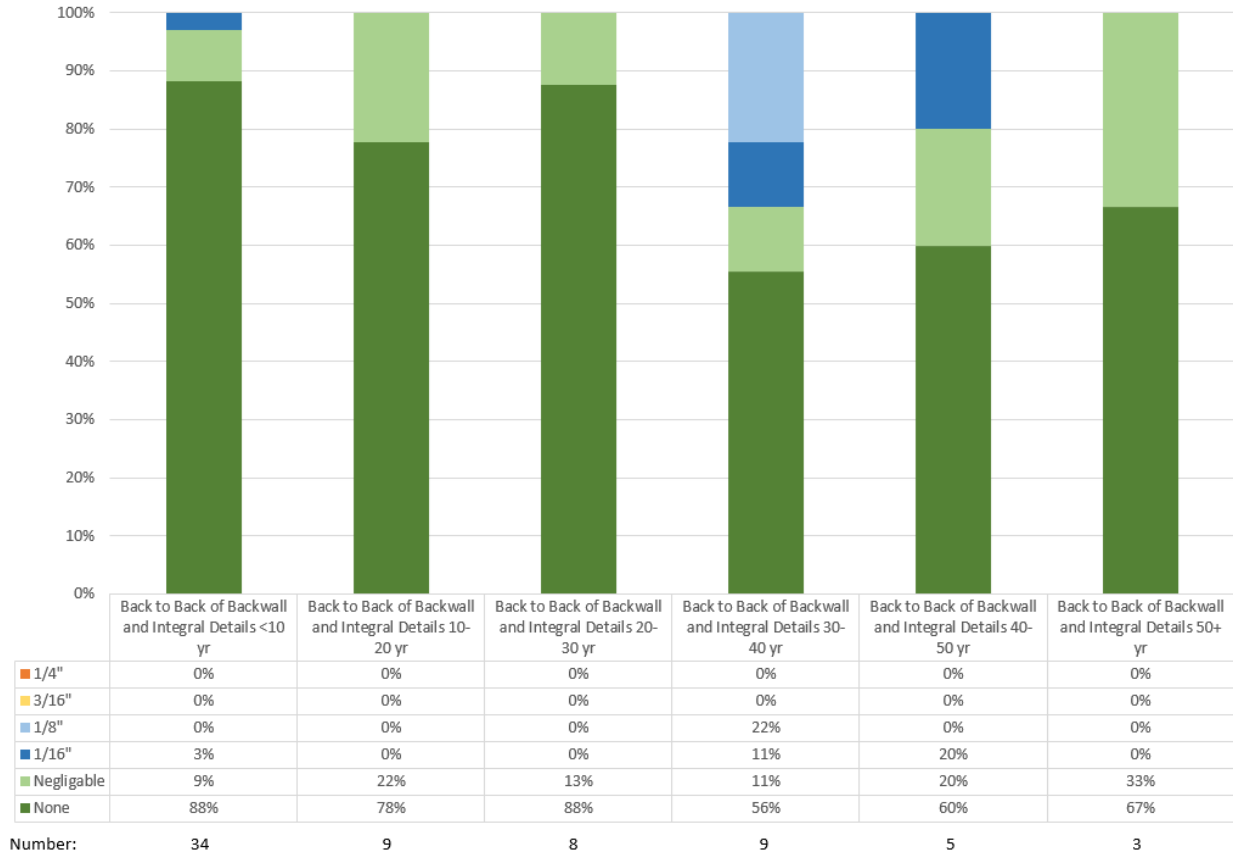
**Figure 28. Section Loss in Structures with Detailing Consistent with Current CTDOT Guidelines**

- The FHWA guidelines came out in 1989, prior to this there were 17 structures that met the detailing requirements. Figure 28 shows the section loss in these structures by age. The maximum section loss utilizing the details in these guidelines was found to be 1/8 inch. Additional thickness may be provided to account for this and may need to be increased for structures crossing electrified rail. Increased thickness should only apply to critical sections at critical locations. For instance, increasing flange thickness at the bearing does nothing to increase capacity.
