# MODERN STEEL CONSTRUCTION

VOLUME XV / NUMBER 4 / FOURTH QUARTER 1975

# MARKET SQUARE ARENA

# FIRE ENDURANCE FOR Steel-Frame Nursing Homes

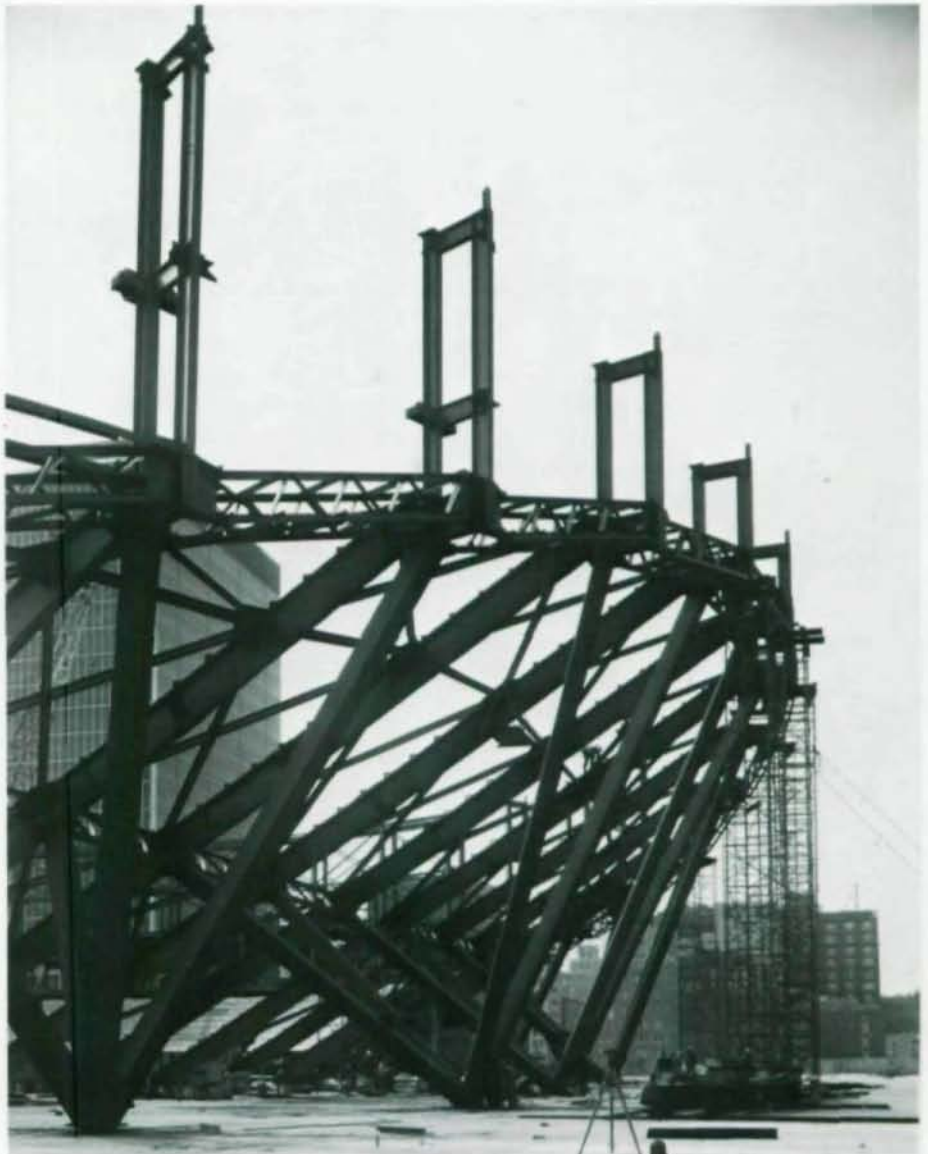
*Space frame of north garage.*

The required 76 support points for the dome had to be transferred to the foundation through the garages without compromising the parking density or traffic patterns in the garages. This was accomplished by developing a fully triangulating space frame, the basic element of which is a four-joint column cluster. The two outer columns are splayed and each carries one of 48 common dome/seat stringer support points. The inner pair of columns is splayed and provides intermediate support to the upper seat stringer section to keep this section from exceeding the maximum size manufactured. To complete the triangulation of the space frame, the sixth floor was reinforced to provide the bottom chord. Thus, the space frame consists of the splayed cluster columns, the seat stringer, and the concrete sixth floor deck.

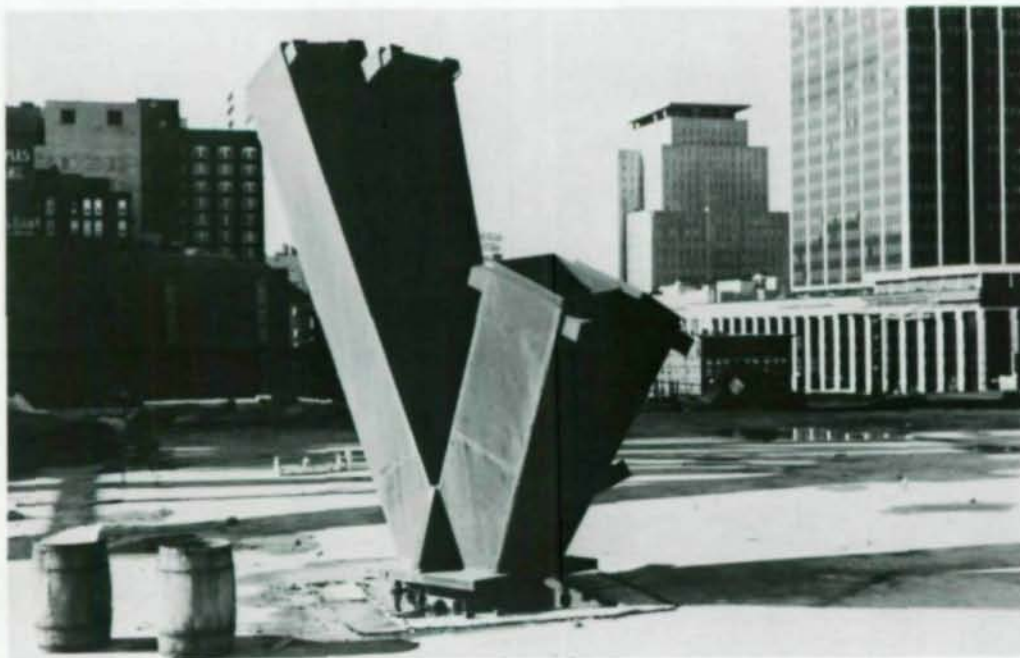
Typical four column "cluster" base erected with bearing in place.

The column bases were installed with a "uni-ton" rotation free, translation fixed bearing attached to the base with temporary pins to maintain alignment. These pins were burned off after the completion of erection. To allow for field tolerances, the "uni-ton" bearing base plate was field welded to a preset leveling plate. Similar detailing was utilized where the cluster bases rest on the steel structure over the street. The column tubes are 20 in. square with wall thicknesses varying from  $\frac{3}{4}$  in. to  $\frac{1}{2}$  in. Prior to fabrication of the column bases, a full scale mock-up was constructed and then cut apart for destructive tests to qualify the welds. This also provided a test of

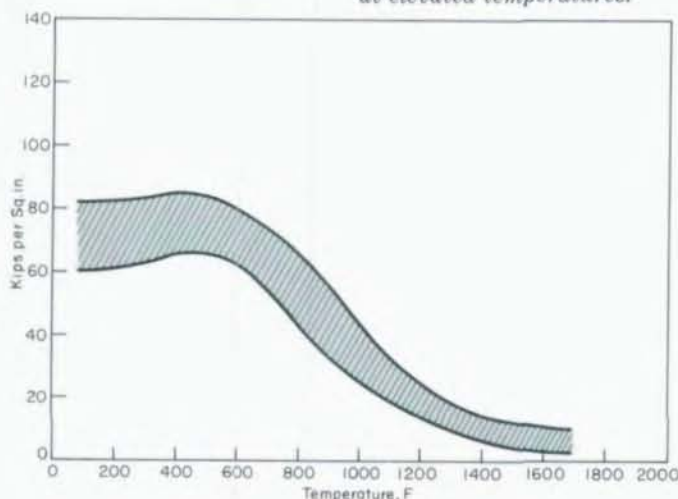
Tensile strength of ASTM A7 and A36 structural steels at elevated temperatures.
