# PIXAR ANIMATION STUDIOS: FABRICATION AND ERECTION CHALLENGES

Ron Long and Dan McGill & Jawed Umerani, S.E.

## Project Description

The new headquarters for Pixar Animation Studios, located in Emeryville, California, is a two-story 220,000 square foot exposed steel frame structure with masonry brick veneer facade. It is a state-of-the-art seismic base isolated building, designed for the seismic performance goal to remain operational after the Maximum Considered Earthquake (MCE).

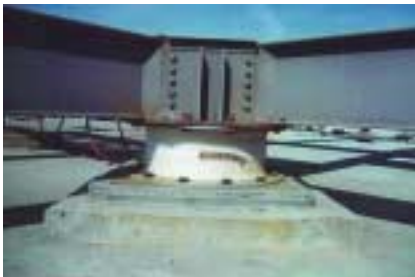
*First floor framed platform supported over base isolator.*

Over the building footprint of 240 ft. x 480 ft., there are 120 High Damping Rubber Isolators and 92 PTFE/Stainless Steel Sliders supported over Pile Caps. The first floor steel framed platform is supported over the isolation system.

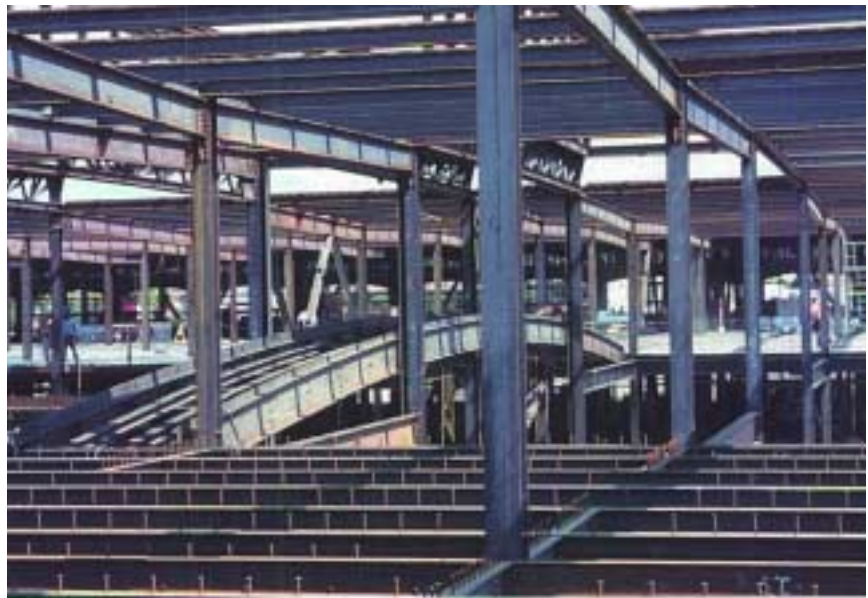
*Interior framing and walkway bridge.*

Central atrium features saw-tooth roof and skylight, supported over triangular trusses. Two pedestrian bridges, cable suspended

from the roof trusses, connect second floor of the east and west wings of the building. The bridge features include built-up & bolted girders, wood decking and rod bracing below the deck.

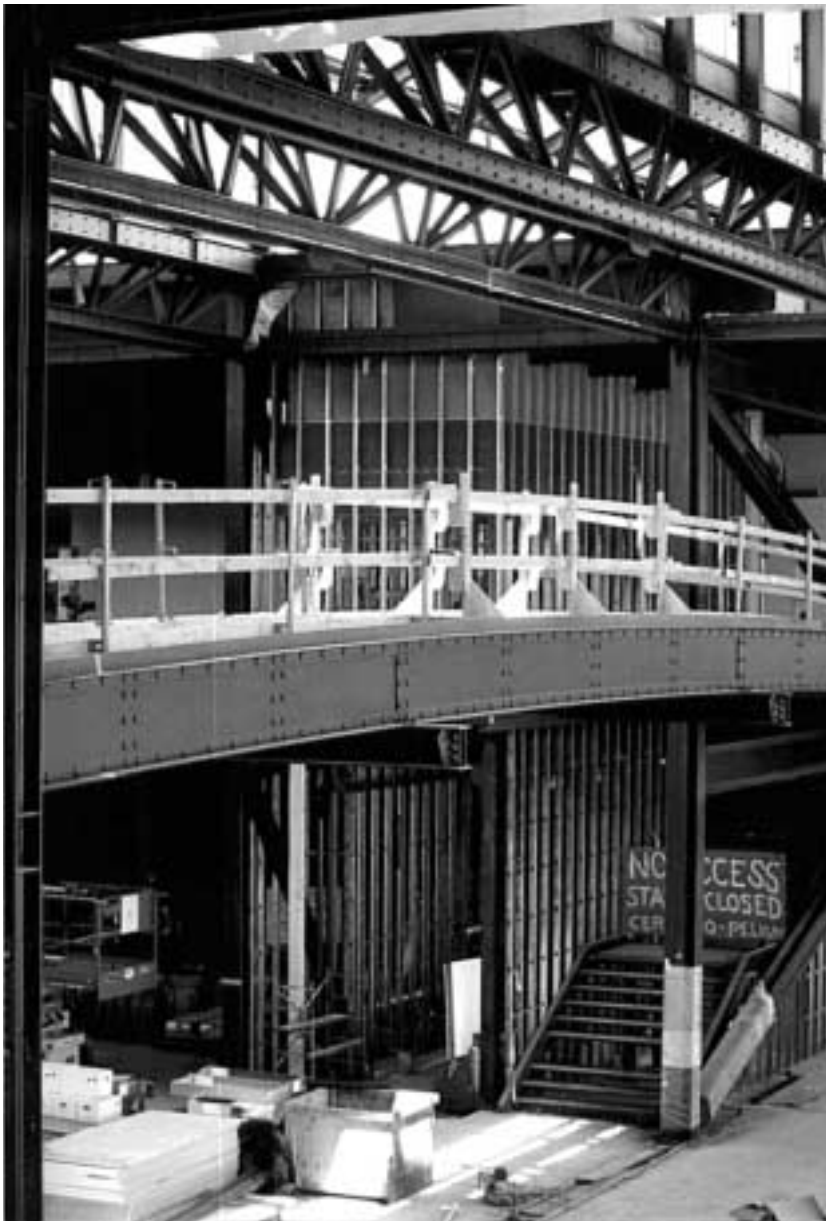
*Interior truss and bridge framing.*
