# Braced for the FUTURE

Buckling restrained braced frames maximize aesthetic appeal, seismic preparedness and flexibility for the City of Pasadena's new office building.

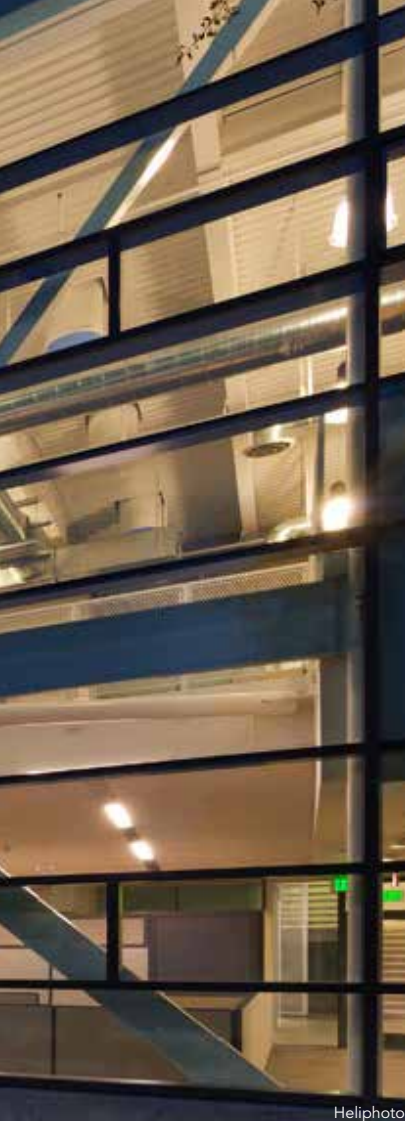
▲ A view from the north elevation.

As the new facility is set in the foothills of Pasadena, the architect elected to use two-story curtain wall systems along the entire north face of the building and part of the west face to maximize daylighting. A structural steel framing system was chosen to further support this goal, as it minimized visible framing and brought more natural light into the building. As the building is located in a high-seismic zone—and considering its critical nature—the designers decided to employ a buckling restrained braced frame (BRBF) system for the lateral system. (Brandow and Johnston worked directly with BRBF-manufacturer Star Seismic during the design phase to determine the widths of the braces and gusset plate sizes, and the system uses Star Seismic Power Cat braces

with pin-type connections.) Not only does the BRBF system provide better ductility and seismic performance, it also helps control the framing member and foundation sizes. And as it remains exposed along the west and north sides, the designers felt it provided a clean and more pleasing aesthetic than that of a conventional braced frame system.

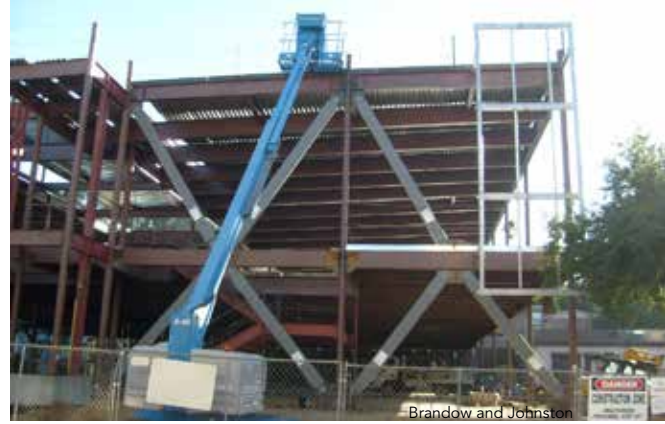
▲ West elevation, and BRBs, under construction.

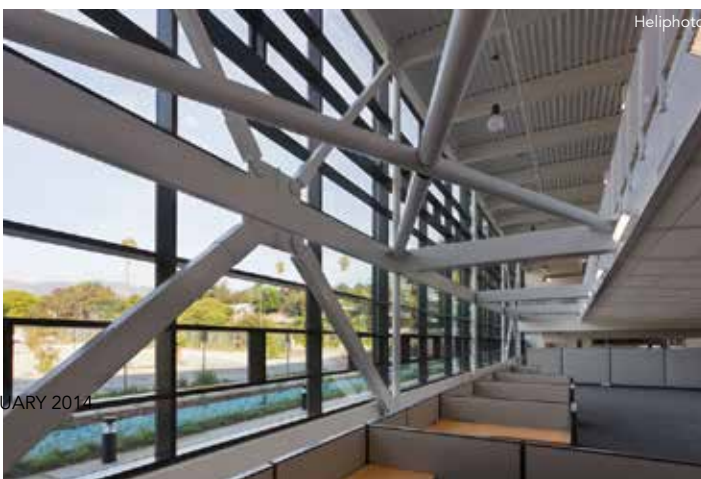
▼ The horizontal truss at the second floor of the north elevation.

To emphasize the north curtain wall system, the second-floor diaphragm at the north side of the building was set back 12 ft, 6 in. from the exterior two-story wall. Since the BRBFs are located at the perimeter of the building, an exposed horizontal truss system was designed using 20-in.-deep HSS and 8-in.-diameter standard HSS to transfer the lateral loads to the braced frames. This exposed horizontal truss system blended well with the exposed BRBF along the north wall.

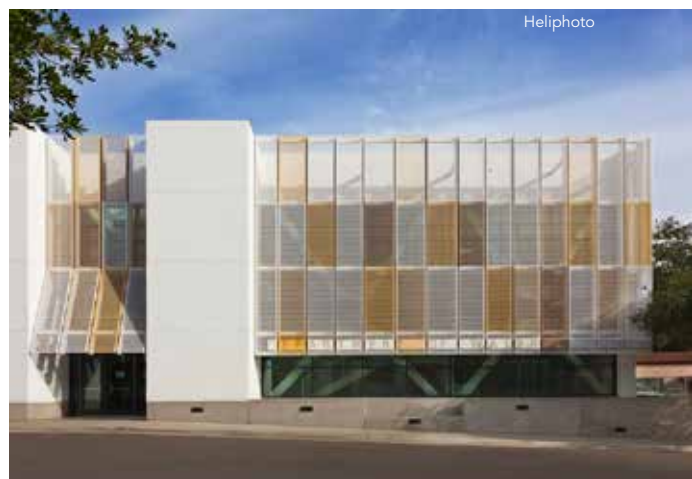
▼ The perforated metal panel system of the west elevation.

The architect selected perforated metal panels to shield the west and south sides from the Southern California summer heat. A system of HSS6×4 outriggers and posts cantilevering from the structure were designed to support the panels; the width of the member sizes was minimized in order to maximize the amount of natural light coming into the building.
