New York Route 367 over Bentley Creek

Village of Wellsburg, New York

Project Description

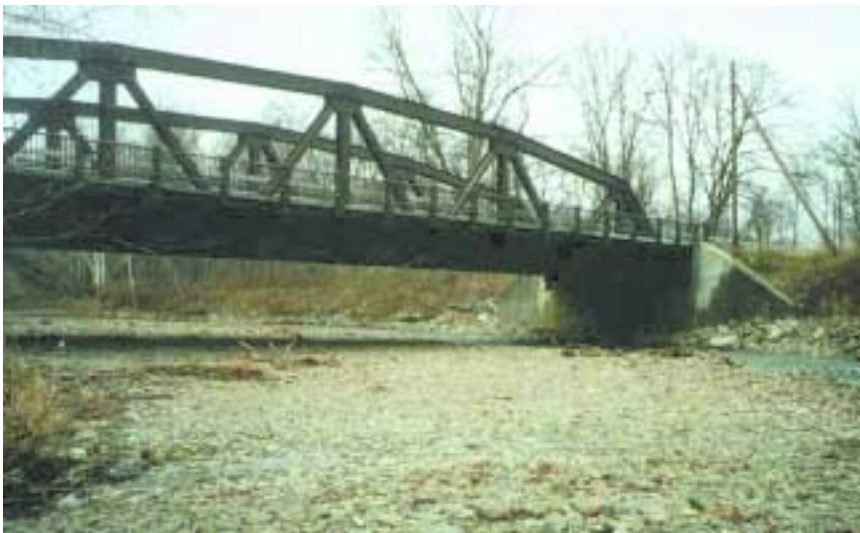
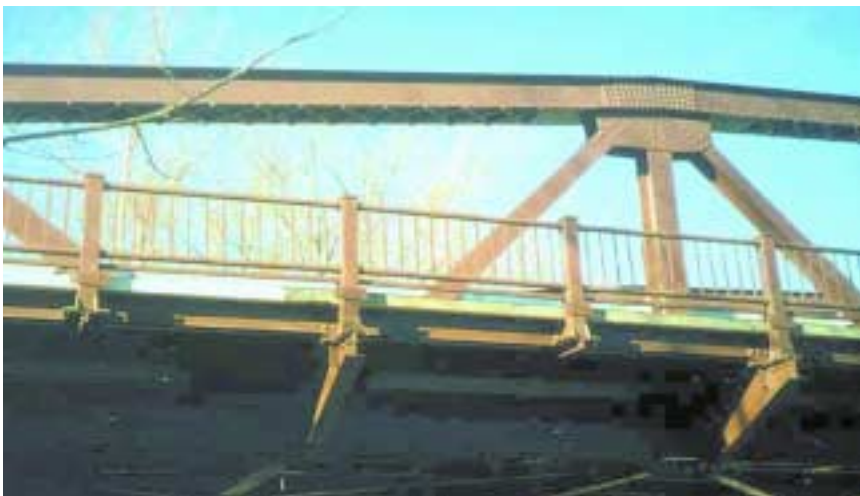
Creek in Chemung County found new life with the installation of a lightweight fiber reinforced polymer (FRP) composite deck. Though it was considered a prime candidate for replacement due to its age, condition and 14 ton weight restriction, the service life of the bridge has been extended by an expected 30 years by merely replacing the deck, performing some minor steel repairs and painting the structure.

A 32 psf FRP deck replaced the 170 psf original concrete deck and excessive courses of asphalt wearing surfaces that had been added over the years. Because the new deck is radically lighter than the original deck the bridge load ratings were almost doubled, raising them higher than the original design. This was possible despite the fact that the structural steel had suffered some section loss and corresponding loss of strength. A total dead load of 265 tons was removed.

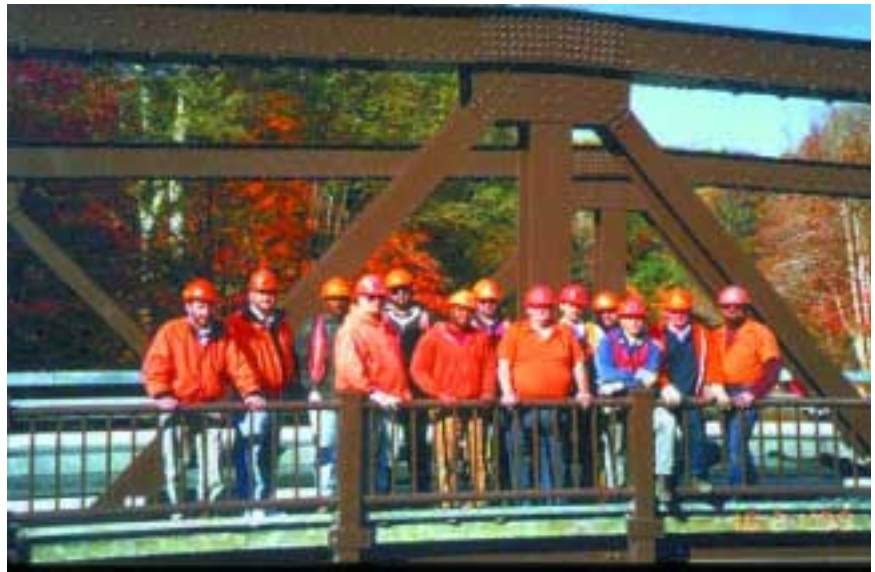
- Deck to steel attachment—a pre-cast polymer concrete haunch with a bolted connection between the floor beams and the deck;
- The sizing and design of the deck section to match “existing” thickness so that approach modification was minimized;
- Eliminating the need for using the existing stringers for support; 4. modular deck assembly (6 panels covering a 25' × 141' area);

- Load carrying deck panel splice details;
- FRP curb (behind the steel box beam railing); scupper frames cast into FRP deck;
- FRP sidewalk (which reduced the dead load by 32 tons); and
- Field cut FRP filler panels between the deck and sidewalk to protect the bottom truss chord from water intrusion, prolonging the life of the structure.
