# Green Again

by Rico Cedro, AIA

The renovation of an innovative 1970s building in Zeeland, MI, demonstrates a commitment to sustainable design with its Gold-level LEED™ rating.

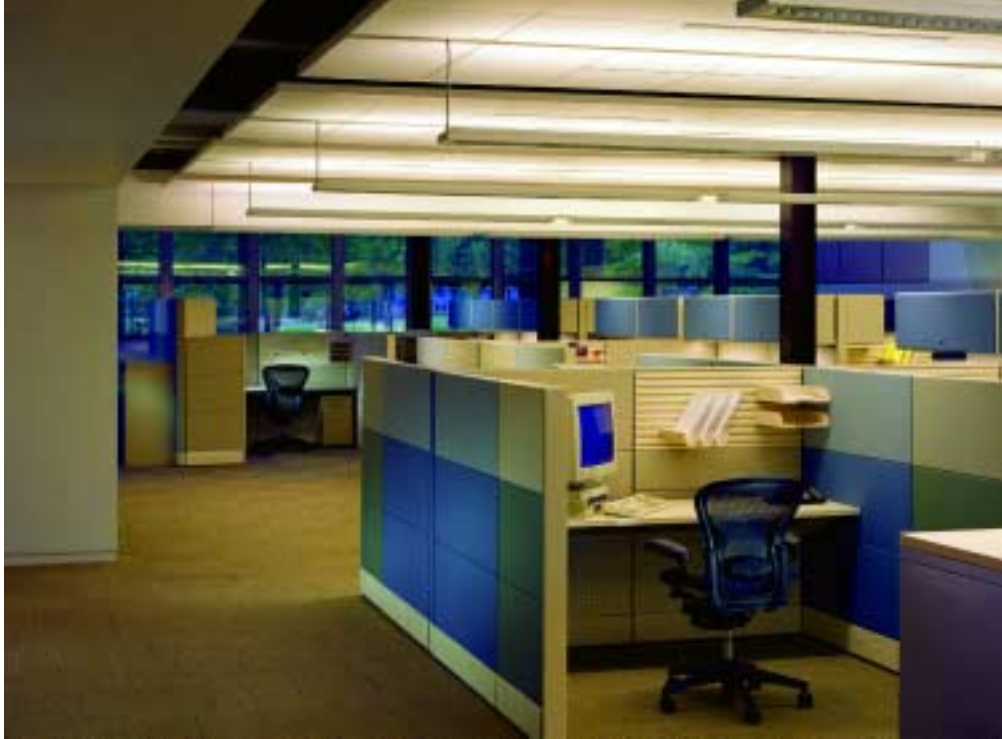
*Above:* Recycled materials are specified throughout, including acoustical ceiling tiles, gypsum board, and steel products such as framing studs, reinforcing bar, structural shapes and sheet metal.

Recycled materials are specified throughout, including acoustical ceiling tiles, gypsum board, and steel products such as framing studs, reinforcing bar, structural shapes and sheet metal. More than 50% of the building materials were manufactured within 500 miles of Zeeland, which both reduced transportation energy and supported the regional economy. Herman Miller manufactured most of C1's furniture. All furnishings contain a high proportion of recycled content. The project was recognized for environmental design innovation in this area.

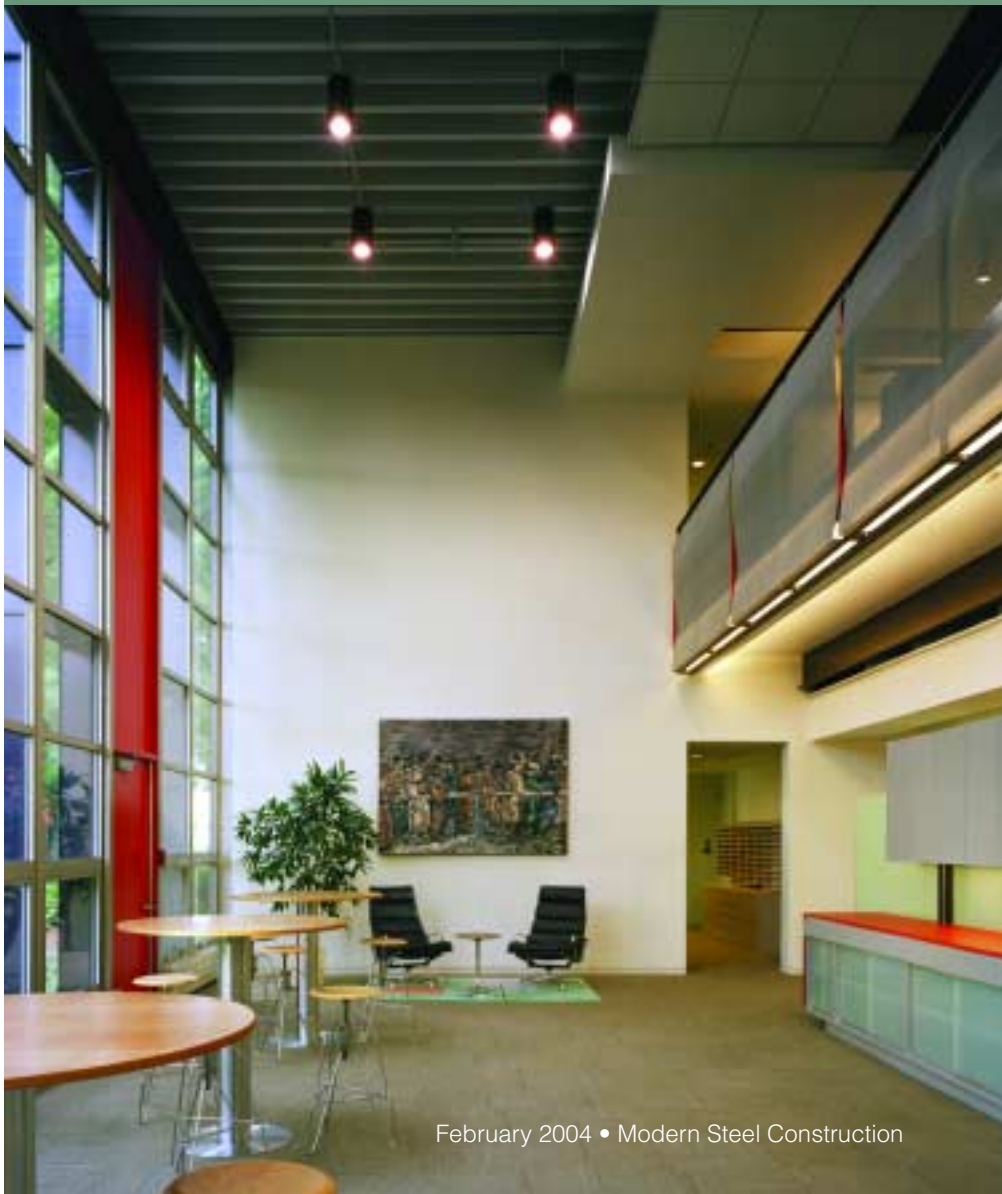
*Below:* New mezzanine balustrades of folded, perforated steel panels replaced the bulky fascias of the building's original interiors.

New mezzanine balustrades of folded, perforated steel panels replaced the bulky fascias in the building's original interiors. The visual and physical lightness of these new steel elements helps dissolve the separation between the mezzanine and the main floor.

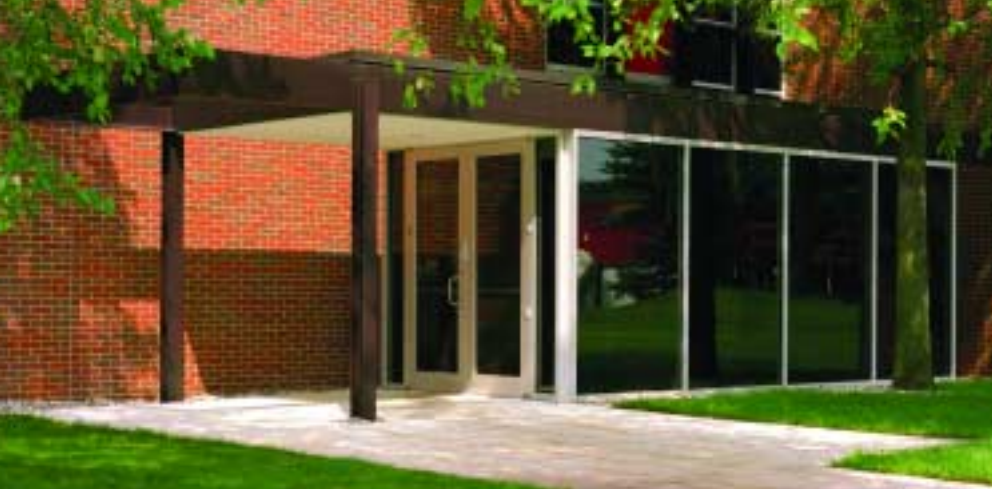
The new entry vestibule features an exposed welded frame of W6x15 columns and C15x33.9 beams in-filled with glass.

link the new parking lot to the original building. Set in a grove of existing birch trees, this exposed steel structure consists of a welded frame of W6x15 columns and C15x33.9 beams in-filled with glass. The channel beams bear directly onto the masonry walls of the original building.

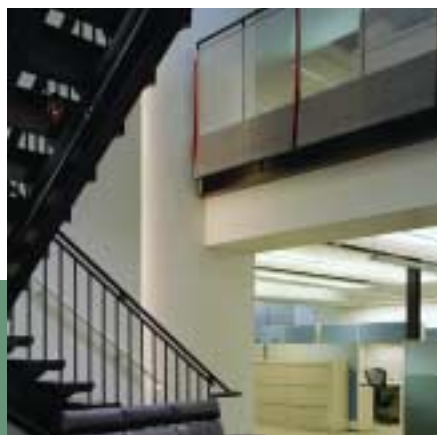
Old bulkheads at the balconies (left) were replaced with new, semi-transparent railings (right).
