Rapid Rehabilitation

A design-build contract helped complete a typically 18-month bridge rehabilitation in only 47 days.

The Pickaway County State Route 22 bridge over the Scioto River, about 30 miles south of Columbus, OH, required a quick replacement during summer 2003—and a design-build team achieved that goal in just 47 days.

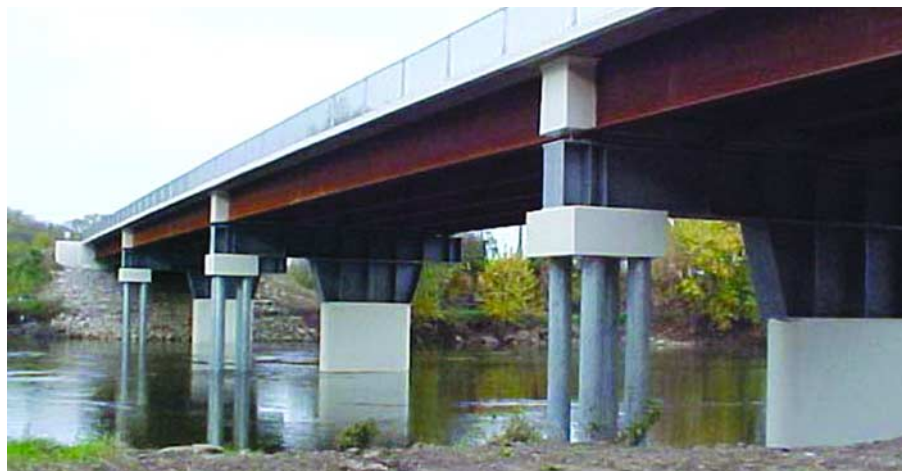
The structure was widened by 10' on the south side. The additional width was supported by new piles in groups of four.

To accelerate the construction schedule, the design-build team chose metal stay-in-place (SIP) forms. To accommodate the additional 12'-10" of deck width, the team saw-cut the existing piers below the pier-stem construction joint and replaced this portion with a steel plate girder extending outward to the south side of the structure. The cantilever portion of the replacement piers was supported by groups of four piles that were driven and capped with concrete. The steel piers were galvanized to reduce maintenance since they would be submerged during periods of high water.

Pre-Closure Work: The design-build team was concerned about the possibility of hitting the existing foundation of the structure while driving the support piles for the cantilever end of the steel replacement piers. To ensure that this would not lengthen the closed period of the bridge, piles near piers 3, 4, and 5 were driven before the bridge was closed. No difficulties were encountered except that the pile
