BY MARC ALPER, P.E., S.E., AND ANDREW TRIVERS, AIA

## A new luxury condo building holds its own in a thriving commercial and cultural hot spot in suburban St. Louis.

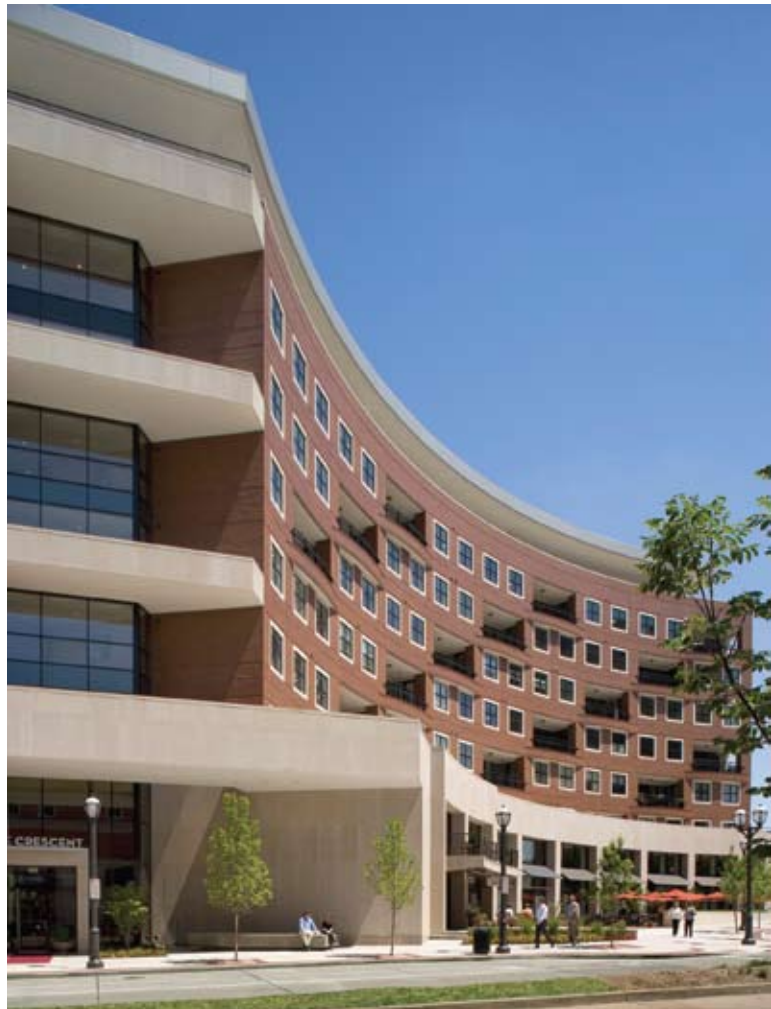
The Crescent includes 72 condominiums, 27,000 sq. ft of retail space, and a 300-car parking garage.
