# Test of TIME

A casino project, meant to help bring Buffalo's waterfront to life, comes back to life itself after a years-long, recession-induced delay.

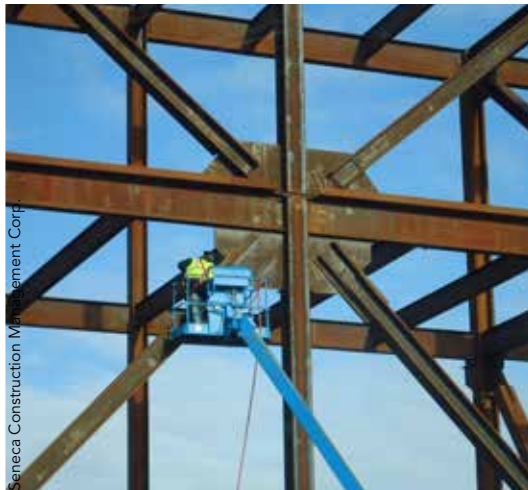
▲ The structural steel was dismantled and initially intended to be sold off as surplus.

At the onset of the scaled-down project, some parties had written off the reuse of any steel and actually started the process of liquidating it as surplus prior to the project team being engaged. The owner's representative and structural engineer (Wendel) were able to convince the remainder of the project team of the potential value of reusing the existing steel, both from a financial and scheduling point of view.

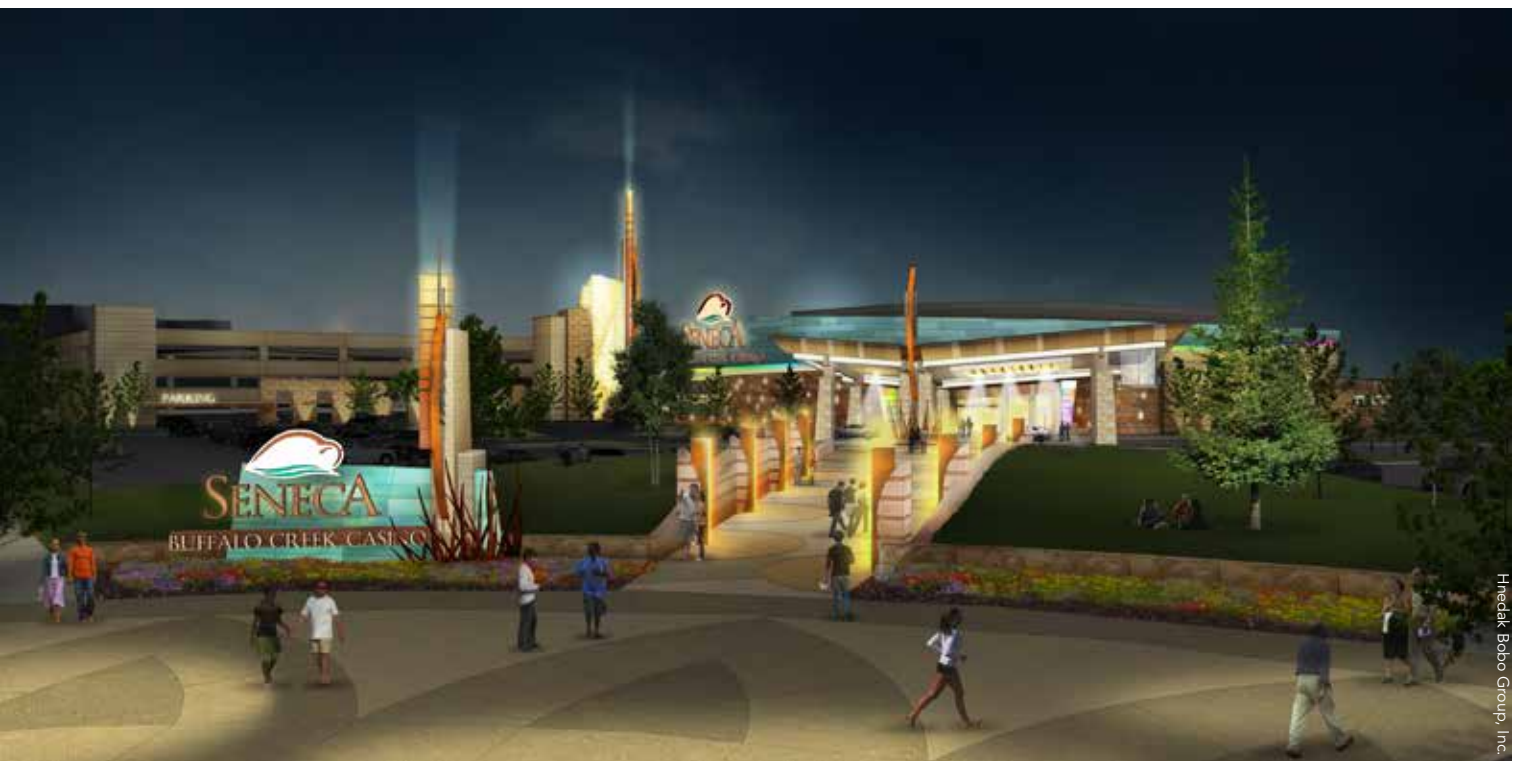
▶ The completed casino used 94% of the original steel framing.

Through the team's diligence and perseverance, 94% of the building's total steel (540 tons) and approximately 85% of the

foundations and anchor bolts were reused—a level deemed unattainable at the onset of the project. Taking this route reduced the cost of the steel package by an estimated 20% and the schedule by a month, as compared to starting over completely. The SBCC opened this past summer and is doing its part to achieve another goal that was long deemed unattainable: revitalizing Buffalo's downtown waterfront. ■

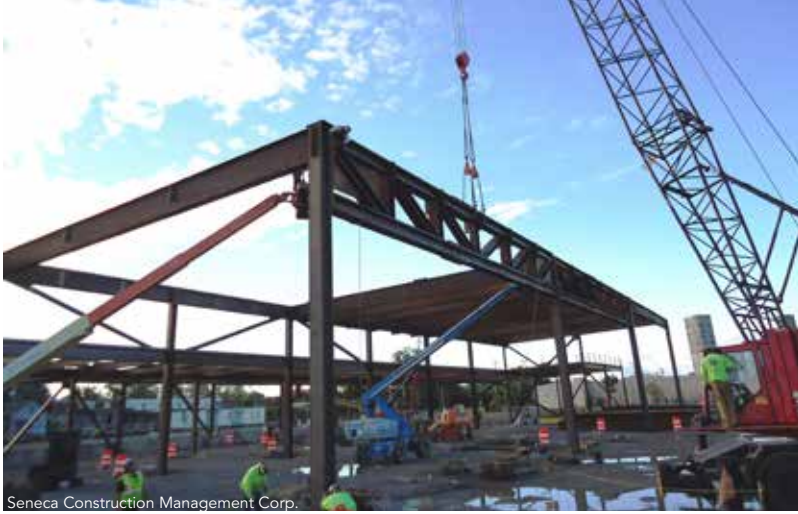
◀ Erection of a reused steel truss.

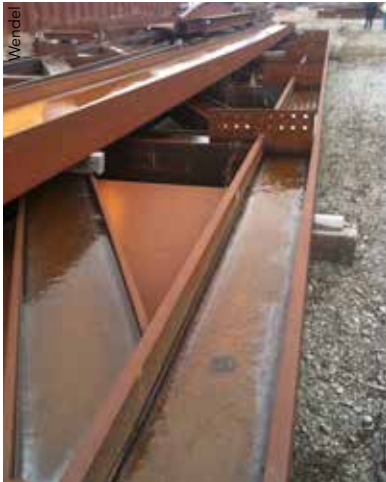
▲ Fabricated steel was exposed to the elements for four years before reuse.  
▼ The completed structural frame.

Both the erected and stockpiled steel had been exposed to the unpredictable and tumultuous western New York winters for four years. To make matters worse, the project site is within 200 yards of an elevated expressway that receives heavy doses of deicing salts throughout the winter months. The presence of airborne salt spray accelerated the deterioration of the steel, particularly on members orientated in such a way to allow for water to pond. Some parties involved with the project were concerned that the steel would rust to the point of being unusable after the first winter. Because the owners understood the value of the steel, however, they commissioned annual surveys of the steel to monitor its condition.

At this point, Wendel's structural engineers were tasked with several unique assignments. The first task was to confirm the structural steel was indeed still sound for reuse. After several conversations with AISC's Steel Solutions Center, it was determined that no technical guidance was available, nor was there any documented precedence established by other projects, regarding the use of steel that had been exposed to the elements for a number of years. Extensive ultrasonic testing was done on all steel that was to be reused, and it was determined that even though the steel was visibly rusty and loose mill scale was prevalent, there was no measurable section loss to the steel members. Testing was also performed to assure that spray-on fireproofing would have an adequate bond to the rusted surface. The team determined that the only preparation work needed was to remove the loose mill scale from the steel with hand scrapers.

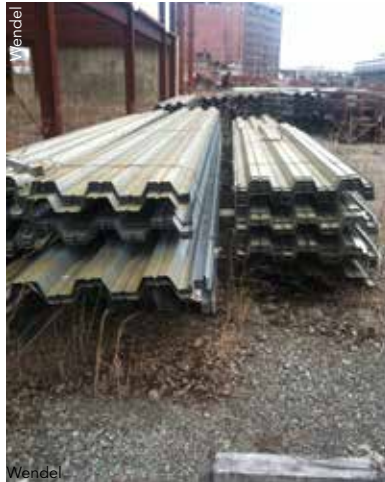
▲ The project team was concerned about potential corrosion caused by trapped moisture in the nested sheets of composite metal deck.

Bundles of galvanized cellular and composite metal deck had also been stored outside and exposed to the elements. The composite metal posed the greatest concern to the team as the nested nature of how the individual sheets were stacked could trap moisture, whereas the cellular deck allowed for adequate airflow throughout the stack. Bundles of the deck were broken apart and tested for sheet gauge and galvanized coating thickness

via ultrasonic testing methods. It was proven that all of the metal deck was still within specification, and with the exception of the top sheet of the bundle, still had the appearance of brand new decking.

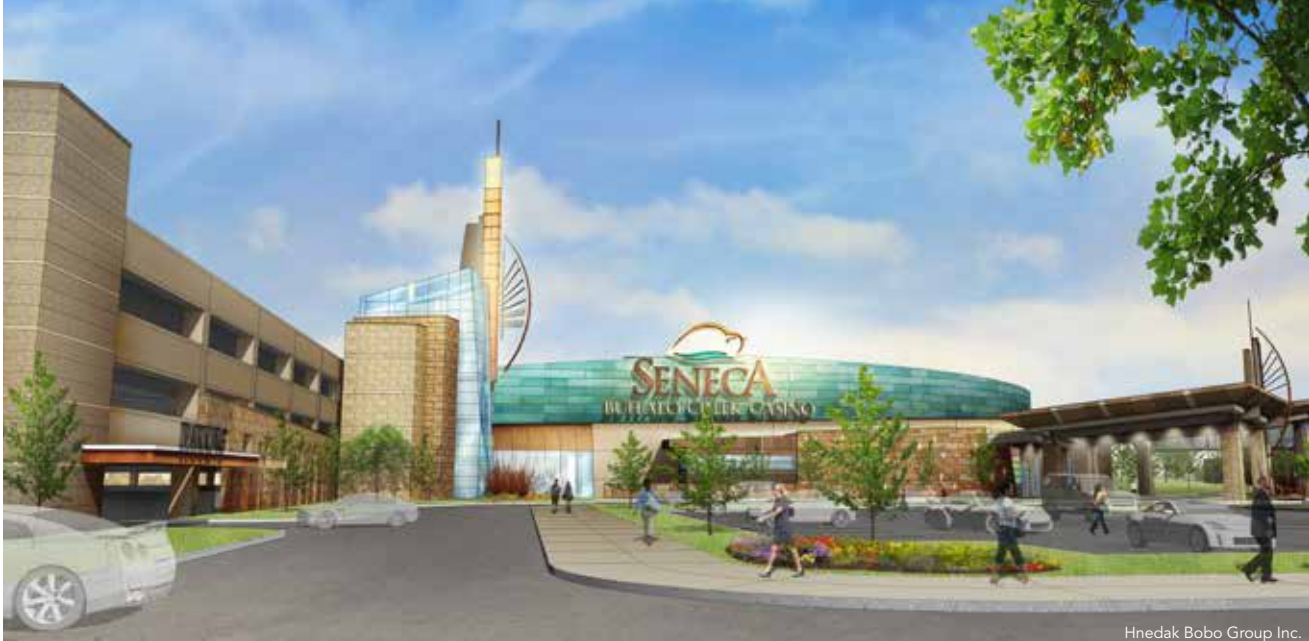
◀ A decorative column cover designed to represent the “Tree of Peace,” celebrating the Seneca Nation’s cultural history.

▲ The building uses 540 tons of steel.
